A Report on Community Archaeological Walkover Surveys of the Southern Foothills of Brant Fell

Project Archive Report

By Dr Douglas James Mitcham
Community Heritage Officer
Yorkshire Dales National Park Authority

May 2023

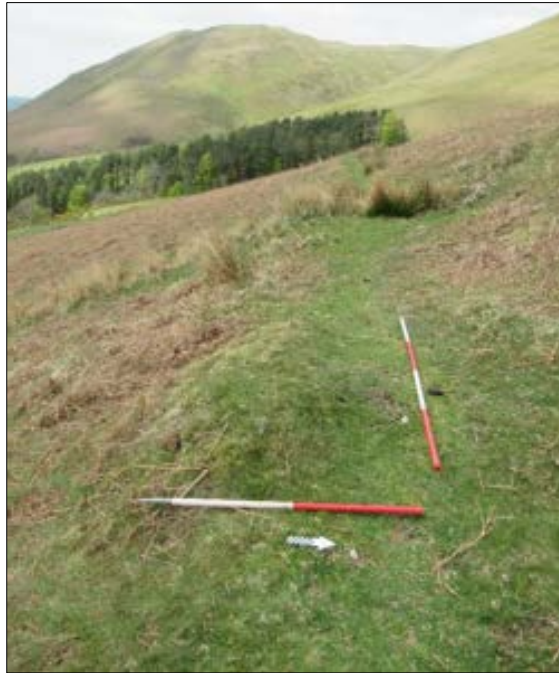
Figure 10: FID16, east-west boundary bank at Knott forming part of MYD33418.

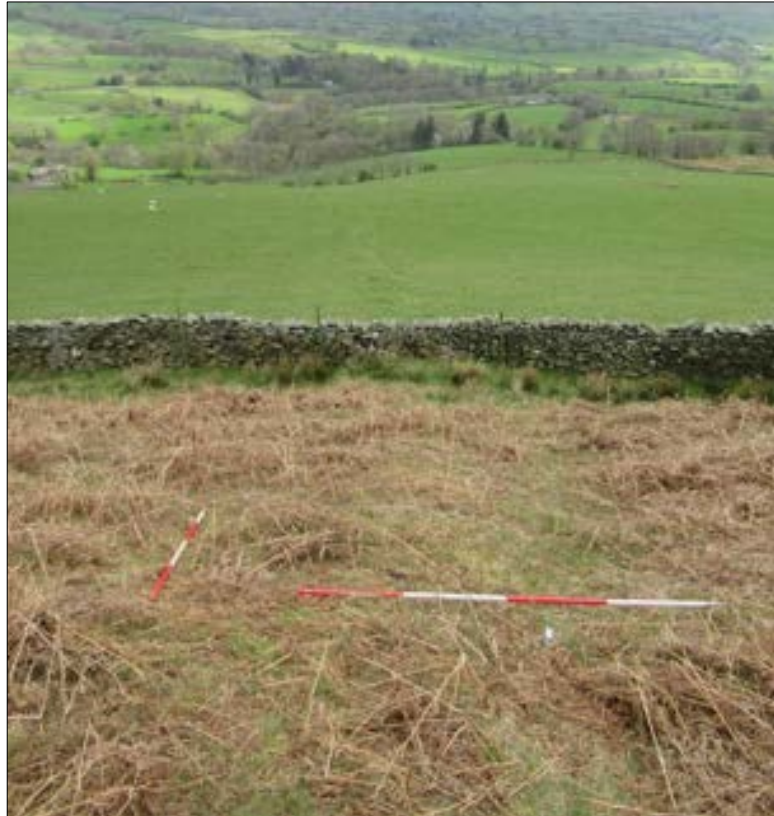
Several of the north-south boundaries (including FID15, 17 and 18) of MYD33418 were observed to underlie and continue beyond the present walled boundary of the common, suggesting they are cut through by this latter boundary and are of an earlier date (figure 11). The northern extent of the MYD33418 field system defined by the east-west boundary FID16 appears to have been abandoned at some stage and the boundary of the enclosed farmland and the edge of the common re-organised further to the south. This may have been due simply to the steepness of the slope, or reflect a more significant re-organisation of the boundaries and use of the landscape in this area, for example with a Medieval field system created further south. Some of the north-south boundaries broadly follow the same alignment as those on the south side of the common boundary wall and they clearly all formed part of the same field system at some stage. Whilst some slight changes in the course of the north-south boundaries can in places be observed on the south side of the common boundary wall.

Figure 11: FID18, a north-south aligned earthwork bank and ditch forming part of MYD33418 which continues beyond the boundary of the common onto the enclosed farmland.

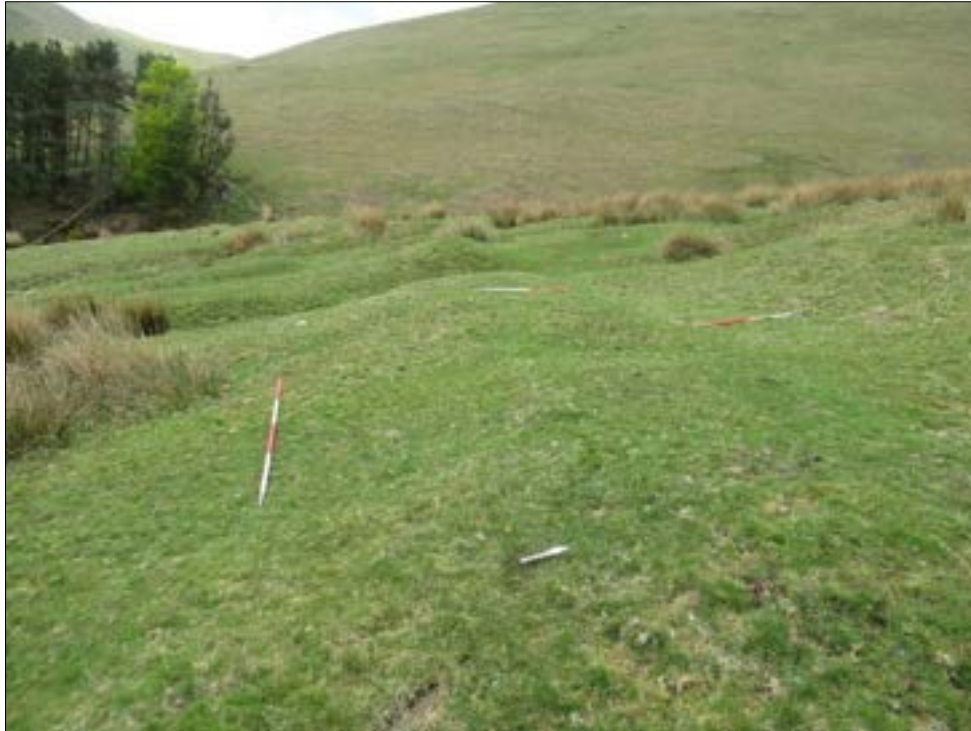
Figure 12: Hollow ways FID8 (running left to right) cutting through the earthwork FID16 (foreground, centre). This relationship was recorded as FID19.

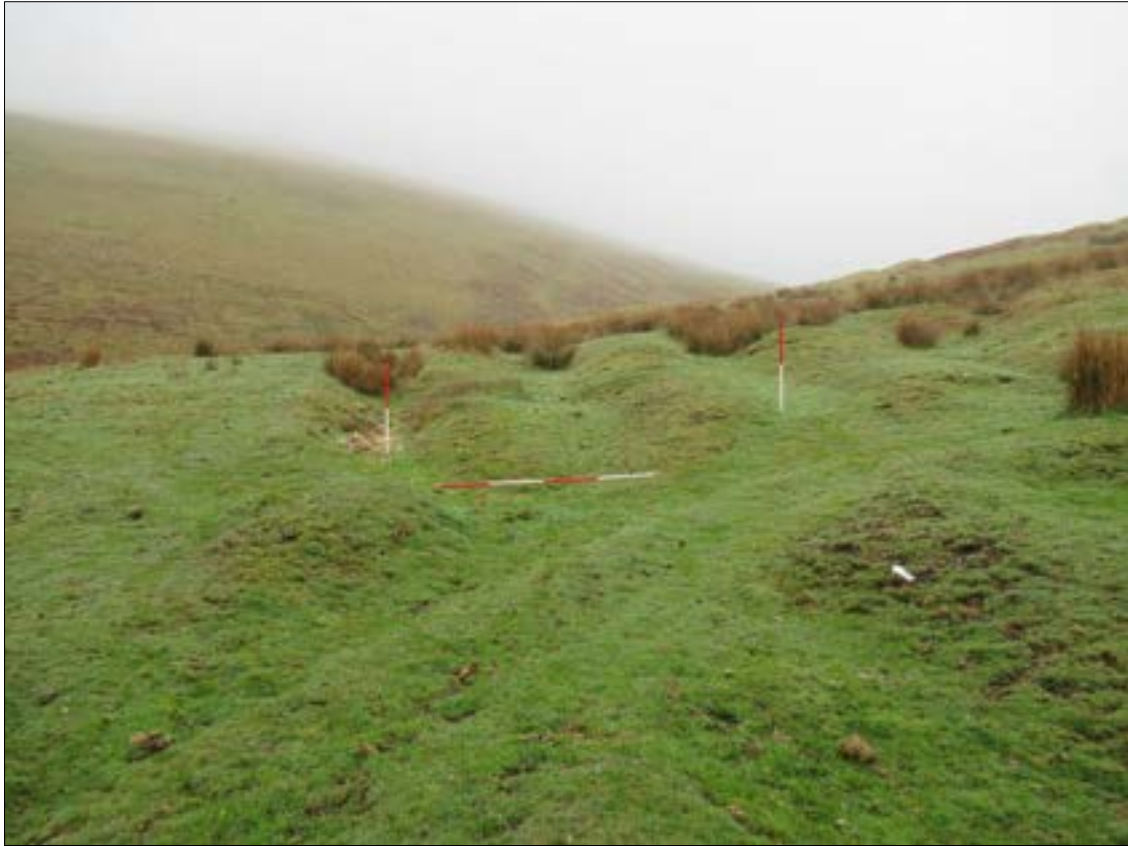
An area of hollow ways (FID8), comprising two groups of adjacent hollow ways following a similar route, but taking slightly different routes at their southern ends to pass through the common boundary wall at two different points, were recorded to the east of Little Ashbeck Gill (figure 13). The individual hollow ways vary in size but are circa 1m wide and up to 0.25m deep. There are many different routes suggesting the sequence has some considerable time depth and they cover an area c.350-400m in length and circa 80m wide. As mentioned the hollow ways were observed to cut through an earlier earthwork boundary forming the northern extent of the field system on the southern slope of Knott MYD33418. The hollow ways are difficult to date precisely but their use is likely to have originated in the Medieval period and continued into the Post Medieval period, perhaps up the 18th or 19th centuries. They were in good condition but some erosion from water action was noted. The group is particularly spectacular example of branching hollow ways when viewed on aerial imagery and its direct physical relationship to FID16, providing an indication of the relative date of the latter, make FID8 of higher significance.

Figure 13: FID8 – a group of hollow ways, east of Little Ashbeck Gill.

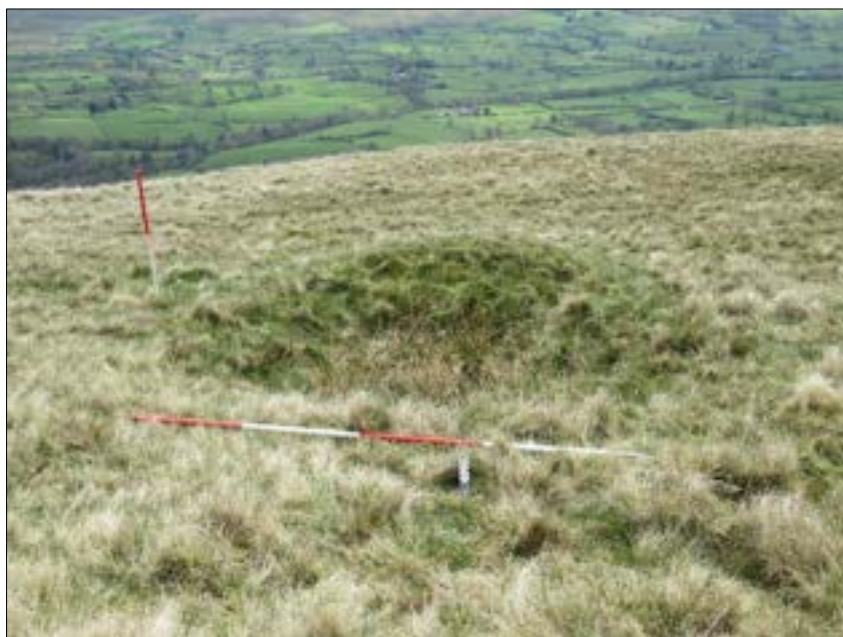
located c.23m east of FID13. The features are both well vegetated and grassed over and clearly not of very recent origin. There is no other evidence of other nearby features such as any evidence of quarrying, mining or other extractive activity. The location was noted as overlooking Sedbergh and the area around it, which could suggest an observation post or listening post associated with the Second World War defences in the area, possibly for spotting or listening for enemy aircraft, or perhaps from military training. A mobile search light battery is known to have existed in Sedbergh during WW2 (MYD33410). Alternatively, the pits may simply be abandoned prospection pits, to test the makeup of the rock strata or availability of minerals, or have been used as shooting hides. They are therefore of uncertain date but could date anywhere from the Medieval period to the 20th century.

Figure 14: FID13 - a small oval pit with adjacent spoil heap at Knott.

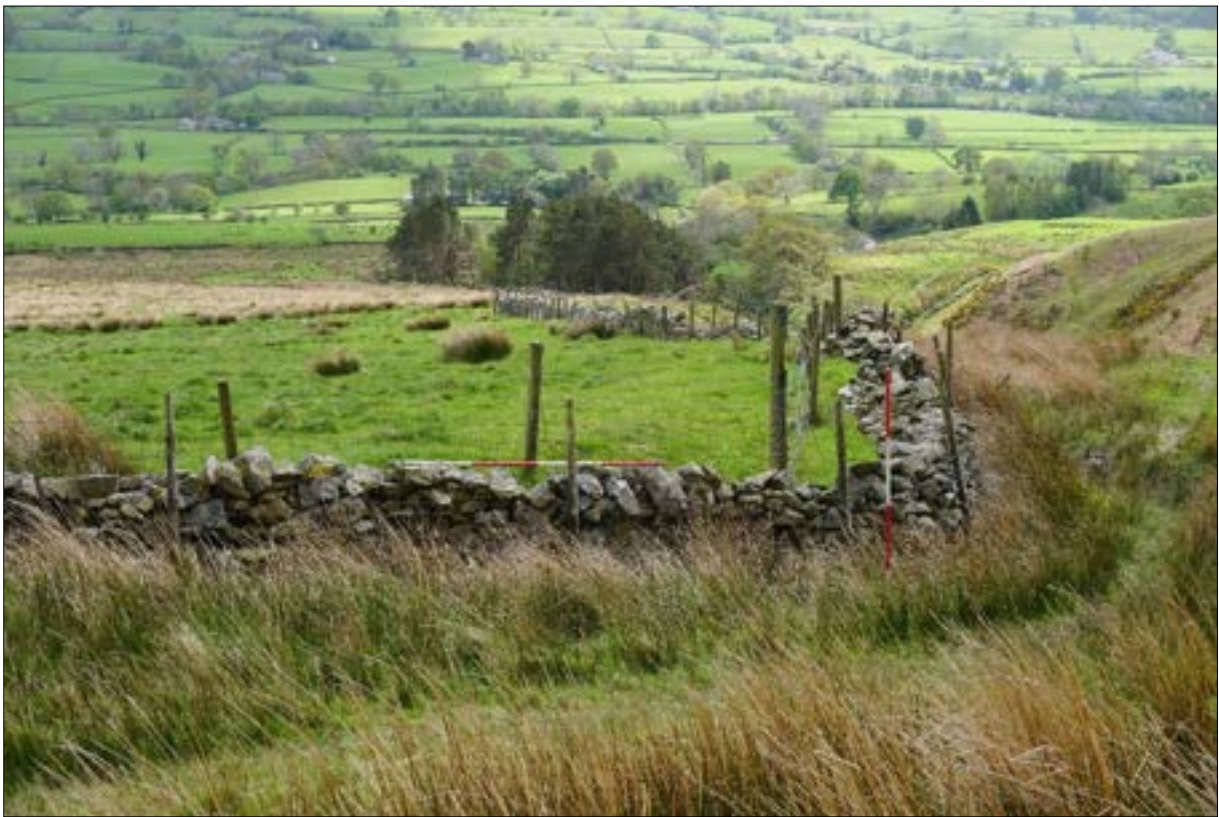
Figure 20: Bank, forming part of FID23, just visible on the south side of the common boundary wall.

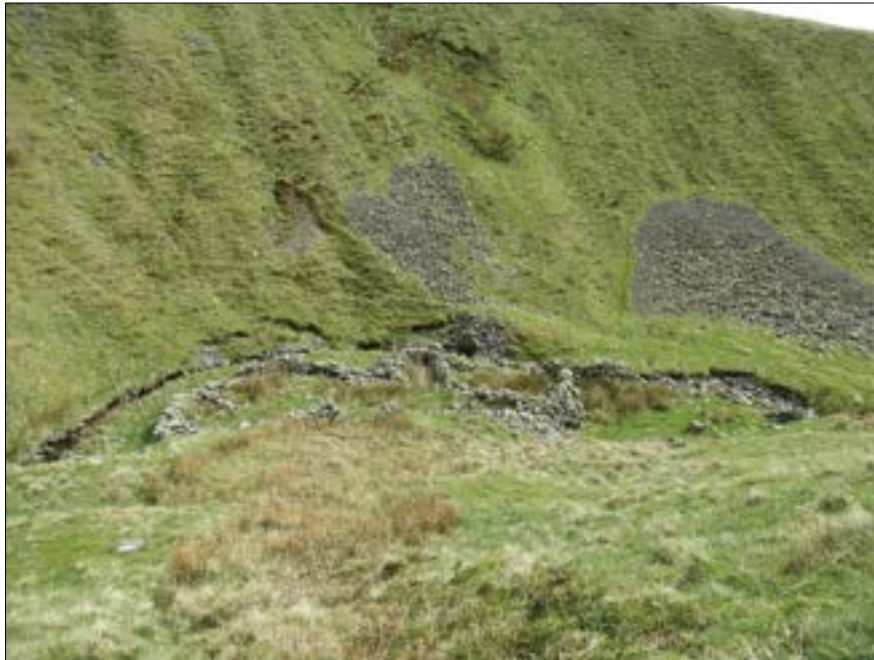
A washfold complex FID3 (MYD60674) was recorded in Ashbeck Gill, known as Ashbeck Fold on the 1st edition OS map (figure 22, figure 21). The site comprises a large sheepfold located on the west side of Ashgill Beck located at SD6667 94070 built of rough drystone wall construction and measuring 13.7m wide, 50-60m in length and circa 1.6m in height. The fold is subdivided into three main sections with the internal walls measuring circa 0.8m in thickness. Two possible internal cells were noted with one located at the northern end of the fold comprising a rough arc of stone forming a small sub-rectangular space on the inside of the external wall. The second is located in the central area of the fold and formed by corners in the northern external wall, and an internal wall which forms a sub rectangular space with an open end into the fold. The external walls measure circa 1m in thickness at their base and are circa 1.6m in height (figure 67). Most of the walls are upstanding to some degree although there are a number of significant areas of collapse, with few of the walls surviving to their original height. There is some surviving evidence of topstones at the south end of the fold on the external walls, comprising more sub rounded boulders laid transversely across the wall in a rough fashion. At least two possible entrances or exits were identified with one located on the eastern external wall next to the beck and immediately downstream of an adjacent dam on the other side of the beck recorded as F4. The fold was judged to be in fair condition although

the site is becoming ruinous and is vulnerable to further deterioration. The date of the site is unknown although the character of the walling might suggest a Post Medieval date for the fold.

Figure 21: Washfold in Ashbeck Gill, MYD60674 (FID3), known as Ashbeck Fold. The remains of the dam with a partly collapsed revetment wall is visible centre right, behind the fold.

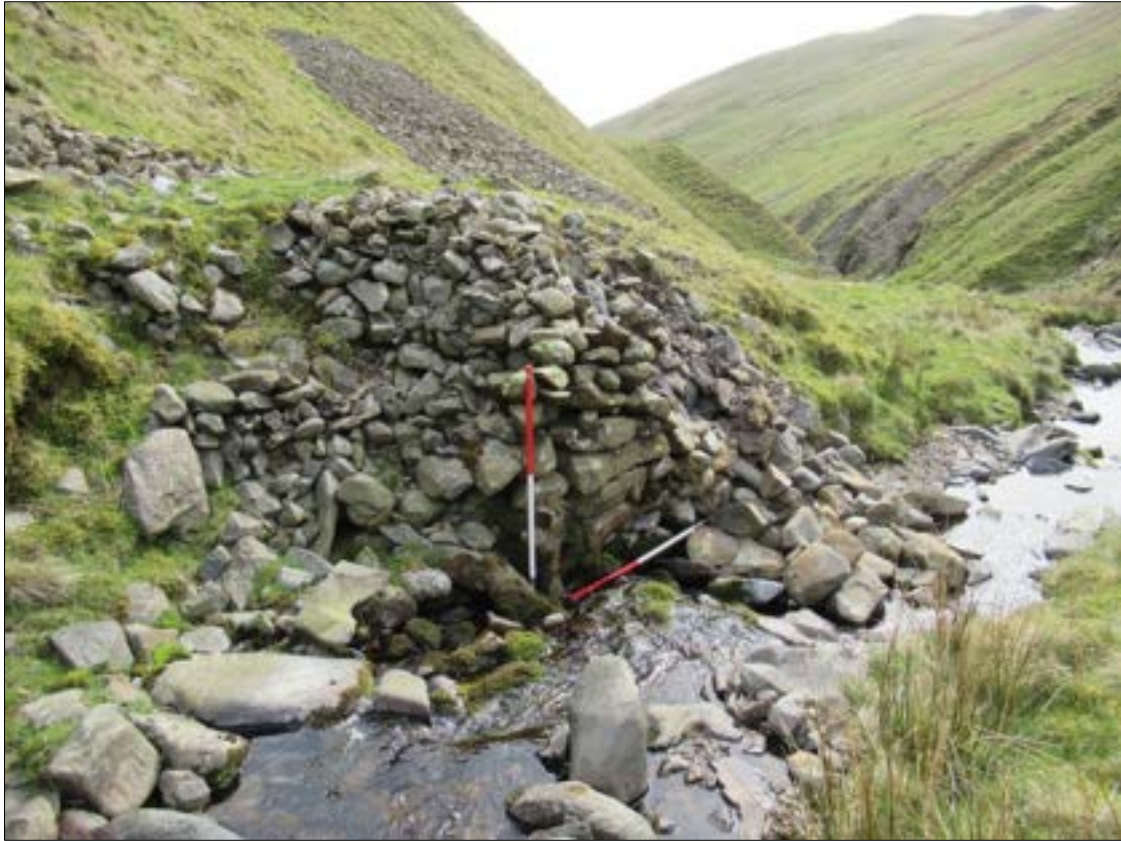
A section of a dam with a rough coursed stone revetment wall on the eastern side of Ashbeck Gill, adjacent to Ashbeck Fold was recorded as FID4 and is located at SD66678 94057 (figure 22). It is built up to the side of the beck. The feature measures circa 2m wide, 1m in length and circa 1.6m in height. The revetment wall is in poor condition and half of the outer wall course has fallen into the beck, exposing a rubble core behind (figure 23). The upper section of the remaining wall is unstable and the feature is extremely vulnerable to further water erosion. The dam likely indicates a former location of a sheep wash, perhaps using temporary boards and is located adjacent to FID3 (MYD60674) - a large sheepfold complex. No evidence of the dam now survives on the western side of the beck but it may have already been washed away or perhaps deliberately removed to prevent it obstructing the flow. It is likely to be Post Medieval in date and related to the adjacent Fold.

Figure 23: FID4 – former dam with revetment wall adjacent to FID3, showing the location of a former sheepwash.

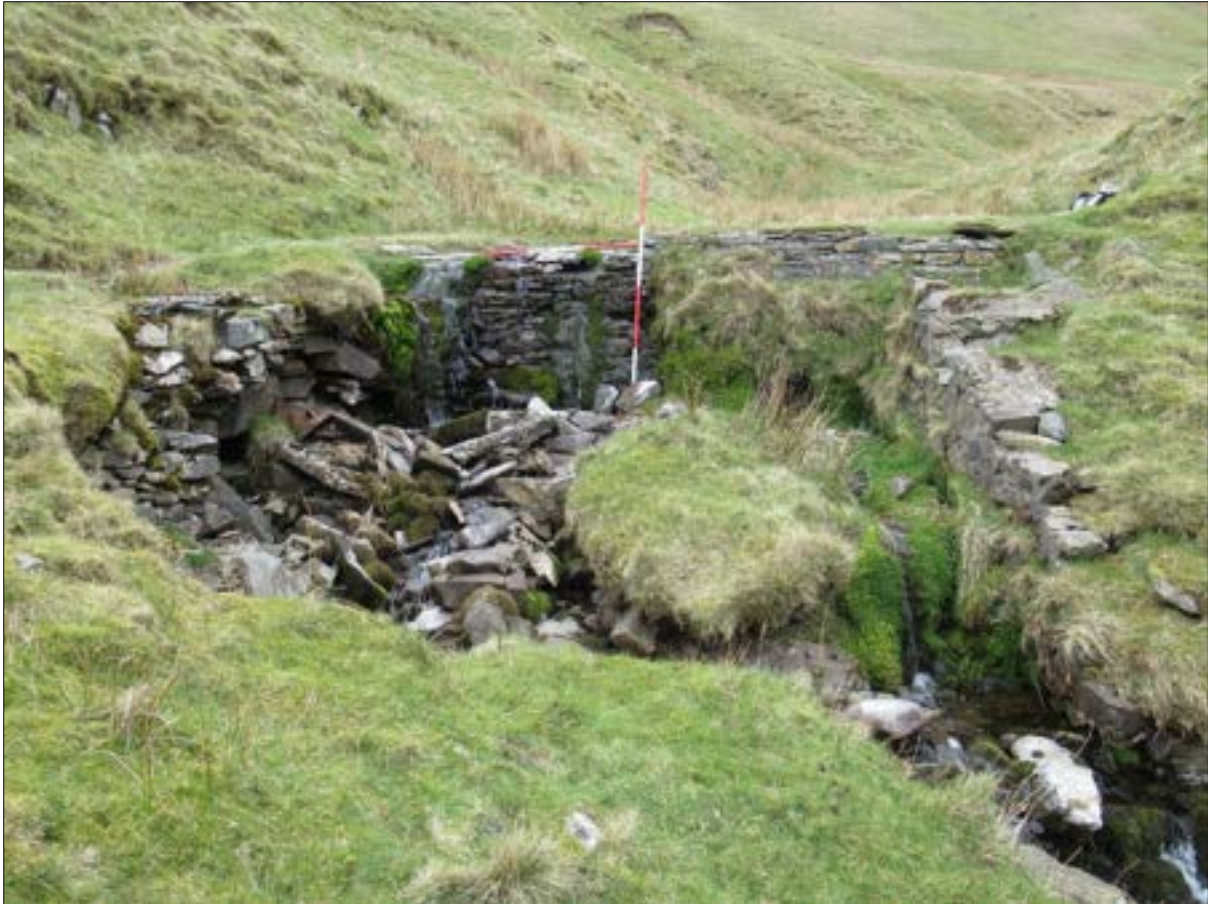
Figure 25: FID1 - Dam with infilled reservoir behind in Ashbeck Gill, formerly associated with the historic water supply system for Sedbergh Town.

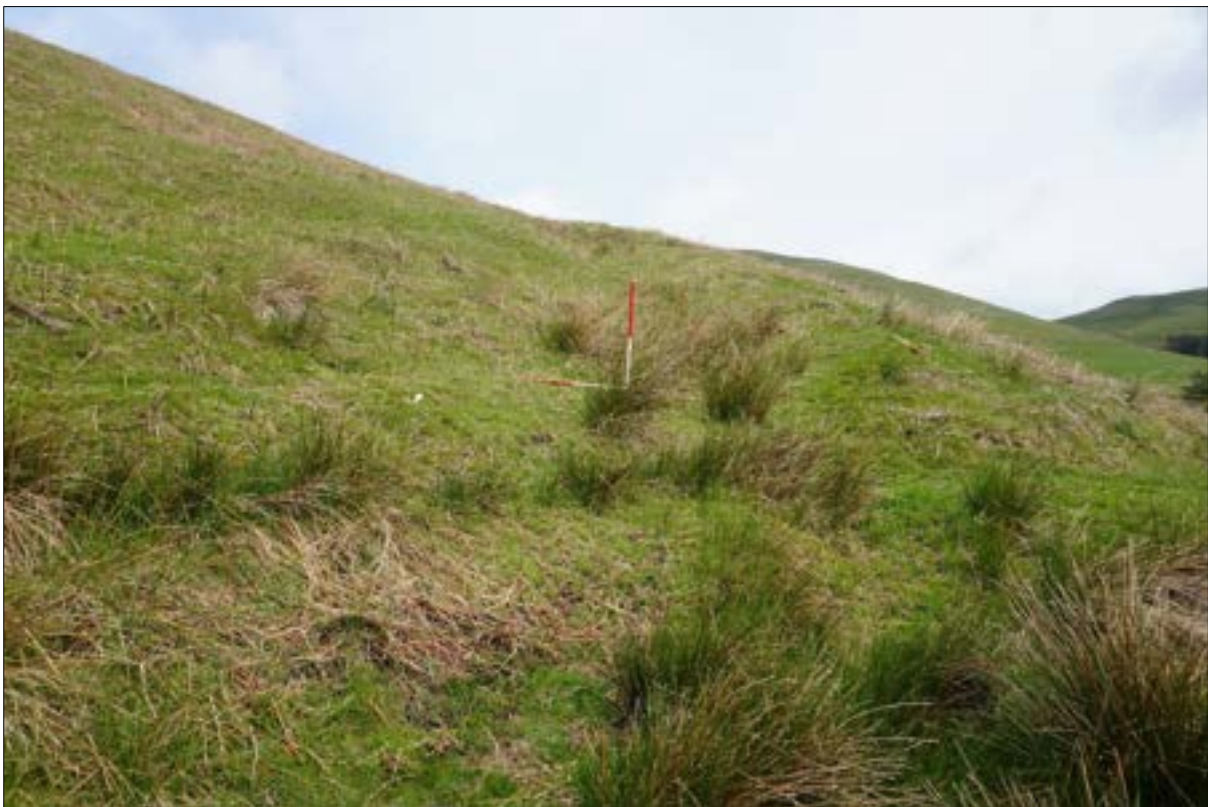
The two bank and ditch earthwork features (FID38 and 39) were also recorded as follows. FID38 was an earthwork bank and ditch crossing the south facing slope of Crook at SD66881 93283. The bank is 3.40m wide and 0.60m high, whilst the ditch is 2.50m wide. The bank runs north up the slope for a distance of 0.5km with a shallow ditch on its western side (figure 27). The bank was observed to continue to the south beyond the boundary of the common, suggesting it underlies and is earlier than the present walled boundary to the common and might be of Medieval or earlier date. A later trackway was also observed to the west of the bank and ditch. The earthwork bank and ditch was judged to be in fair condition.

Figure 27: FID38 - bank with ditch on its western side, Crook.

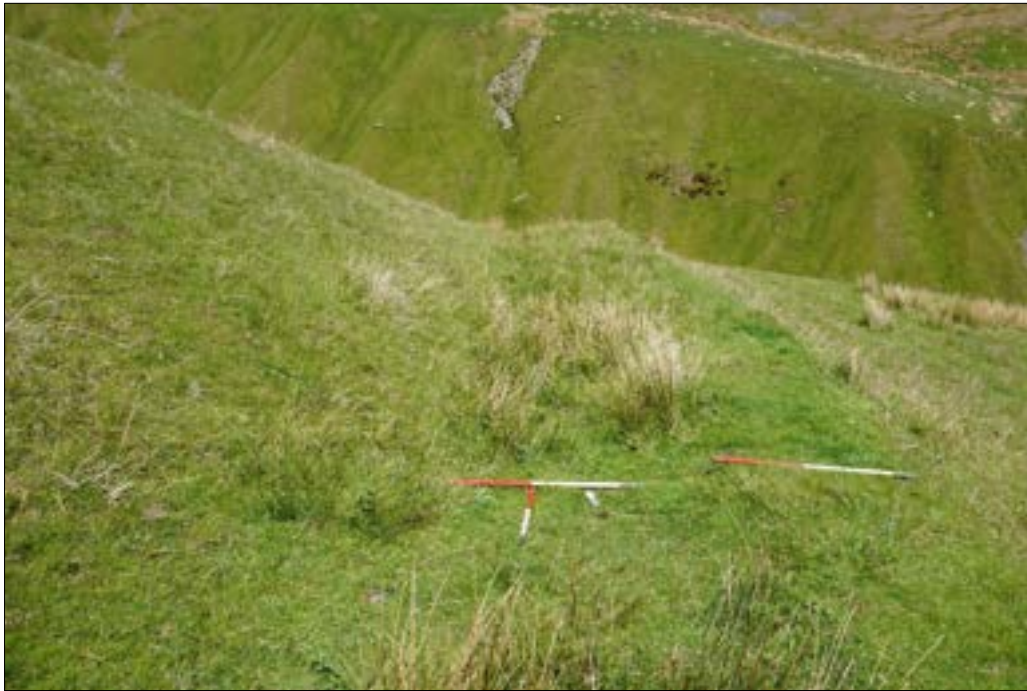
circa 0.5m high. The earthwork runs along the south eastern slopes of Crook for a distance of circa 500m, starting on the western side of Ashbeck Gill adjacent to the stream. Although its course is more difficult to trace at its western end because it is obscured by watercourses and possible trackways on AP's. This boundary FID39 also appears to be cut through by F38, suggesting FID39 is earlier in date. It was judged to be in fair condition.

Figure 28: FID39 – An earthwork bank and ditch at Crook.

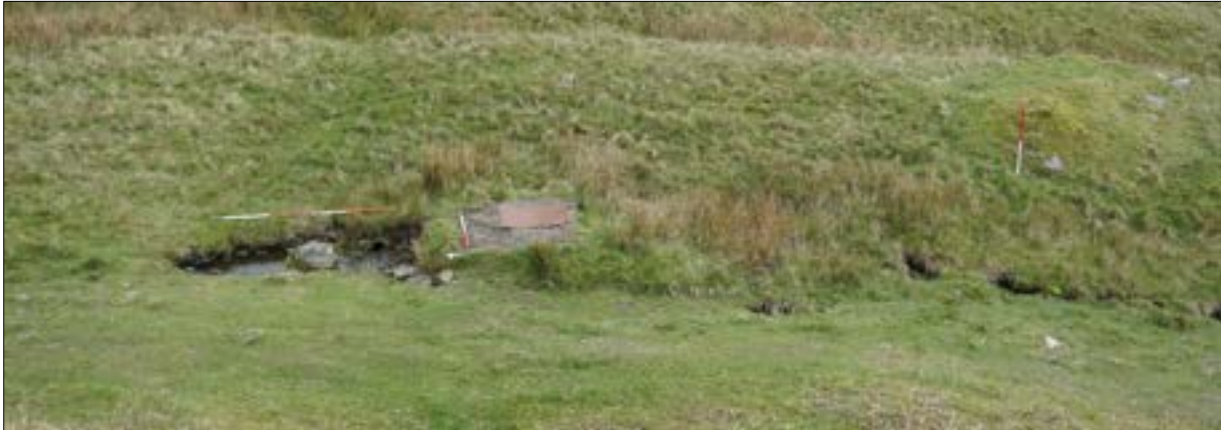
FID25 located at SD65947 93008 also had an overflow channel, a pond and a possible spoil heap associated with it (figure 31). Full descriptions of the others can be found in Appendix 2 - Feature catalogue.

Figure 31: FID25 – A concrete chamber, pond and spoil heap (behind upright ranging rod, right side), west side of Settlebeck Gill.

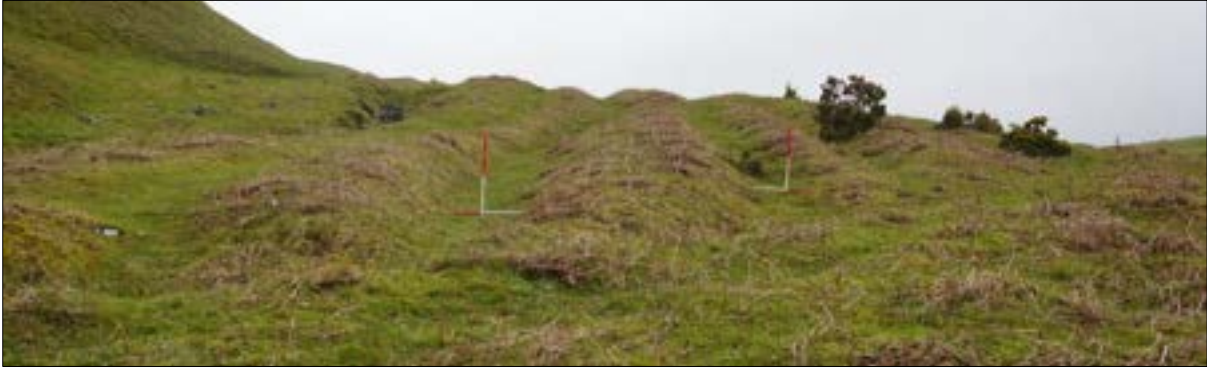
Figure 32: FID24 – A group of hollow ways, west side of Settlebeck Gill.

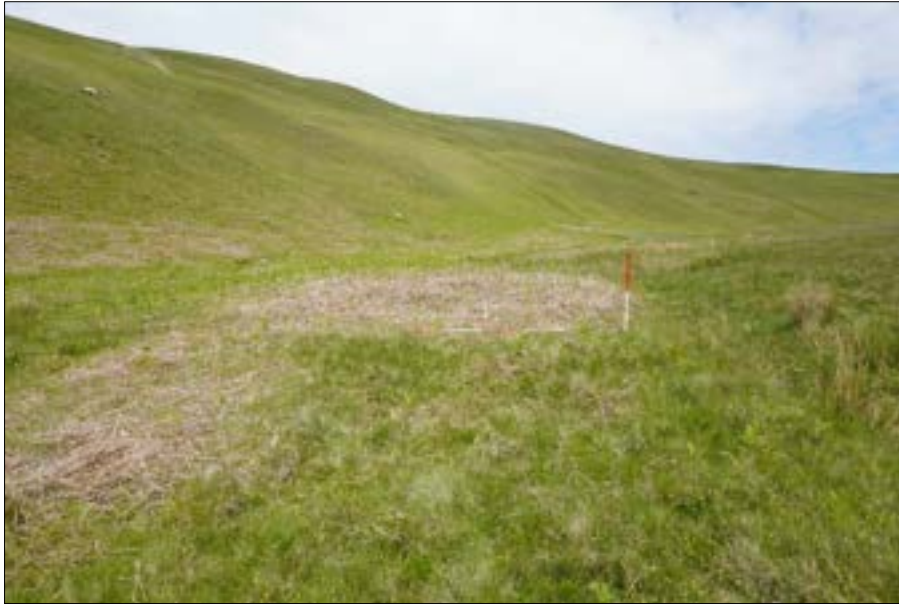
The possible example of a burnt mound FID69 was an unusual discovery within the area, comprising a large sub circular mound with a depression in its centre and a stony bank at its eastern end (figure 33). The mound is located at SD65860 93214 on the western side of Settlebeck Gill. It measures 9.45m wide north-south, 13.8m long east-west and a maximum of 0.9m high at its eastern end. It is located on a plateau below the east facing slope of Winder and above Settlebeck Gill. A narrow gully runs past the east side of the mound which is probably the route of a small watercourse and it was noted the feature is situated in a wet area of the landscape. A possible entrance to the feature was noted facing the watercourse that is circa 1.45m wide. Bracken encroachment was noted as an issue and a footpath passes very close to the edge of the mound on its western side and could threaten it if it moves eastwards. Alternatively, it is also possible the mound could be kiln-like feature of later e.g. Medieval or Post-Medieval date, and consideration should be given to whether it is similar to FID26. However given the landscape context and form of the feature, together with its apparent isolation, it is interpreted here as a possible burnt mound of prehistoric date.

Figure 33: FID69 - Possible prehistoric burnt mound adjacent to a stream.

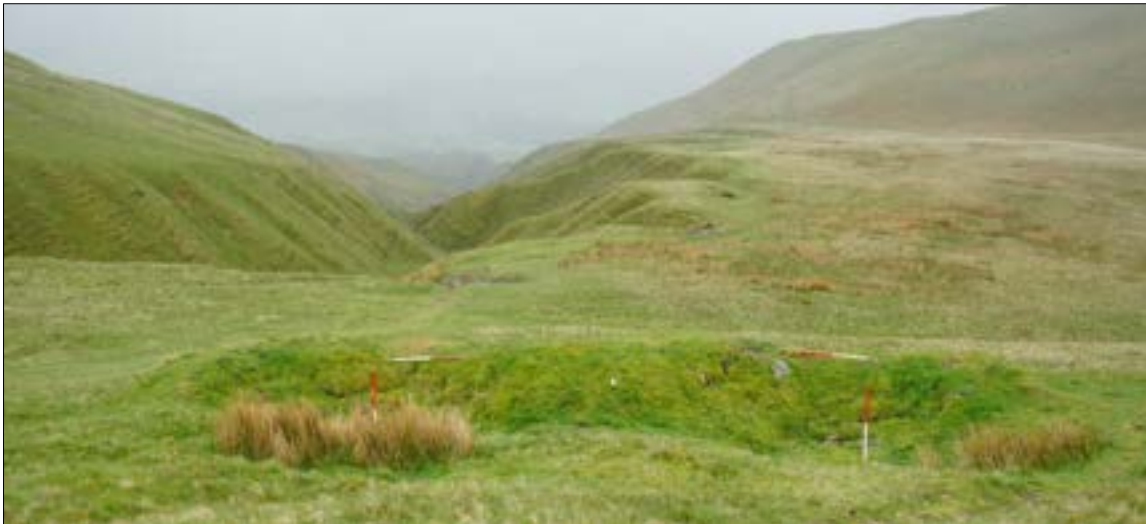
Figure 34: FID27 – A sub circular earthwork, resembling a double kiln-like feature.

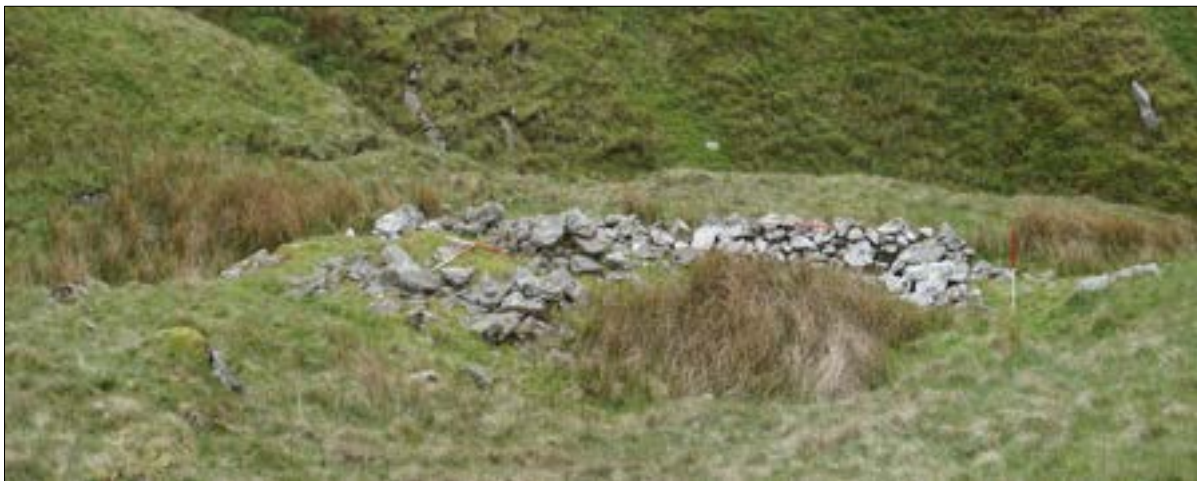
Finally, a ruinous stone built fold located at SD66013 935559 on the western side of a tributary stream at the head of Settlebeck Gill was recorded (FID29) (figure 35). This had an oval shape comprising two main internal spaces with a third small internal cell on its eastern side. The drystone wall structure is in poor condition and the structure is severely collapsed and now largely ruinous. The site is 11.10m long and 7.80m wide. A possible entrance and the remnants of a short section of wall were noted on the western side of the main fold wall. The eastern side of the site was quarried out leaving a shallow cliff edge of exposed rock. This may have been done to provide the stone required to construct the fold or to create a larger level area into which it could be built. The walls were circa 0.7m wide and where standing survive to a height of 0.8m. They are formed of sub angular and sub rounded stones piled into quite rough courses but any confident interpretation of the style and age of the walling was not possible. The streamside location strongly suggests the feature functioned as a wash fold and its setting is very similar to Ashbeck Fold, although no evidence of a dam could be identified. Several low lying areas now occupied by reeds may indicate possible locations for a dug out sheepwash although further investigation would be needed to confirm this. Again, it is likely to be of Post-Medieval date, and likely of similar date to Ashbeck Fold.

Figure 35: FID29 – the collapsed remnants of a former wash fold, Settlebeck Gill.

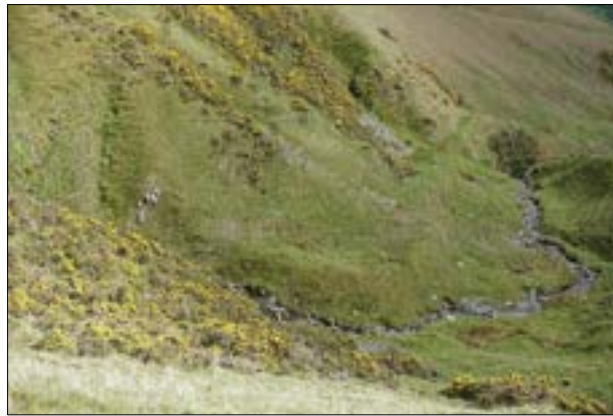
long, 14.80m wide and circa 0.5m deep. There are several spoil heaps along its western edge. A trackway leading out of the quarry and south down the east side of Settlebeck Gill was also observed. Another track was noted heading north out of the end of the quarried out area. Both FID30 and 31 are interpreted as Post Medieval quarries. They are of very different character to and likely to be considerably older than the late 19th century quarry FID5. Finally, another trackway was recorded on the upper east side of Settlebeck Gill and alongside it – leading to an area of branching holloways at its northern end. An area of hollows at its southern end, located close to the boundary wall are shown on figure 30 as a LiDAR feature polygon in orange. These were not recorded as a feature as they were found to be too difficult to interpret on the ground - as to whether they were partly the result of the formation of hollow ways being further eroded away by water action or simply reflected natural water channels or gulleys.

Figure 36: FID30 - Surface quarry and trackway in Settlebeck Gill.

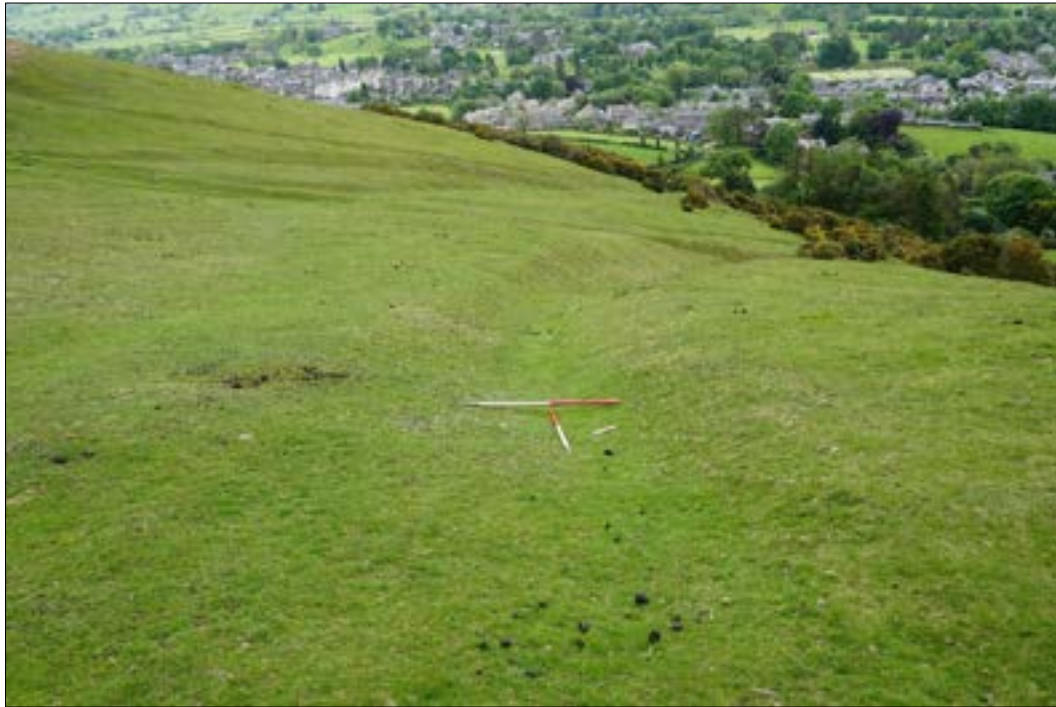
Figure 39: FID40 - A group of hollow ways, south west of Winder.

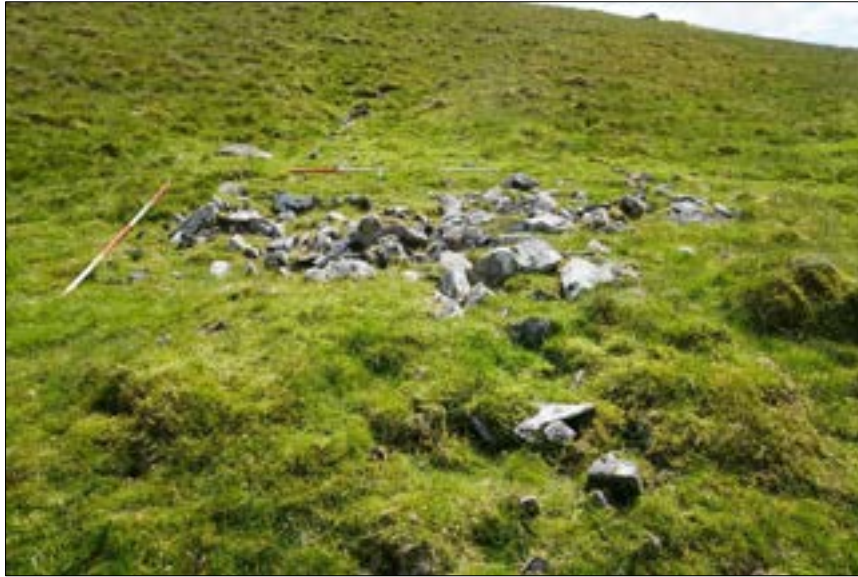
Figure 42: FID73 - A sub circular stone spread, which may be a denuded prehistoric cairn.

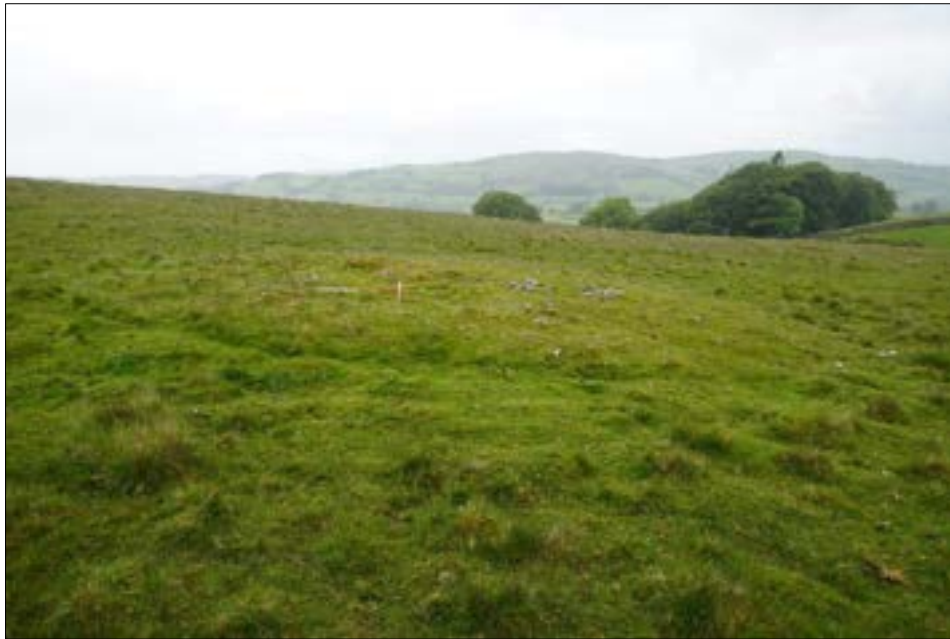
Figure 44: FID67 (MYD33355) - An enclosed single cell structure, a hut circle or denuded kerbed cairn.

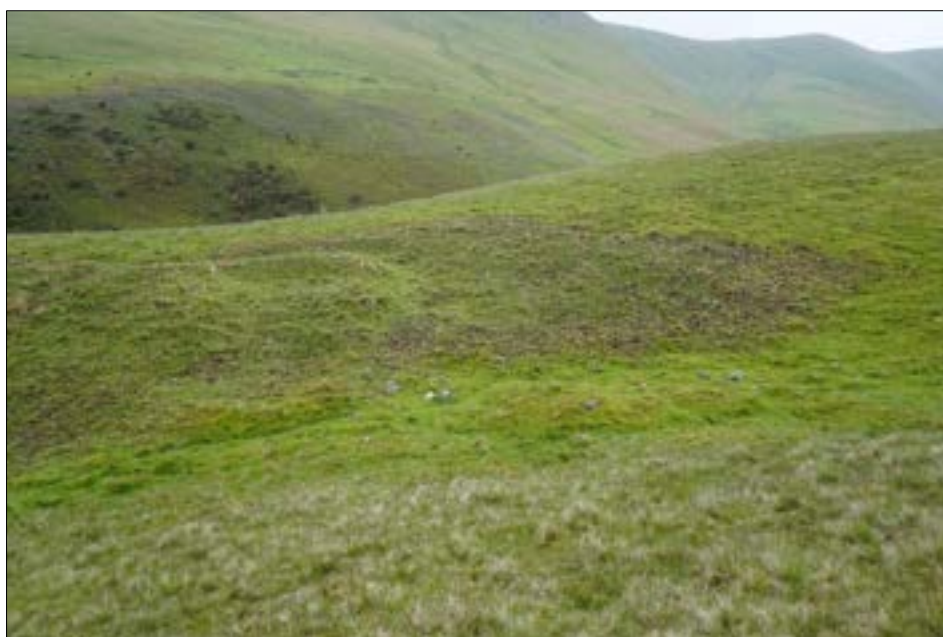
Figure 45: FID55 – An L-shaped rectangular earthwork, south of Crosdale beck, interpreted as a shieling.

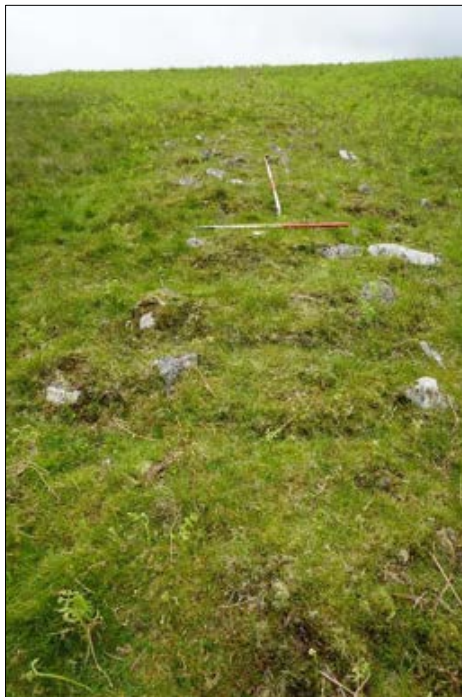
Figure 53: FID80 - Bank of enclosure forming part of MYD33261

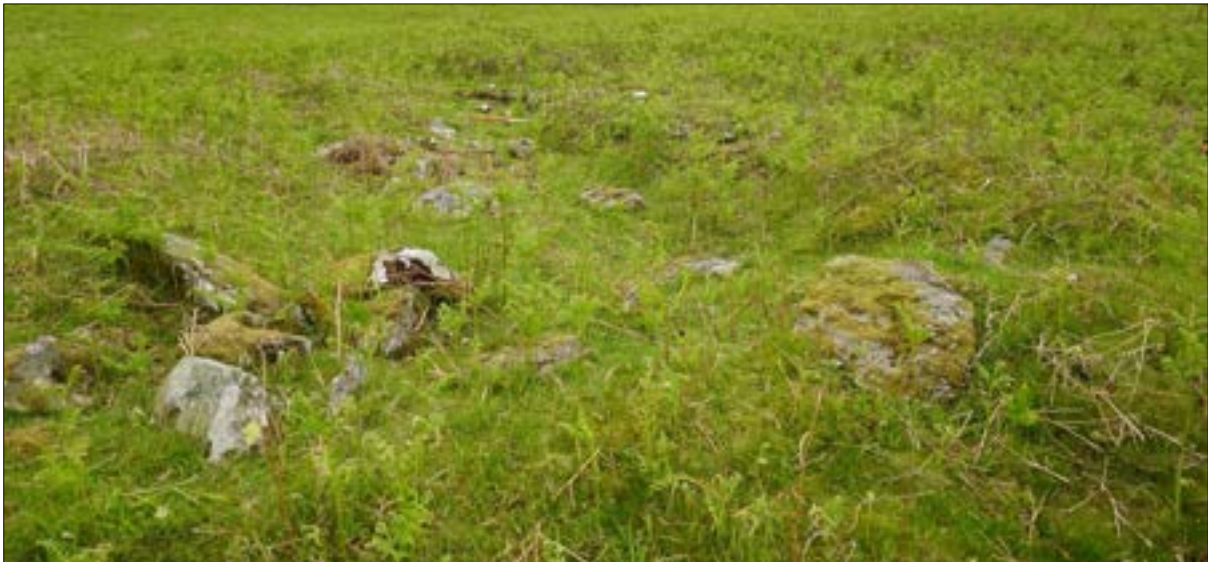
Figure 54: FID82 (MYD866) – A view along the rectangular building. The extent of bracken encroachment can clearly be seen.

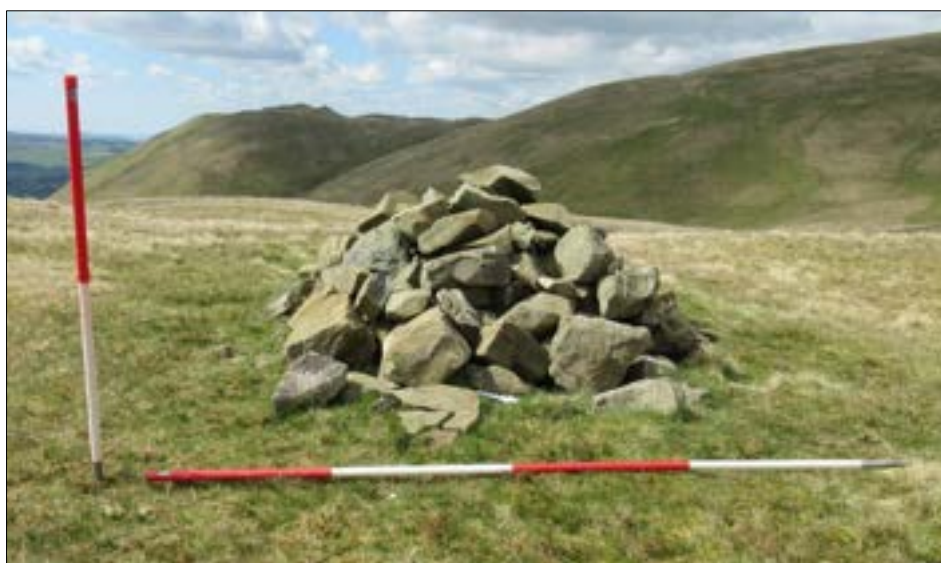
Finally, an oval cairn (FID12) was noted on the fell summit with a pointed profile and graffiti from 1947 strongly suggesting it is a modern feature of mid-20th century date – this was recorded partly as a training exercise and for the avoidance of future doubt should it subsequently be reported (figure 74). The irregular rectangular sheep fold MYD50564 attached to the common boundary wall was not recorded as it was not accessible.

Figure 74: FID12 - Modern cairn on the summit of Knott, with 1940's graffiti on the flat broken slab just behind the horizontal ranging rod, left of centre.

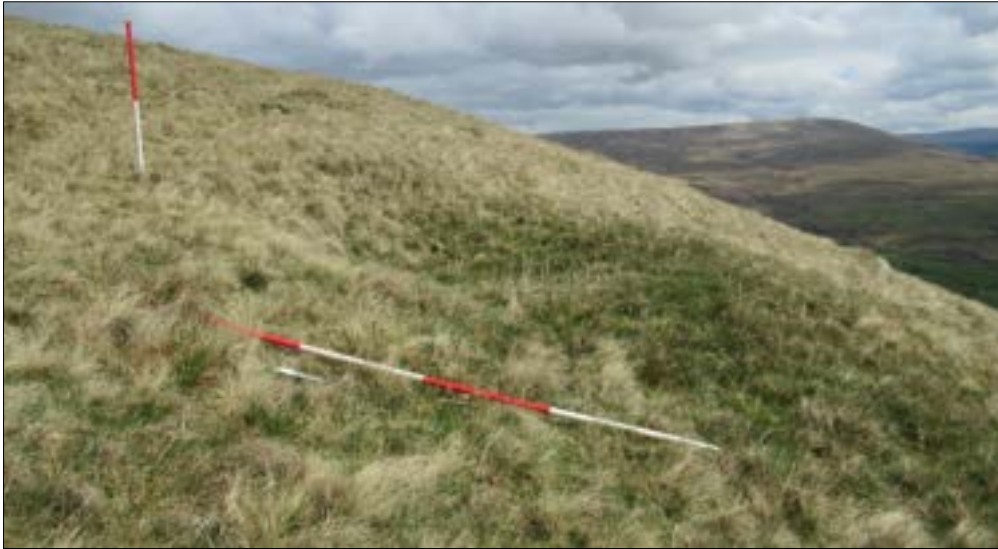
Figure 75: FID14 - Oval shaped pit and spoil heap, at the south western end of Knott. View facing north east.

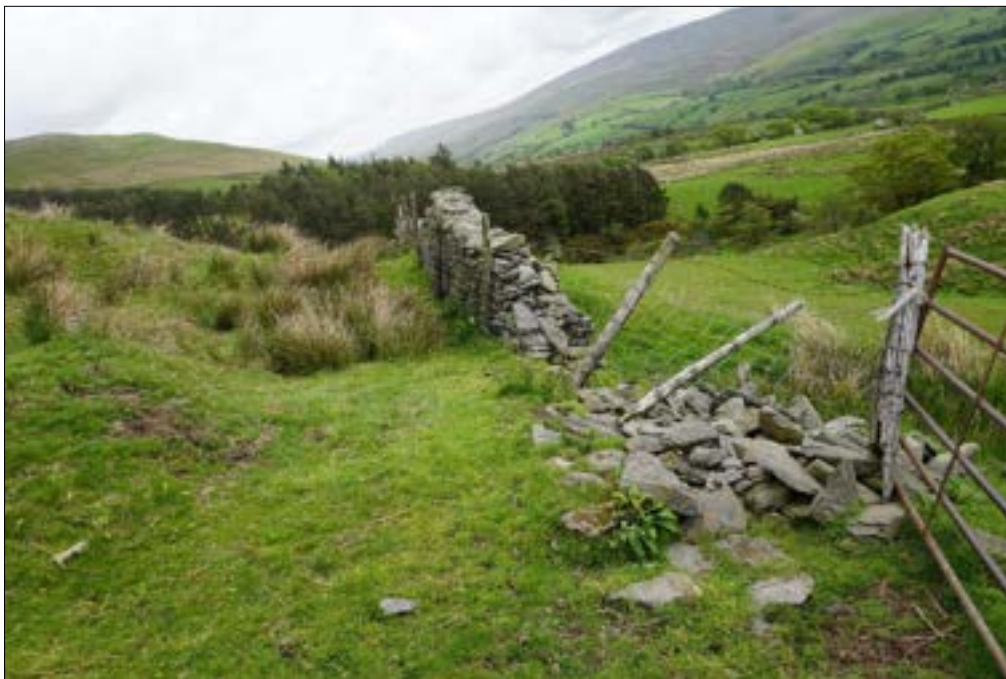
Figure 90: FID38 - Bank observed to continue under the common boundary wall. View facing east taken from the later trackway, situated west of F38.

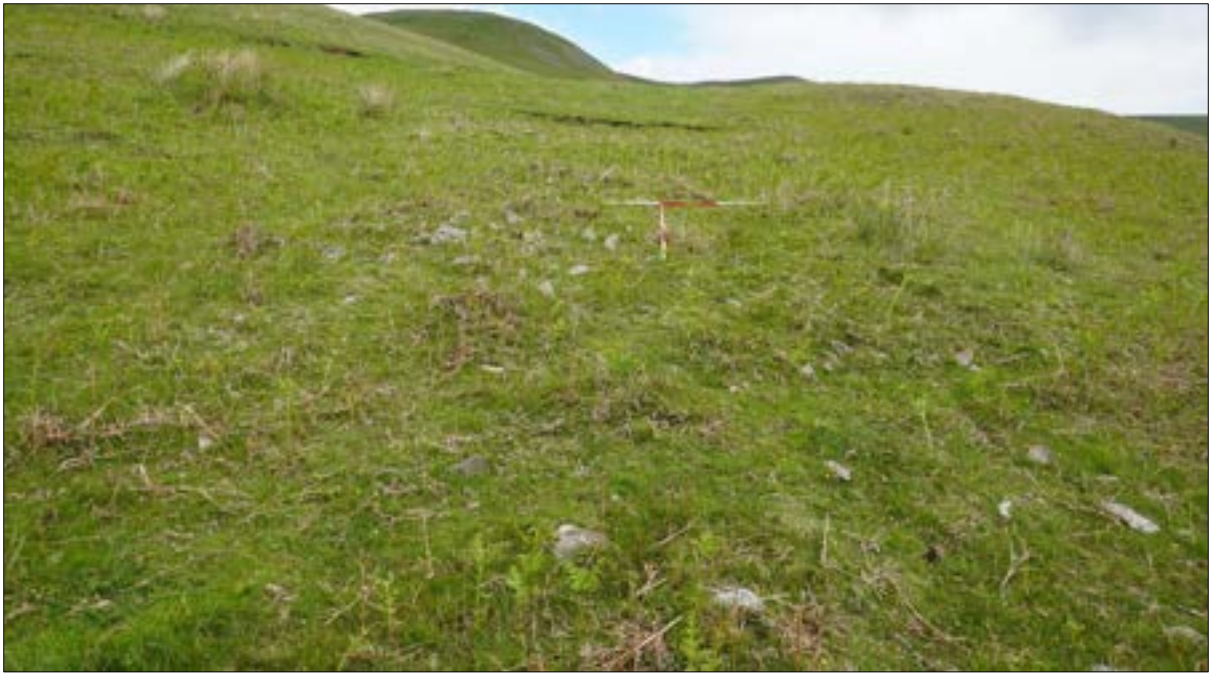
Figure 91: FID44 - A curvilinear stony mound on the north side of Crosdale Beck, facing north east.

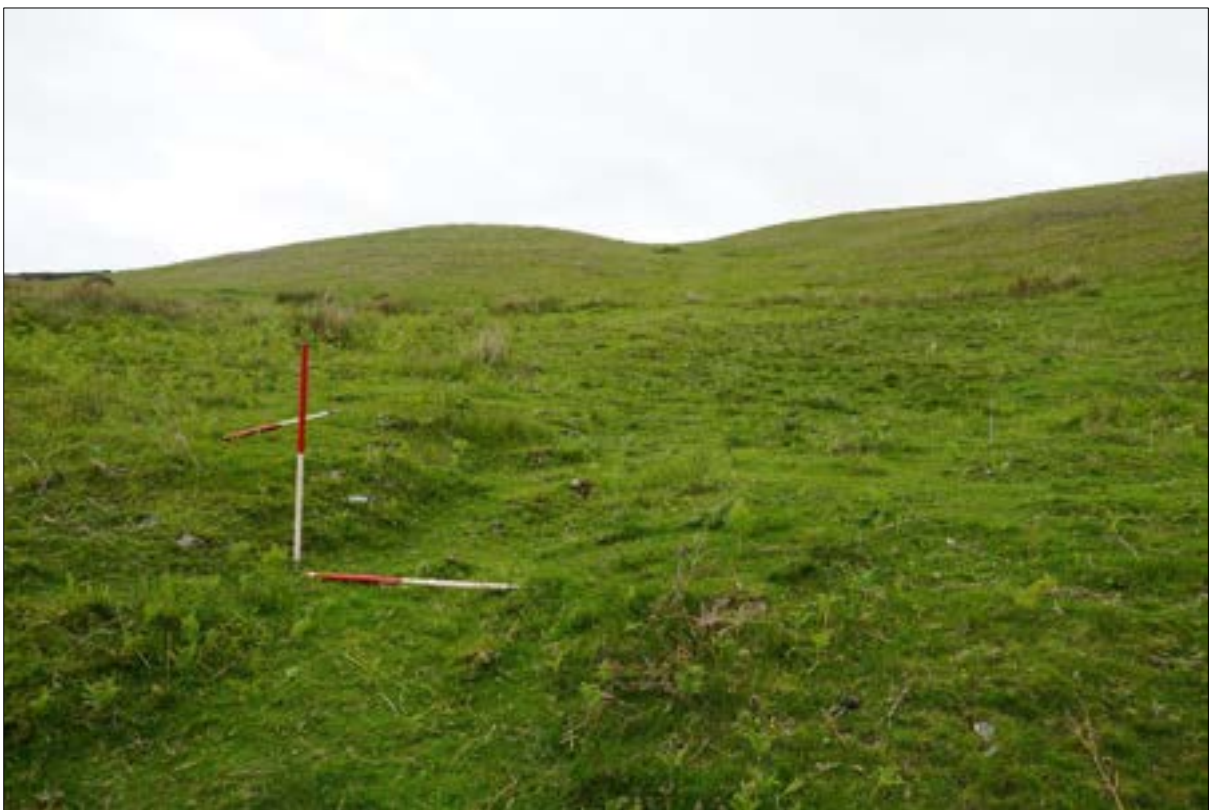
Figure 92: FID45 - An earthwork bank and ditch recorded on the HER as MYD55509, north side of Crosdale Beck, facing west. Bank was observed to continue and join another further up the slope (see figure 93).
