A Report on Community Archaeological Walkover Surveys of the Southern Foothills of Brant Fell

Project Archive Report

By Dr Douglas James Mitcham
Community Heritage Officer
Yorkshire Dales National Park Authority

May 2023

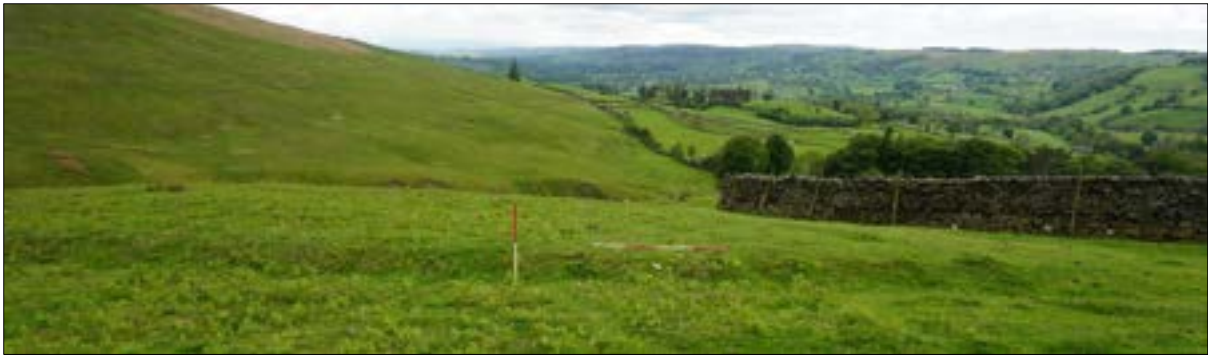
Figure 93: FID45 - view of northern end of earthwork bank and ditch F45 where it joins another earthwork bank to the left of the wall.

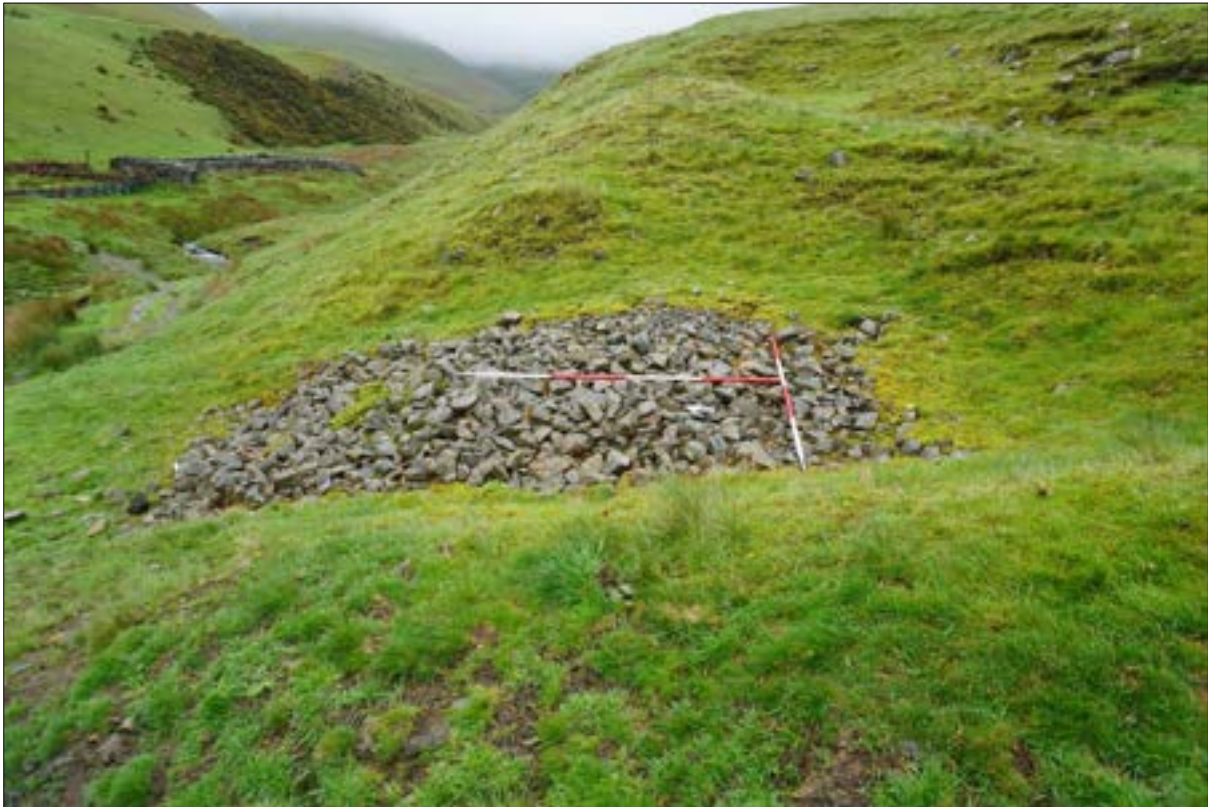
Figure 99: FID52 - Detail shot of spoil heap within quarry containing Late 19th to early 20th century pottery and modern glass.

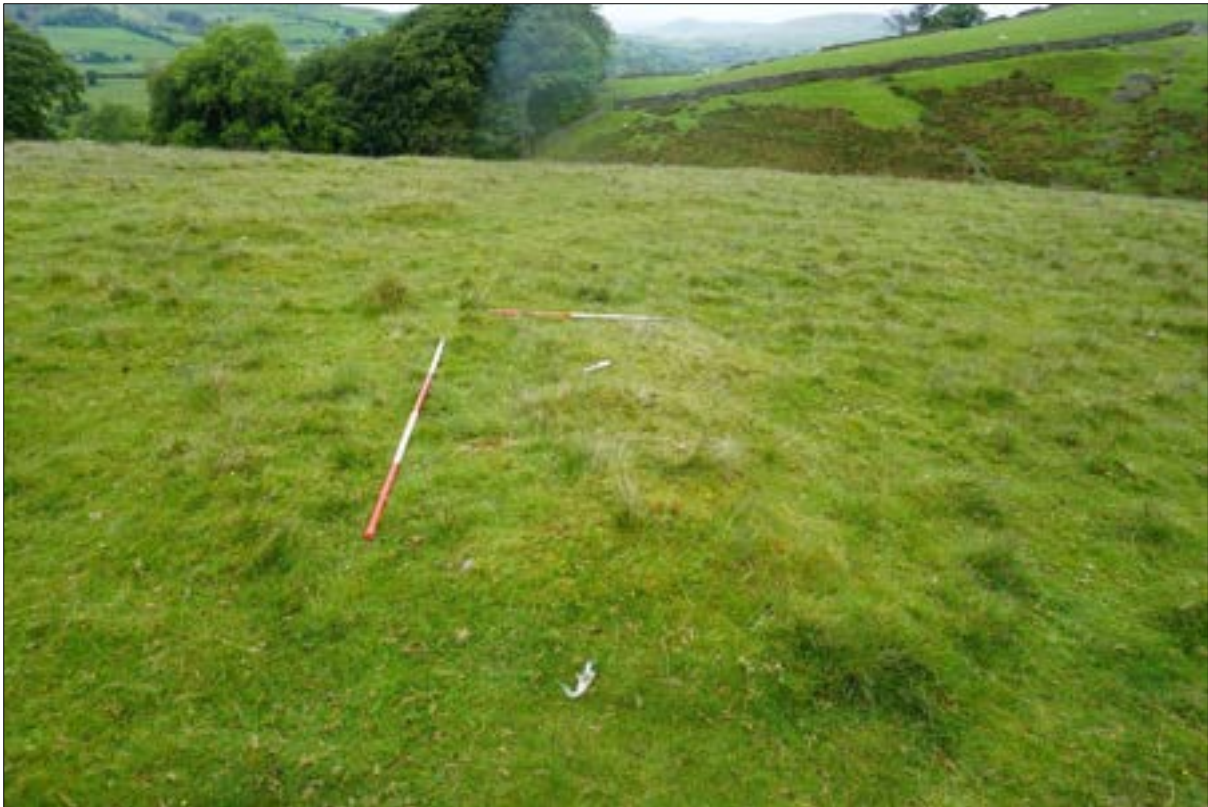
Figure 107: FID64 - A low stony mound of lenticular shape on the south side of Crosdale Beck. It is located about 10m from another very similar mound recorded as FID63 and is circa 8m east of the Craggstones enclosure MYD33352.

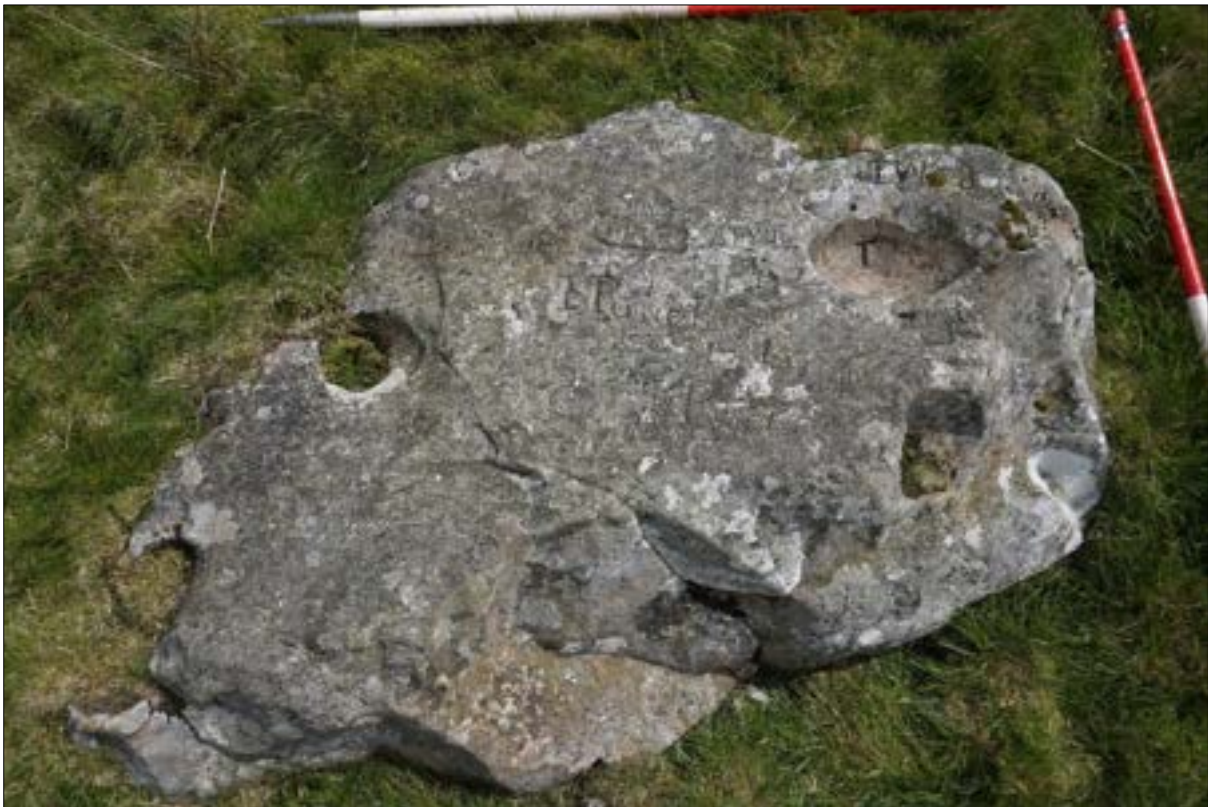
Figure 112: FID71 - A large earth fast stone block with a flat top inscribed with historic graffiti is located on the north side of Winder.

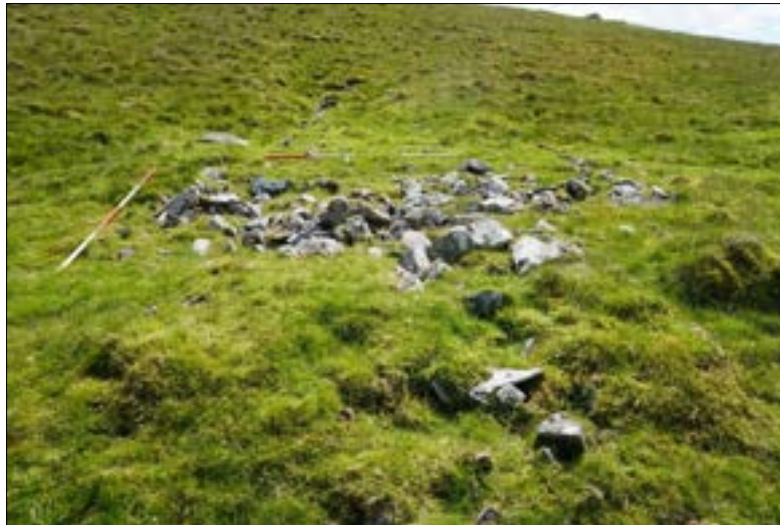
Figure 114: FID73 - A spread of stone on the hillside on the north side of Winder, facing south. It was regarded as looking artificially constructed and was observed to be sitting on a platform. A severely denuded cairn is the favoured interpretation.

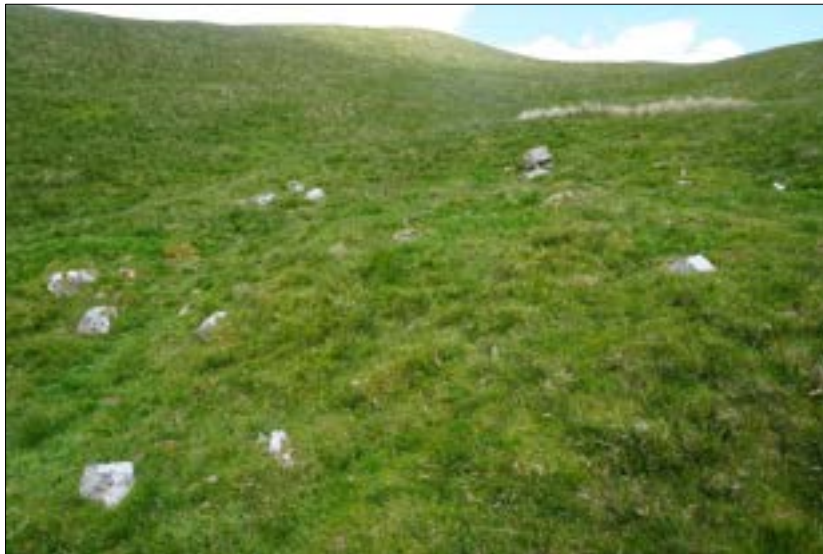
Figure 115: FID74 - A sub circular arrangement of large stones with a possible L or C shaped bank behind to the east and north, downslope from a spring head on the south side of Winder. They are of uncertain origin and may simply be a result of natural processes.

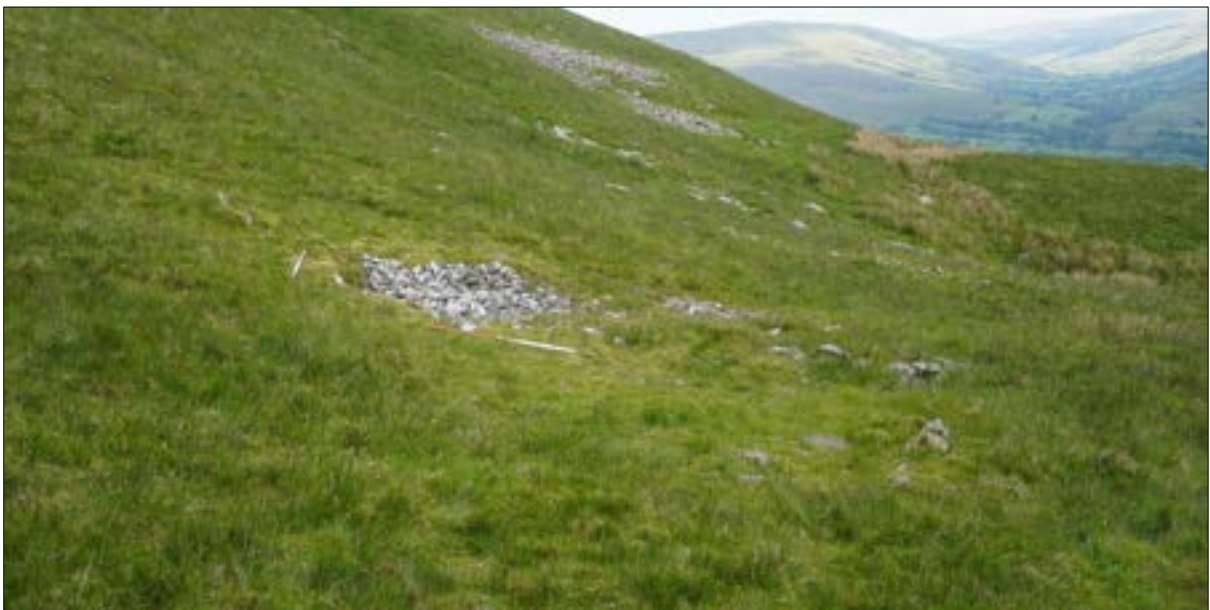
Figure 117: FID76 - A number of stone spreads situated on the south side of Winder spread over an area circa 100m by 30m. Whilst the spreads may be the result of natural scree accumulation some evidence was observed of working or shaping and drill marks on an embedded stone. The spread in the foreground also appears to be infilling an area cut into the slope – suggesting this resulted from human activity rather than natural processes.

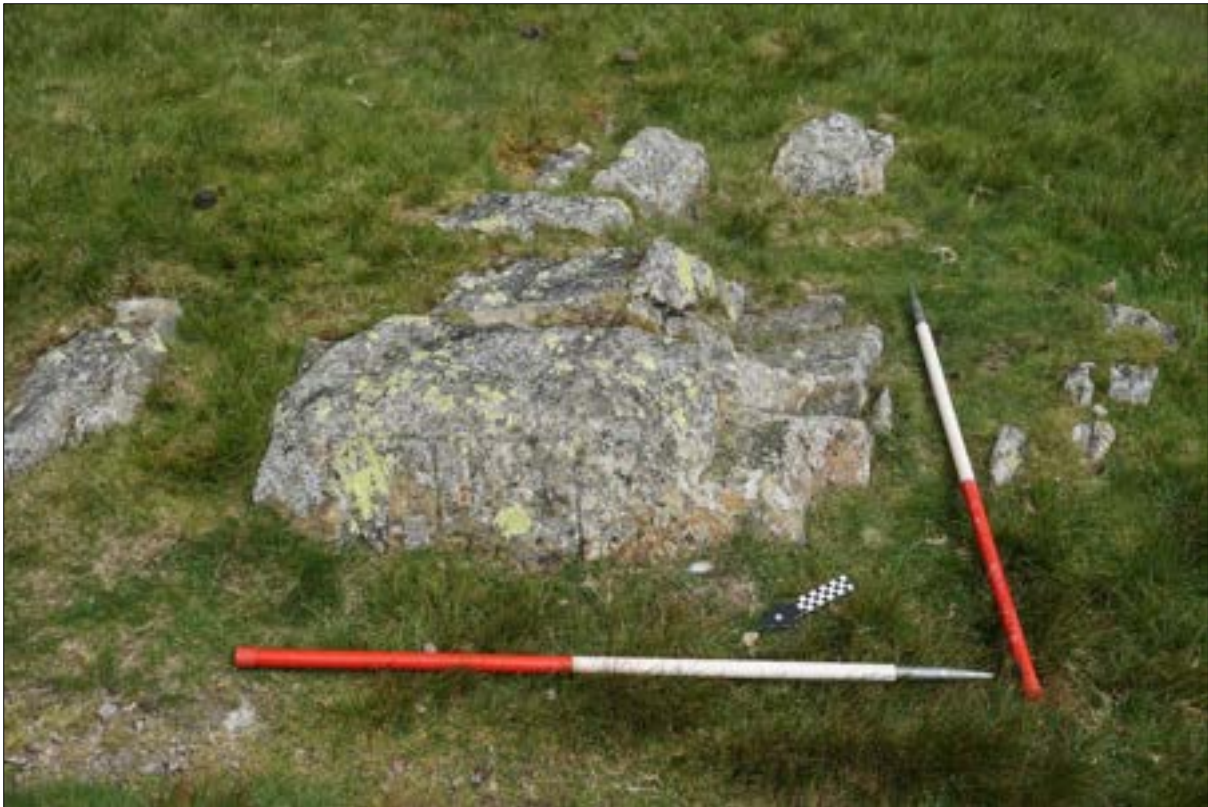
Figure 118: FID77 - Historical graffiti was observed comprising various sets of letters on an earth fast boulder and on the surrounding outcrop on the summit of Winder. A number of letters were distinguishable and no dates were present.

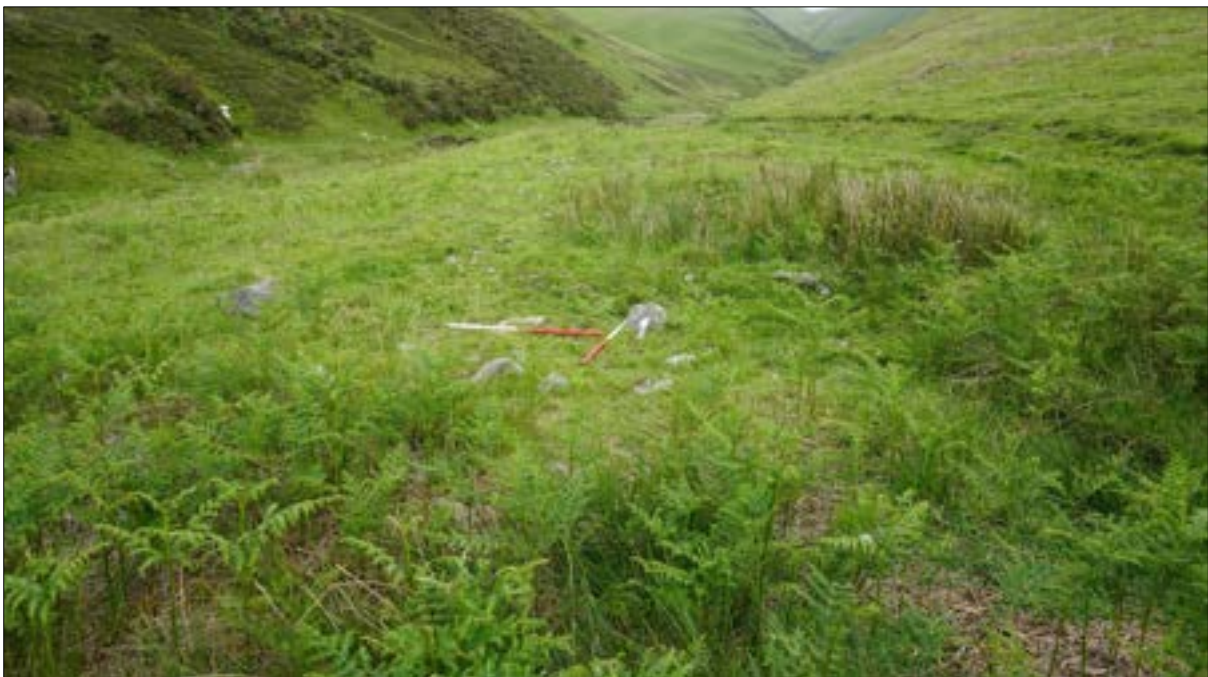
Figure 119: FID78 (MYD33256) - A number of sub-circular features, comprising at least two circular structures and either additional examples or ancillary structures arranged in a linear group on the south side of Bram Rigg Beck. View facing north. Vegetation growth (mainly bracken) made the photography very difficult.

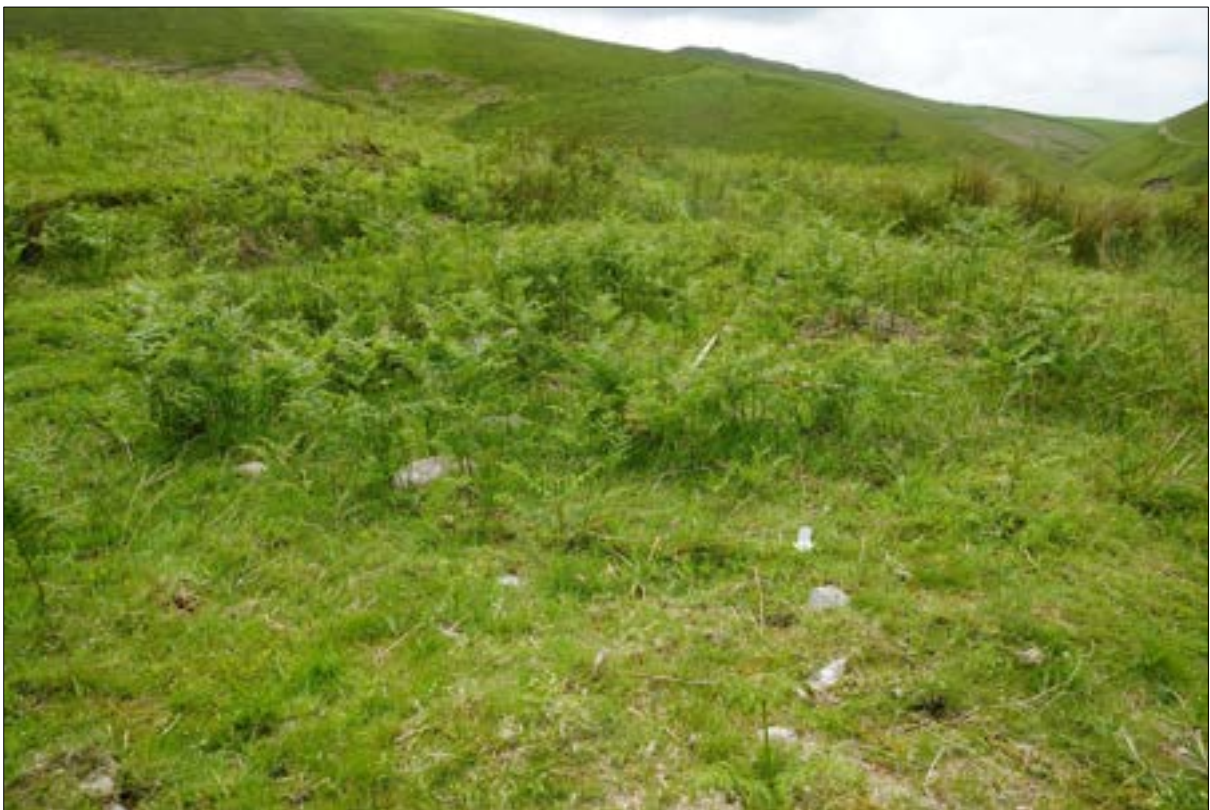
Figure 121: FID78B - A circular stony bank measuring 6.7m by 6m and circa 2m wide, which may have an entrance facing north, although largely obscured by bracken. View facing south.

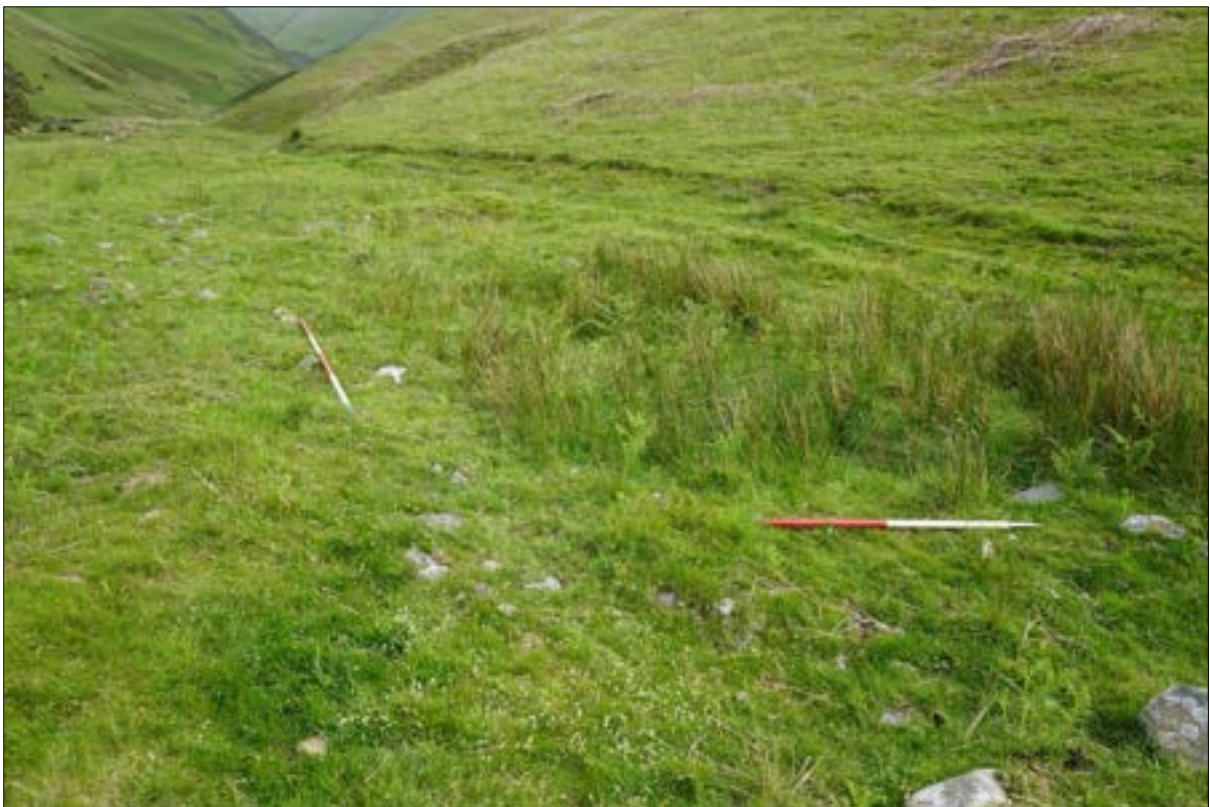
Figure 123: FID78D (MYD33256) - Another circular stony bank with an opening measuring 4m by 7m.

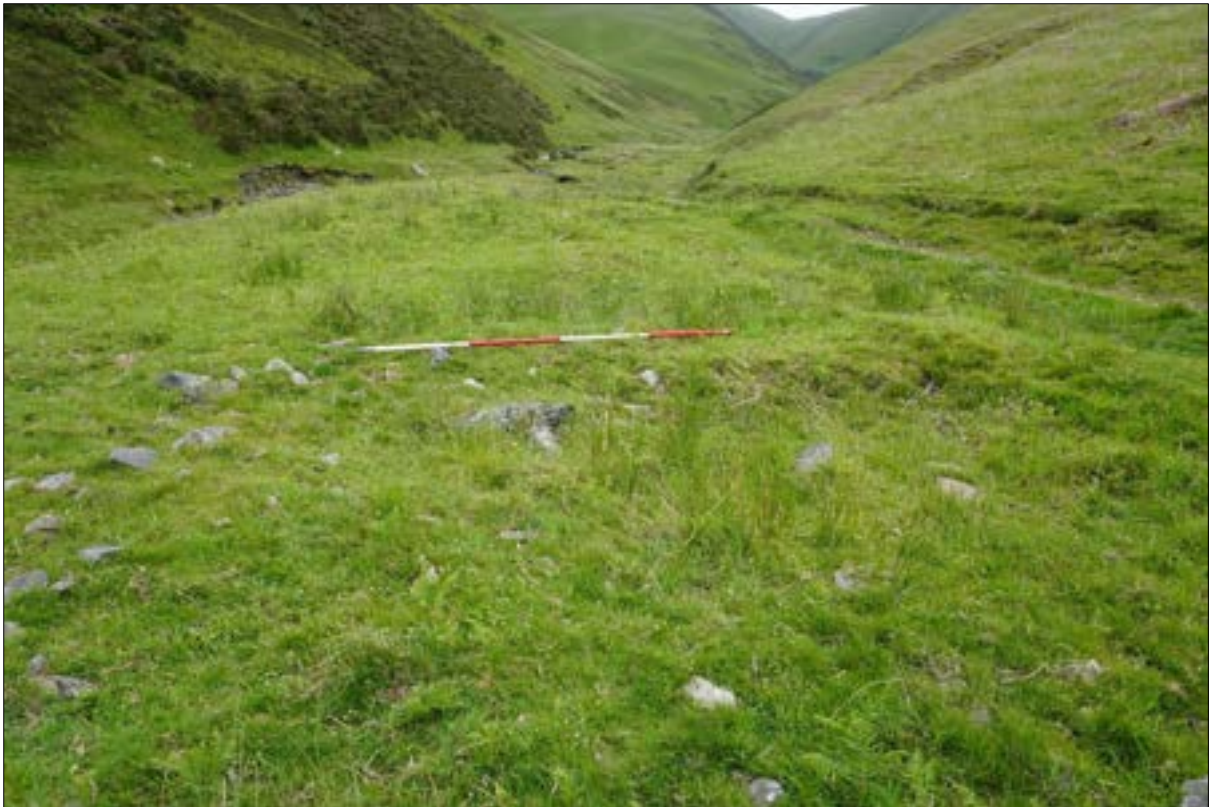
Figure 124: FID78E - A curvilinear stony bank (78E) measuring 1.3m wide and 4.6m long and a stony spread at the north east end of MYD33256, with the bank possibly reflecting a boundary to the group of features. View facing north east.

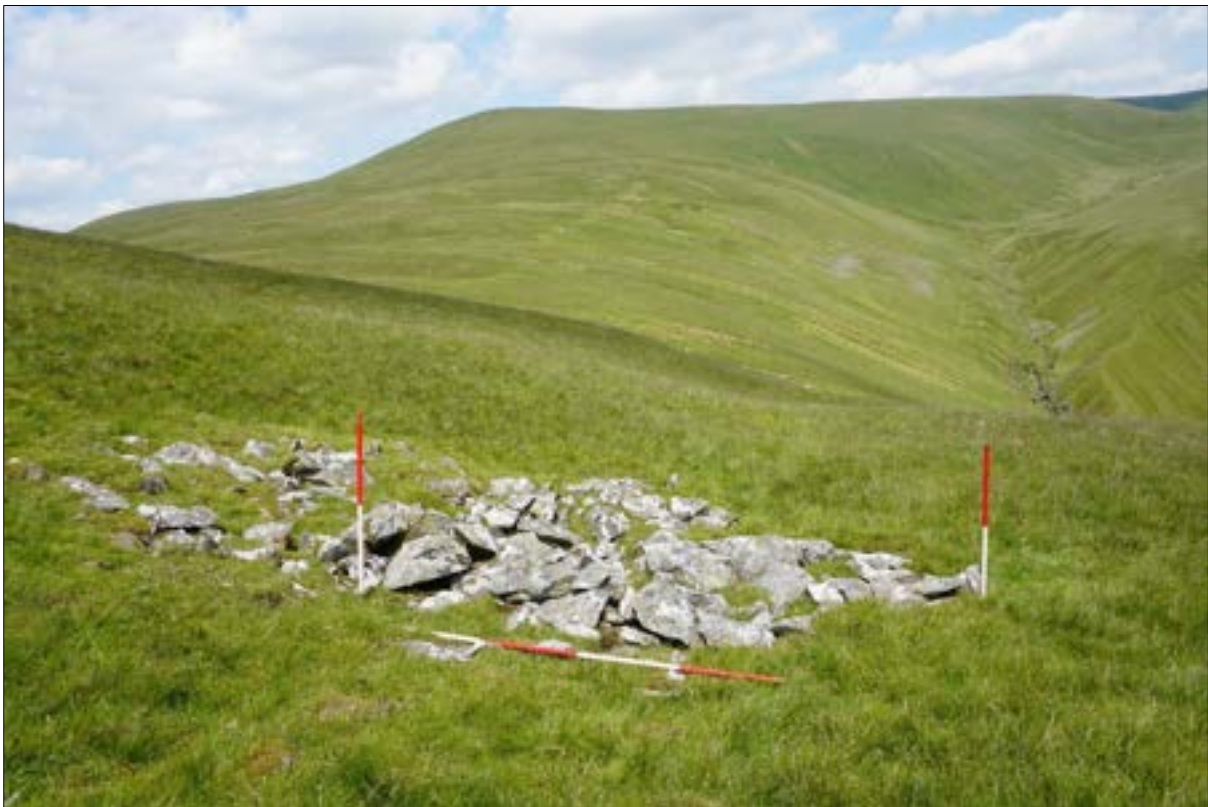
FID93 was a small C-shaped stone built shelter located at SD66566 93583 to the east of the summit of Crook, circa 15m north of FID92. The feature measures 3m wide and 4.10m long and up to 0.25m high. Whilst has suffered from extensive structural collapse the southern wall survives in slightly better condition to a height of

0.25m, although it is largely collapsed and spread out. The wall is circa 0.5m wide and where it survives is circa 0.25m in height. It is in extremely poor condition. Again this ruinous probable shelter is of uncertain date but is most likely to be Post Medieval, it may be either a shepherds shelter or quarrying shelter and is similar in character to FID92. Again FID93 does not appear to be of recent origin and is regarded as a historic feature.

Figure 136: FID93 - A small C-shaped stone built shelter located to the east of the summit of Crook and circa 15m north of FID92.

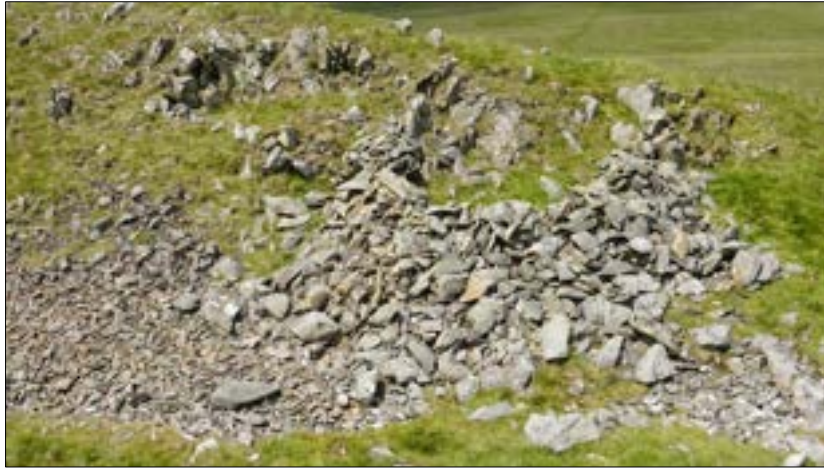
Figure 137: FID94 - A C-shaped wall of crude loose rubble construction on the summit of Crook – This is modern feature likely constructed by fell walkers – but note the completely different character of FID94 to other shelters recording during the project that are likely much older historic features e.g. FID91-93, 70 & 72.

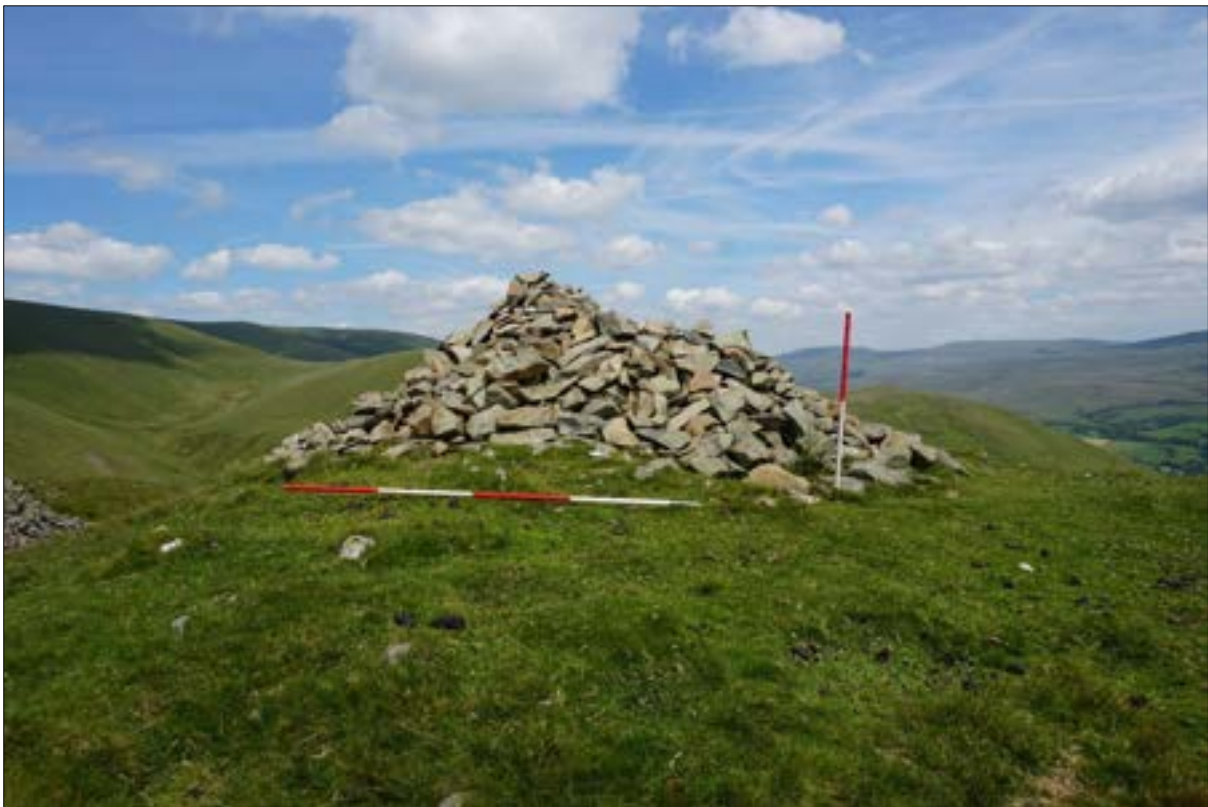
Figure 138: FID95 - A modern summit cairn with a pointed profile shape was observed on the summit of Crook – this is modern marker cairn and not a historic feature.

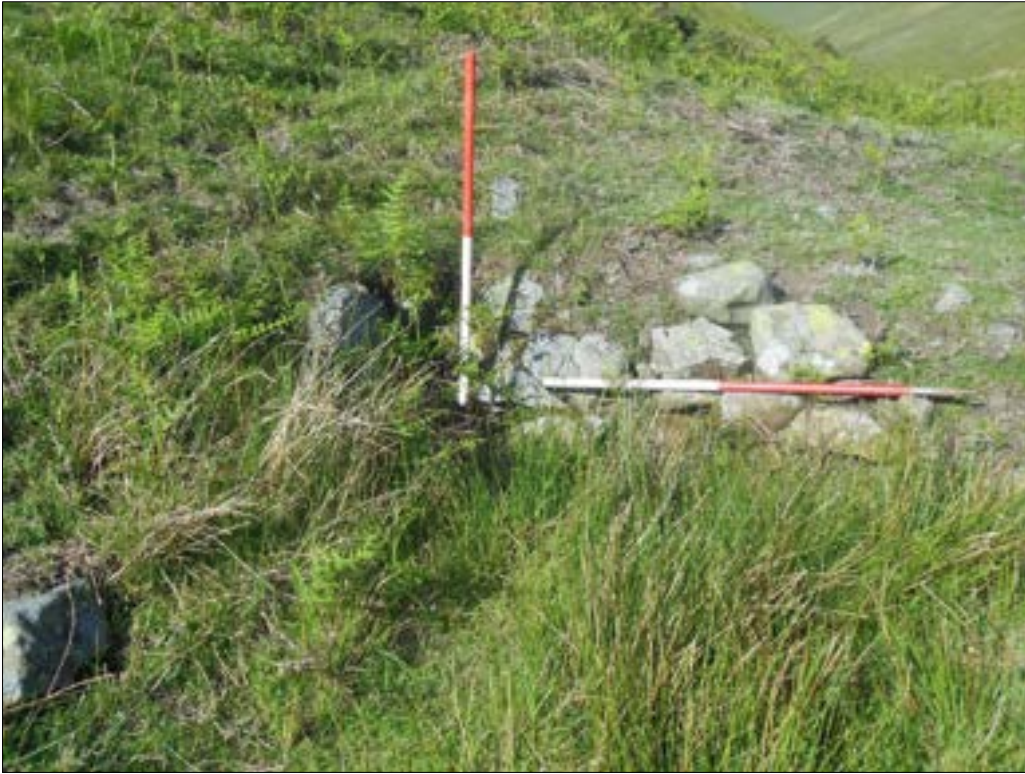
Figure 139: FID96 - A short section of stone wall located on the north side of Crosdale Beck built into the hillside.
