Grassington Moor

Yorkshire Dales National Park

PEATLAND RESTORATION PLAN

April 2023

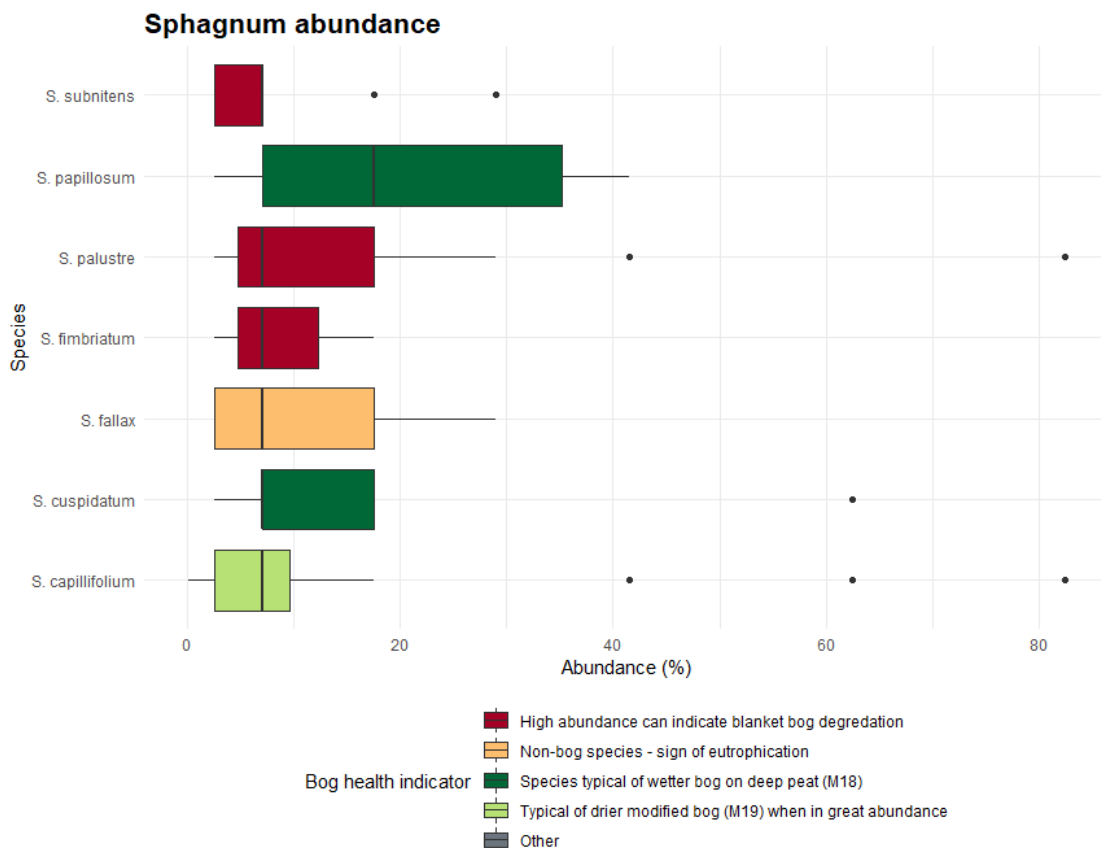
Of the 7 species recorded on site, the most common were *Sphagnum capillifolium* and *Sphagnum fallax* which are both indicators of modified, drier or nutrient-enriched bogs. Overall, *Sphagnum papillosum* was the most abundant species recorded but this was restricted to wetter areas of Blanket Bog. The proportions of each species can be seen in the chart below.

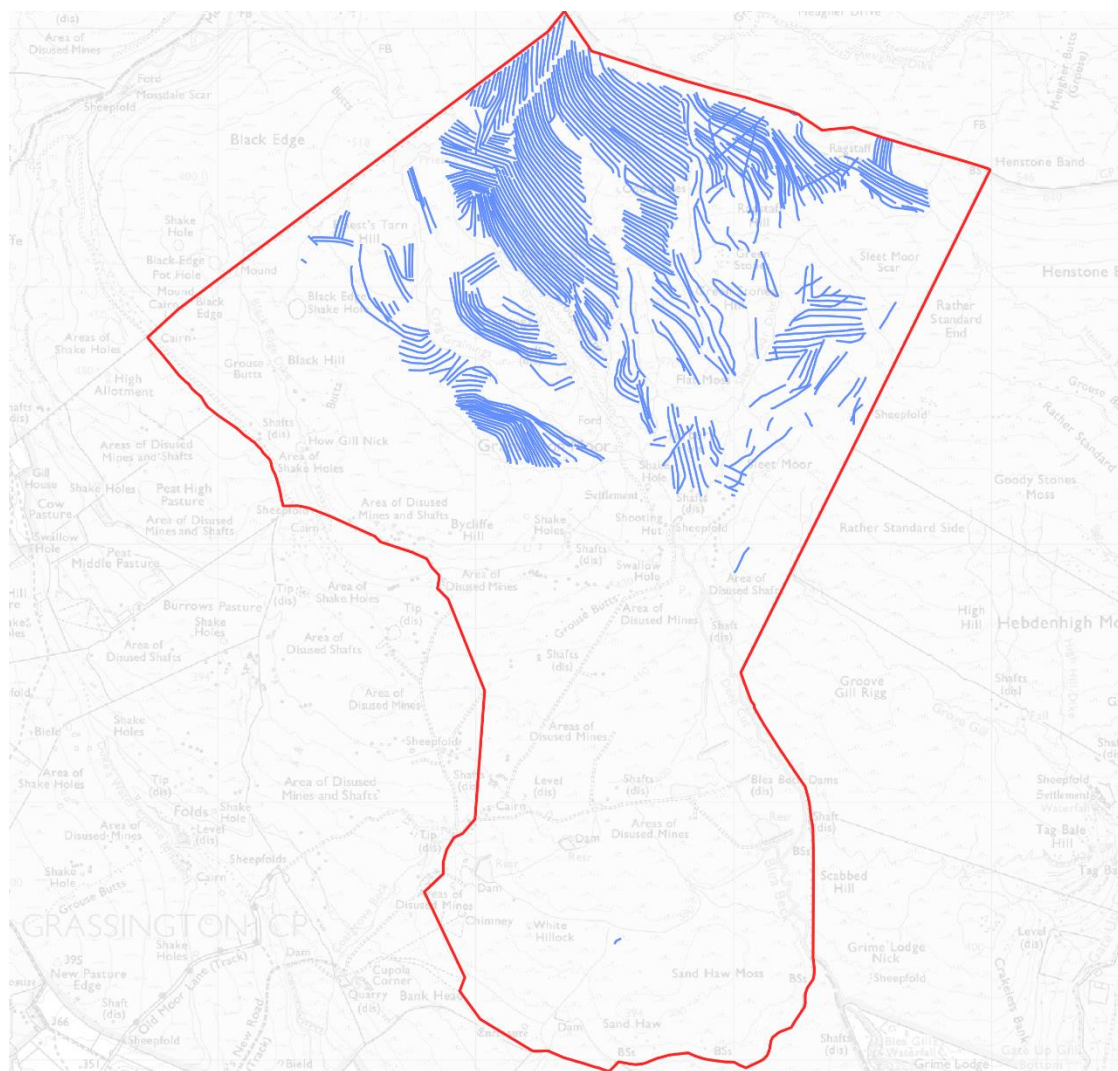
Figure 5.4: Grips to be blocked.

**Grassington Moor
Grips to be blocked**

— P1, P2, P3

Works area	Width (m)	Restoration category on maps	Estimated length (m)	Maximum number of dams (n) at 7.5m spacing
1	<1m	P1	81,532	10,851
	1 - 2m	P2	571	71
	2 - 3m	P3	65	9
2	<1m	P1	9,319	1,238
	1 - 2m	P2	239	31
	2 - 3m	P3	34	0
Total			91,760	12,200

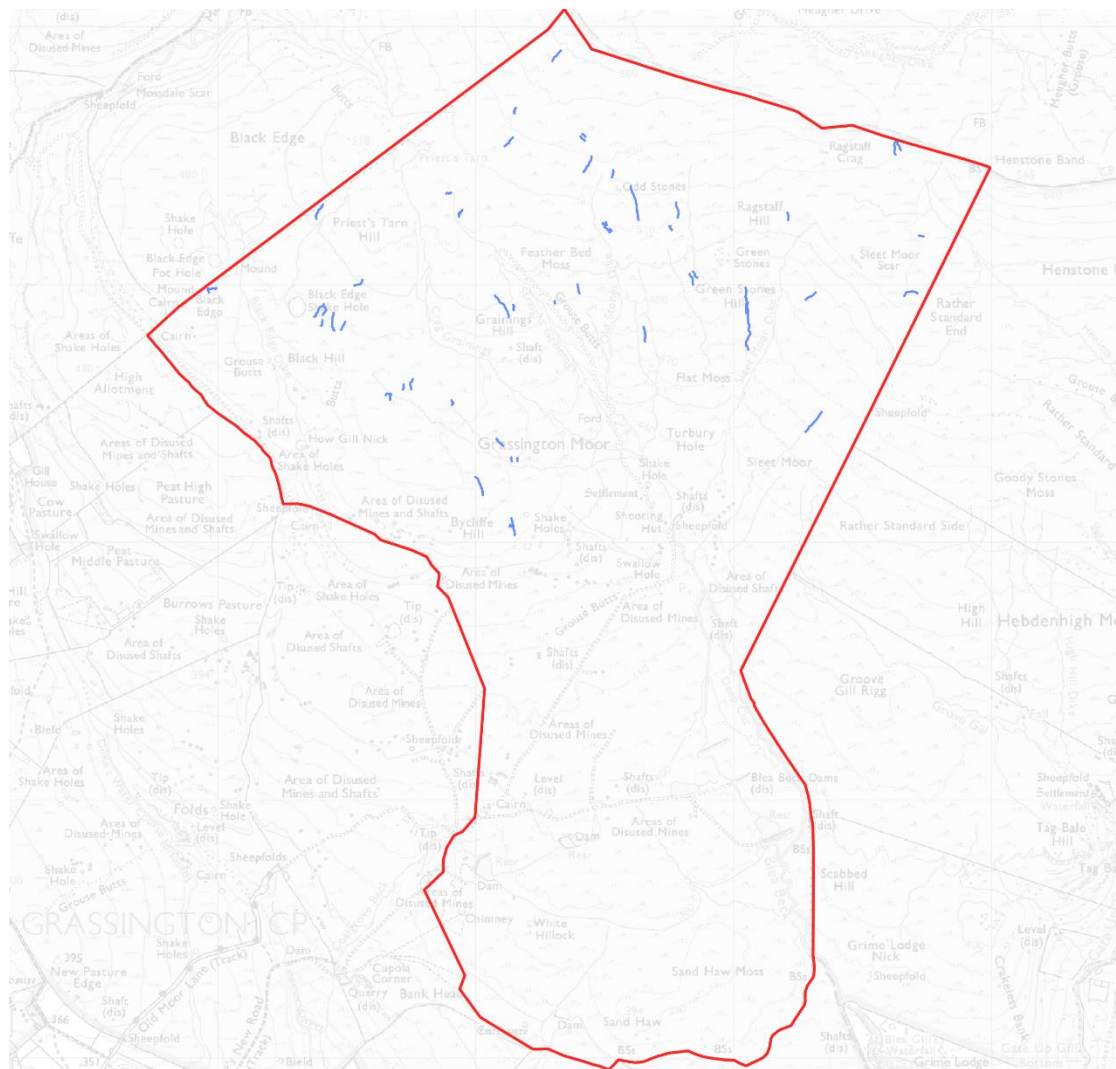
Figure 5.6: Gullies to be blocked.

Grassington Moor Gullies to be blocked

— P1, P2, P3

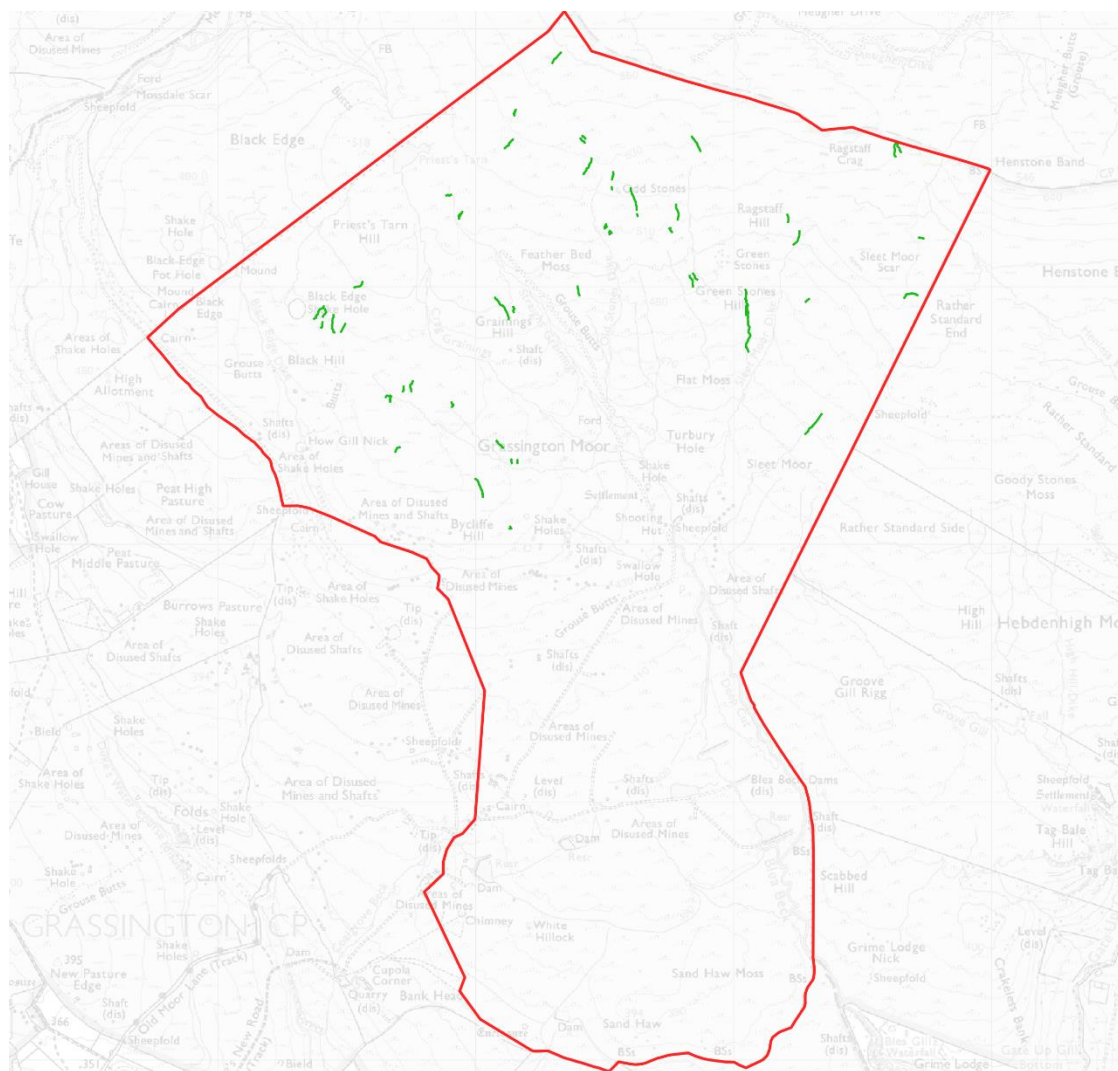
Figure 5.7: Gullies to be reprofiled.

Grassington Moor Gullies to be reprofiled

— Reprofile and cover with turves only

Works area	Width (m)	Restoration category on maps	Prescription	Estimated length (m)
1	<1m	P1, P2, P3	Reprofile	82,029
2	<1m	P1, P2	Reprofile	9,494

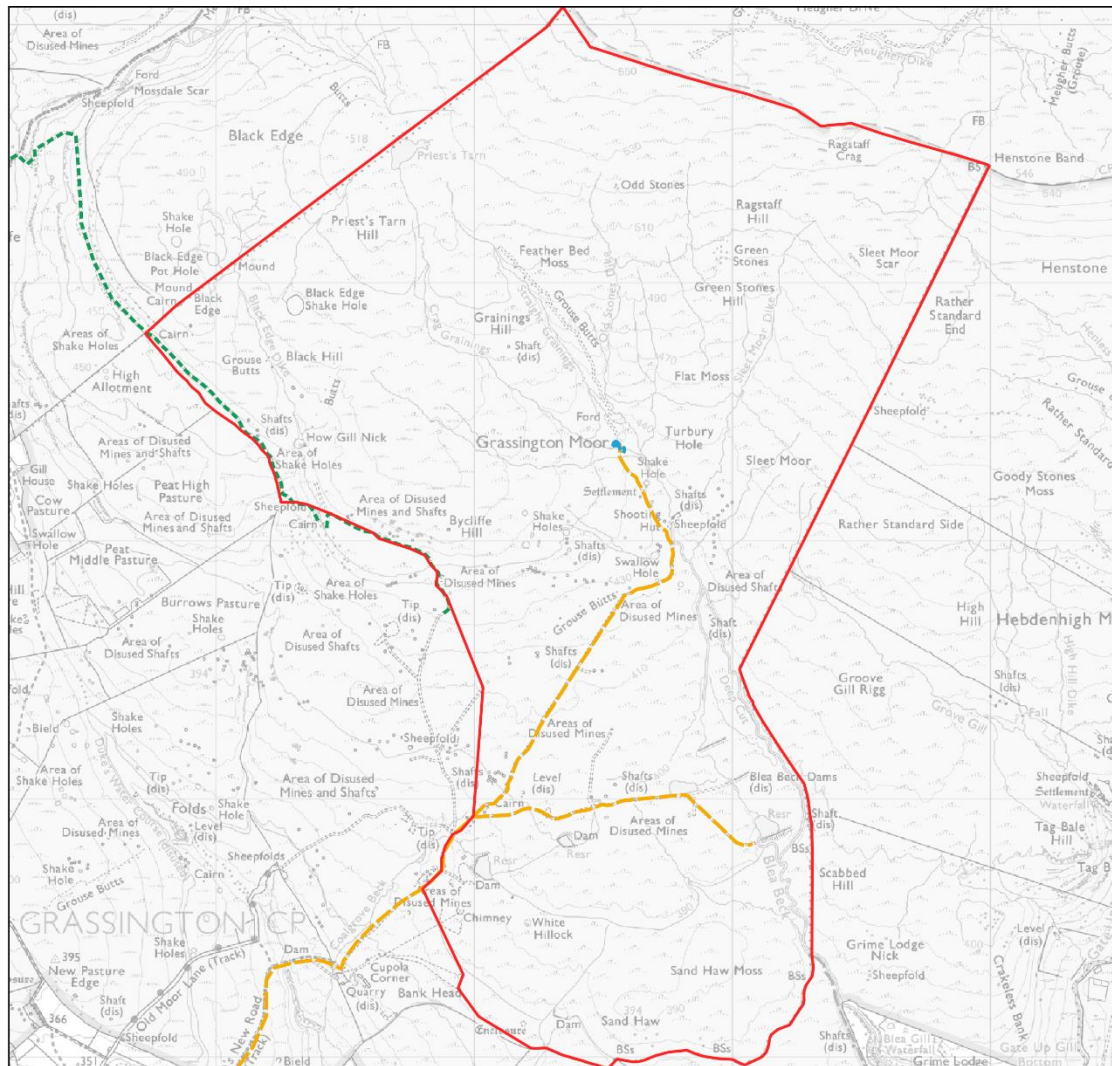
Figure 5.9: Site access.

Access

- Footpath
- Gravel road
- Other
- Site boundary

Access to the site will be along the gravel track from the road. (see Figure 5.9)

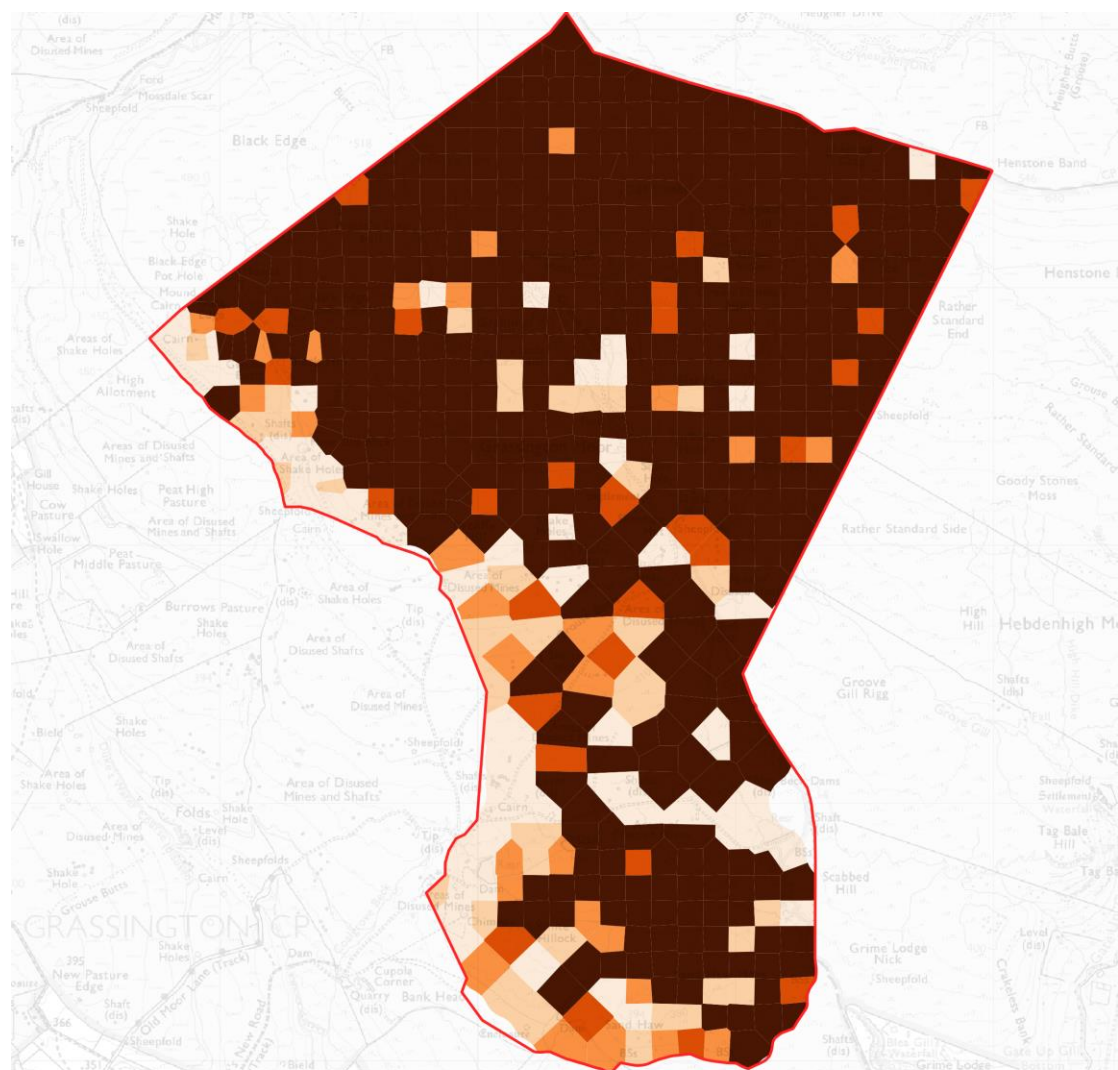
Figure 5.10: Peat depth areas using the voronoi polygon method.

**Grassington Moor
Peat depth (cm)**

- 0 - 14
- 15 - 29
- 30 - 39
- 40 - 49
- 50 +

The field survey data shows that most of Grassington Moor has deep peat. 75% of the site had a depth of 40cm or more, with 20% on shallower peat (<40cm) and the remaining 5% had no peat at all. The deepest peat recorded was over 440cm. An accurate measurement for these deepest points was not possible due to the limitations of the survey equipment. All points which measured 400cm or more were in the north of the site. The shallower peat was mostly along the western boundary of the site. The peat depths can be seen on the map in Part 5 below (Figure 5.10).

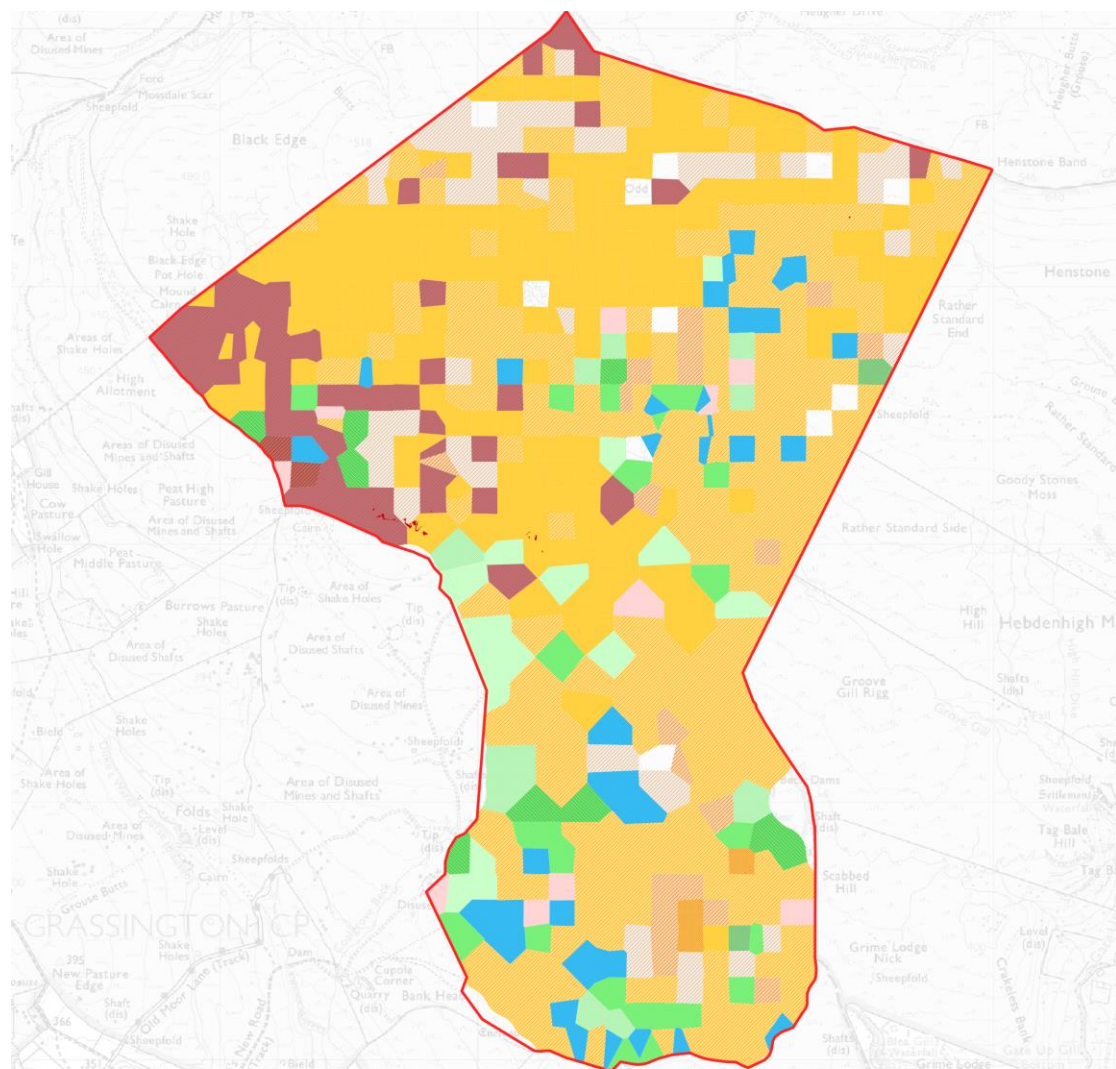
Figure 5.11: Vegetation community areas using the voronoi polygon method.

Grassington Moor NVC

- Blanket bog (M19)
- Cross leaved heath – Sphagnum papillosum mire (M18)
- Wet bog with abundant common cottongrass (M17)
- Hare's-tail cottongrass dominated blanket mire (M20)
- Wet heath (M15)
- Dry heath (H9)
- Dry heath (H12)
- Acidic flush (M6)
- Acid grassland (U4)
- Acid grassland dominated by mat-grass (U5)
- Semi-improved acid grassland (U6)
- Acid grassland dominated by purple moor grass (M25)
- Acid grassland dominated by wavy hair grass (U2)
- Juncus effusus rush pasture (M23b)
- Bare peat

The distribution of vegetation communities and a list of others found less frequently can be seen in Part 5 below (Figure 5.11).

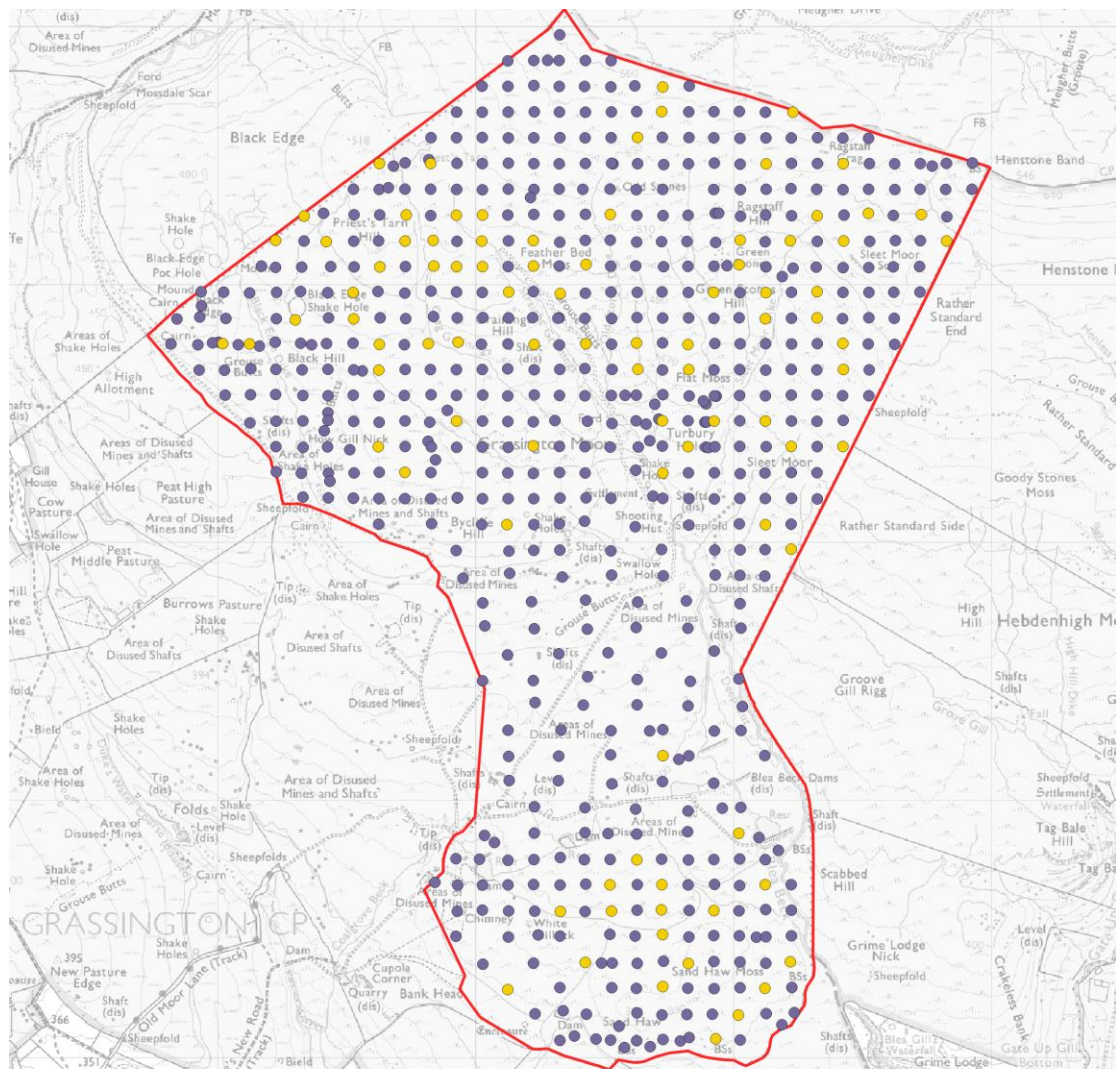
Grassington Moor Sphagnum

- Present
- Absent

Species	Overall presence (%)
<i>Sphagnum capillifolium</i>	6.3
<i>Sphagnum fallax</i>	4.9
<i>Sphagnum palustre</i>	2.4
<i>Sphagnum subnitens</i>	1.7
<i>Sphagnum cuspidatum</i>	1.4
<i>Sphagnum papillosum</i>	1.1
<i>Sphagnum fimbriatum</i>	0.5

A variety of Sphagnum moss species are present across the site in Blanket bog and heath habitat types (see Part 5, Figure 5.16).
