Archaeological Excavation of a Lime Kiln at Nordy Bank Clee Liberty 2023

Project	Our Upland Common (Season 3 Industrial excavations)
Client	Foundation for Common Land
Doc ref	034-CleeLibKiln-fieldwork062023.docx
Author	Matthew Williams
Date	December 23
Site location	359270 284400
Site area	NA
OASIS ID	fearnher1-507534

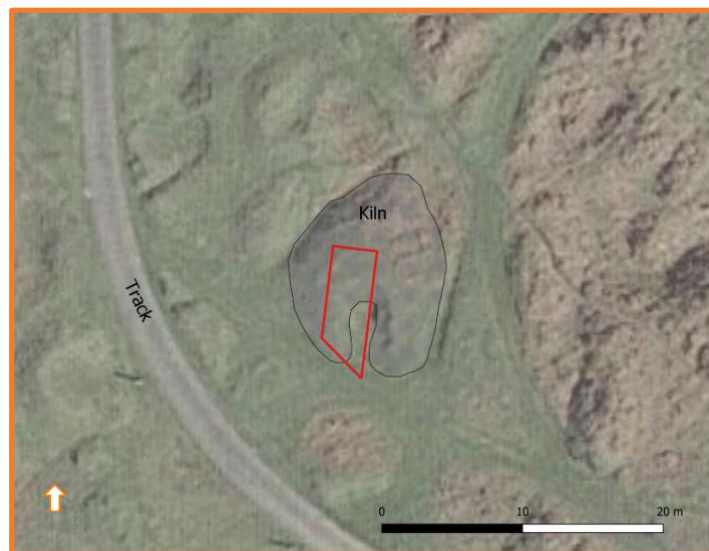
Figure 3 - Trench location detail showing kiln

The kiln consisted of a horseshoe shaped mound measuring 15.00m N-S, 9.70m E-W and 0.90m high, with the opening facing south (see Figure 3). One trench, aligned approximately NNW-SSE, was excavated over the west interior side, measuring 9.00m long (N-S) and 3.10m wide (E-W). The kiln appears to have been dug into a mound of soil and the high sides were on the north and east sides of the trench. At the base of the east end of the trench was the main kiln 'pit and running south from this was the flue.

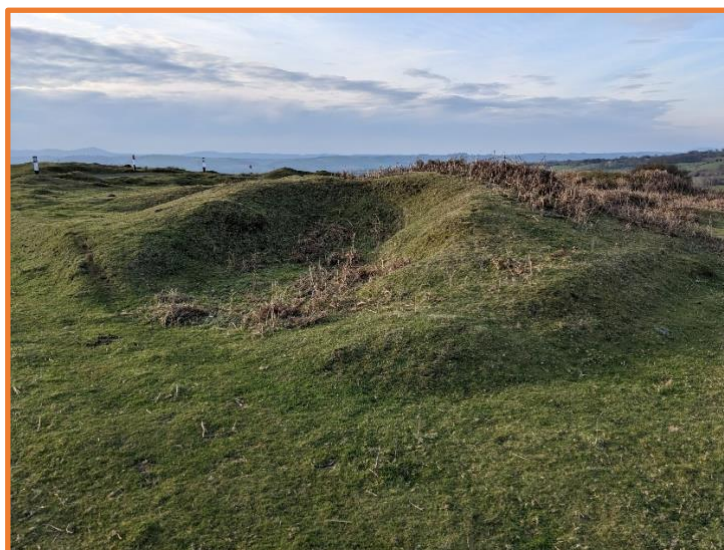
Figure 4 - Kiln looking northwest prior to excavation

The lime kiln is visible as a horseshoe shaped mound next to the track. It appears collapsed as the roof was broken out to get the lime when the final burning was complete. It is now covered in thin topsoil with low vegetation (grass and bracken) and there is some erosion on the south and west sides from sheep tracks.

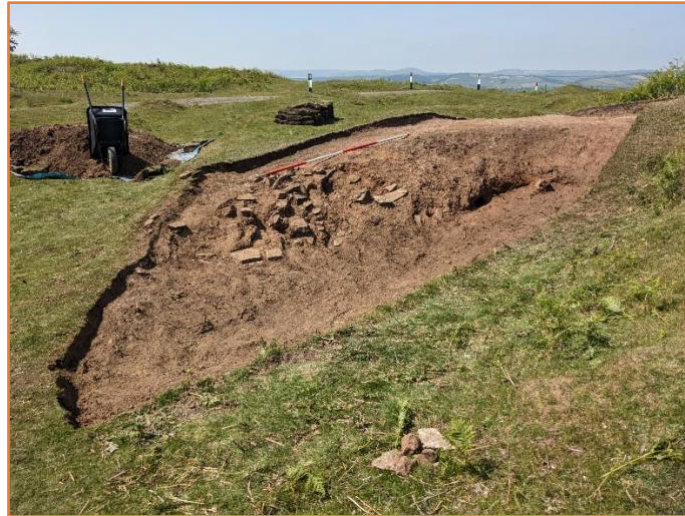
Figure 5 - Pre-excavation, looking north

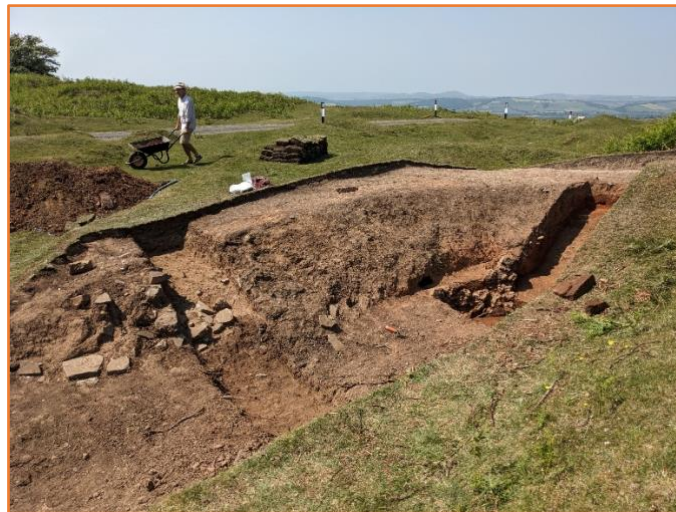
Figure 6 - Post excavation, looking north

The wall (113) was at the north end of a long cut [114] that comprised the kiln pit in the north and the long, narrow flue running south. The cut had steep, straight sides and was excavated to a maximum depth of 0.65m and a length of 4.91m. It was cut into pale brown clay silt (109) which had been scorched to a mid orange behind the stone structure (113). Within the cut and around the wall was a scorched orange silt (110). In the south of the trench was a flue clearance deposit of brown silt with coal flecks (107). This overlay a pale yellow grey silt (111) which was equivalent to (109). Along the edge of the cut [114] was stone rubble (115) which may have been part of the original structure, but had been disturbed and demolished. There was no demolition rubble in the north of the trench.

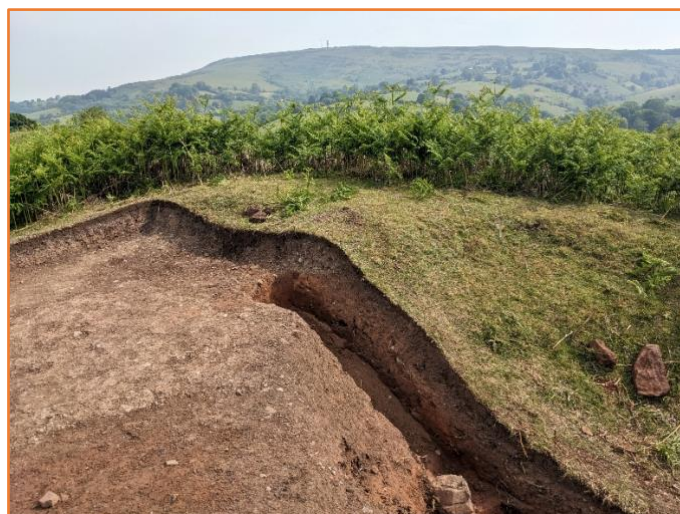
Figure 7 - Post excavation, north end of trench. Looking east

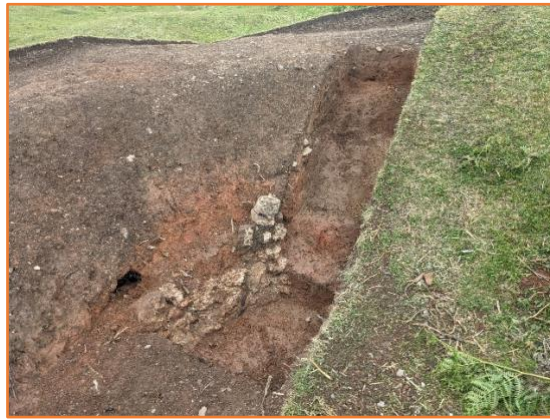
Figure 8 - Stone kiln structure (113), looking northeast

The surviving kiln structure consists of a heated and hardened mid brown silt soil surface within the flue (112) and a wall of burnt and vitrified granite (113) around the main kiln pit. The wall (113) was one stone wide, approximately 0.20m. Six courses were exposed with a total height of 0.65m. The kiln base was not exposed although the break of the slope at the base of the exposed wall suggested that it was perhaps 200mm deeper.

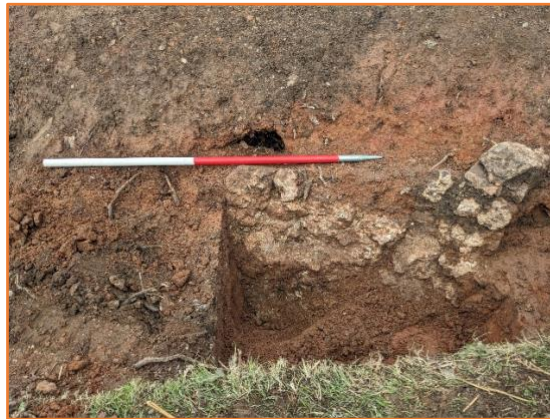
Figure 9 - Stone kiln structure (113) detail. 1m scale

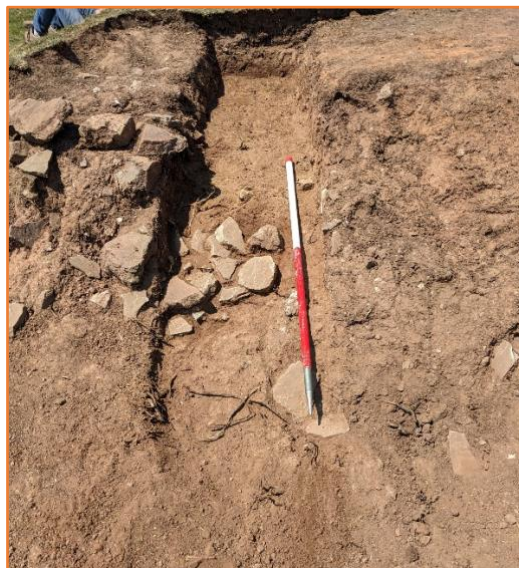
Figure 10 - Stone rubble (115) in flue area, looking north. 1m scale.

The flue ran approximately south from the kiln pit. There was evidence for a scorched surface just below ground level and stone rubble to the side suggested a fairly crude structure, although it had been demolished.

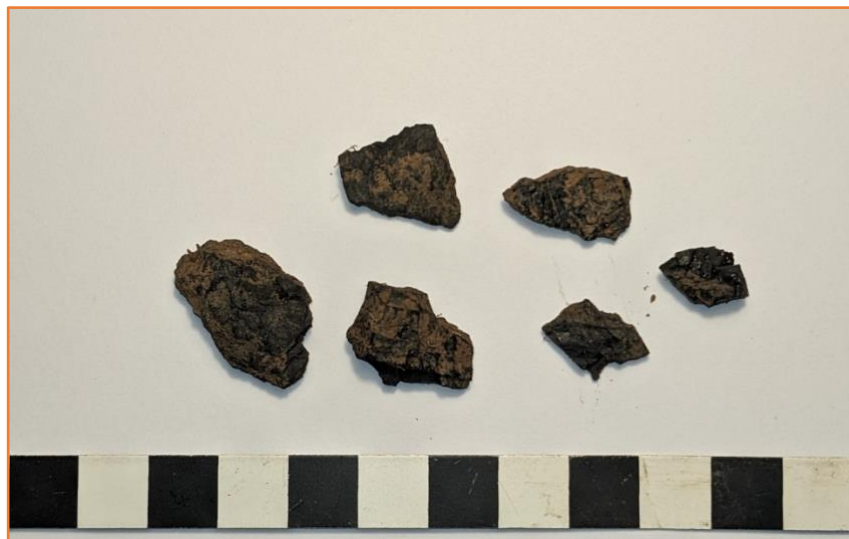
Figure 11 - Coal fragments from deposit (117). 1cm scale divisions.

No charcoal was recovered from the samples; however, several fragments of coal were recovered from the kiln clearance (107) which indicates that coal, rather than wood or charcoal, was used as fuel for the kilns.
