A Report on Community Archaeological Walkover Surveys of the Southern Foothills of Brant Fell

Project Archive Report

By Dr Douglas James Mitcham
Community Heritage Officer
Yorkshire Dales National Park Authority

May 2023

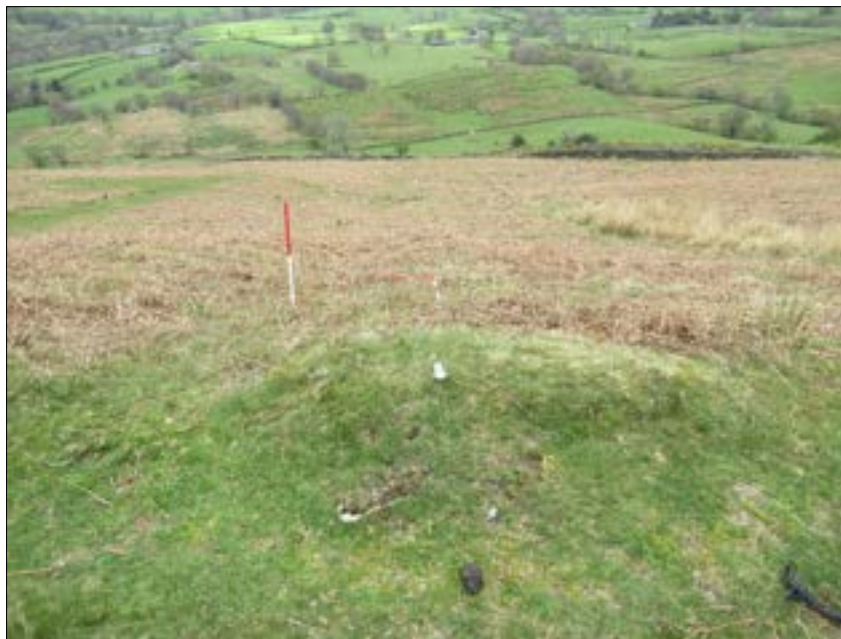
FID15, 17 and 18 comprise subtle, eroded low earthwork banks (c.2-3m wide and c.0.2-0.3m high) with ID15 having a ditch on its western side, whilst ID17 and 18 have ditches on their eastern sides (c.1-1.6m wide and c.0.2m deep), running north-south down the slope (figure 9; figure 11; figure 76). They appear to join a long east-

west boundary bank (FID16, c. 1.35m wide, 0.2m high and c.991m long) at right angles running around the southern end of Knott along the contours at circa 320m, which together form the rectilinear or co-axial boundaries of the field system MYD33418 (figure 10). FID18 is a more complex feature, appearing to split into two banks, with the eastern bank after the split following a more curvilinear course heading more to the north east, which appears to cross and continue beyond the terminal east-west boundary FID16, suggesting either evidence of phasing or perhaps truncation by a later feature. The long east-west boundary FID16 forms the northern extent of this field system, with a later path or trackway situated on its upslope side possibly obscuring the location of a ditch.

Figure 9: FID15 a north-south aligned earthwork bank and ditch forming part of MYD33418. The junction of FID15 with FID16 is visible in the foreground.

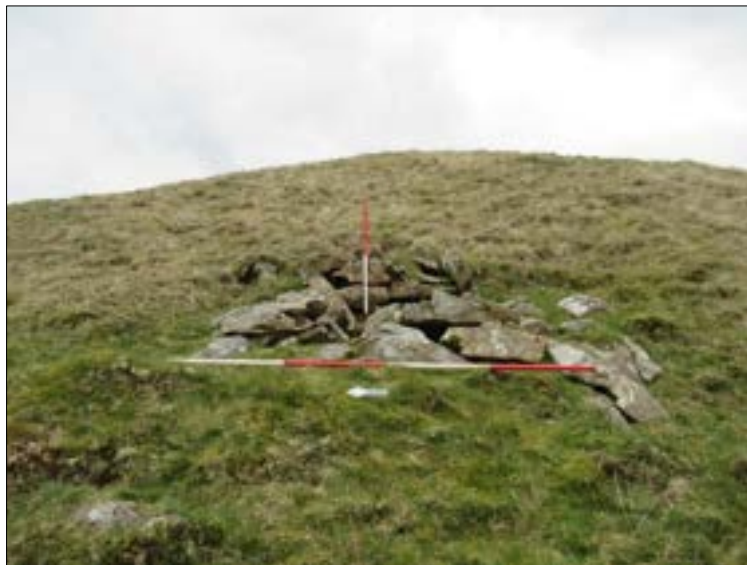
A small rectangular stone shelter (FID10) was identified with an open front and built on a small rectangular platform that was cut into the western hillside of Sickers Fell (figure 16, figure 15). The rear wall was circa 0.5m high and was built up against the hillside at the rear of the platform with stone slabs piled up in crude courses, whilst the remnants of two side walls were less well preserved and more severely collapsed. The fact that the structure is built on a substantially constructed platform circa 3.6m wide and 4m long that has been cut into the hillside, with some evidence that the front edge of the platform was supported by a stone built revetment strongly suggests this is not a modern fell walkers shelter. The stone looks well weathered and the structure does not appear to be of recent origin. It is interpreted as of Post Medieval date as a possible shepherds shelter. The other features included the Post Medieval boundary wall to common in this area (FID21), a cast iron gate (FID22) and further earthworks that relate to the boundary of the common, comprising a bank and two ditches (FID23) (figure 21, figure 22, figure 17).

Figure 15: FID10 – an open fronted stone built shelter.

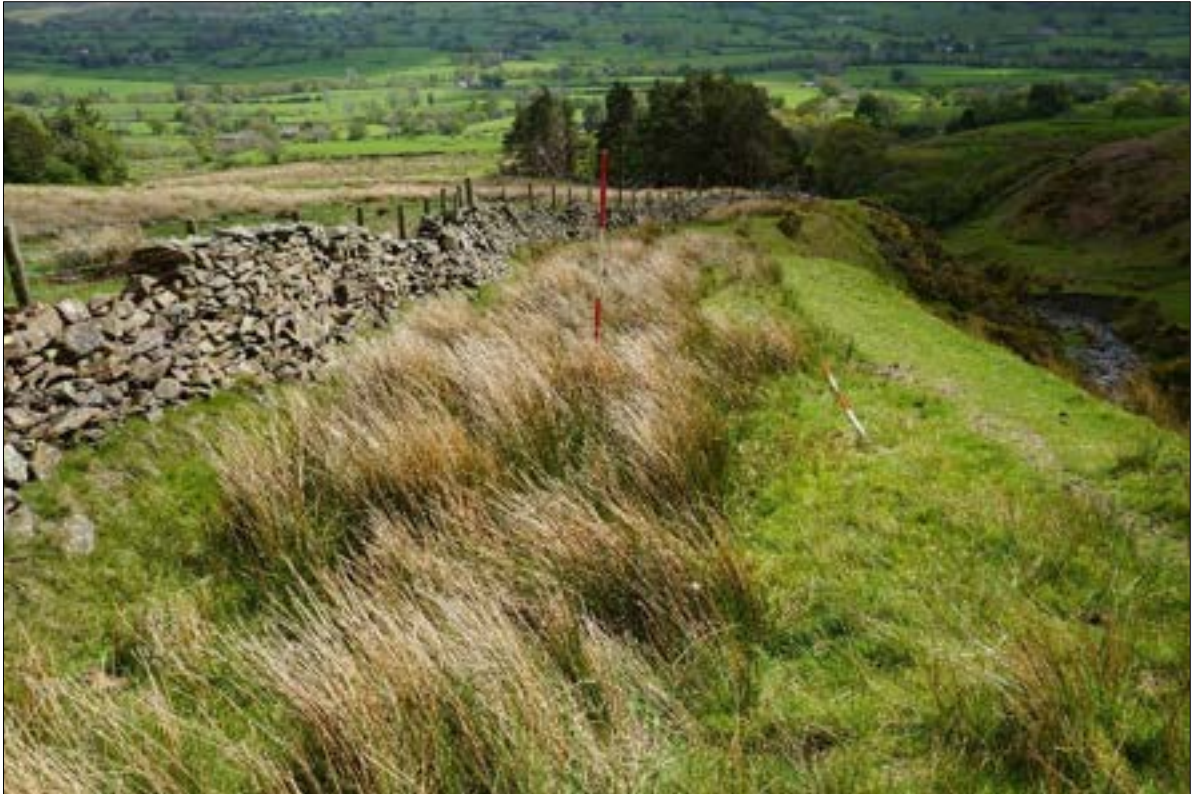
The earthworks forming FID23 comprises two banks and a ditch forming part of the boundary of Brant Fell common which is circa 2-4m wide overall and of variable height up to 1m and was recorded at SD66990 93668. The earthwork follows an east-west, and north-south alignment where it was recorded and mostly follows the present common boundary wall (figure 18). One bank, the smaller of the two, is situated on the north side of the wall and this may be associated with the wall construction. The wall is constructed within a wider ditch. A larger, wider bank that is more severely eroded and is in places quite difficult to see on the ground, is located on the south side of the wall, but appears to cross under it at SD6697993621 (figure 19). It is thought likely the bank on the southern side, along with the ditch may well represent an earlier boundary to the common and that predates the walled boundary. In some places this bank was seen to diverge slightly from the present boundary line. The condition of these features is highly variable and especially with regard to the bank on the southern side of the wall, are more visible and better preserved in some areas than others. The common boundary turns south at NGR SD66974 93671 on the east side of Ashbeck Gill where the second bank on the southern side can clearly be seen (figure 20).

Figure 18: FID23 - A bank (right) and ditch (left, centre) visible to the west of Ashbeck Gill.

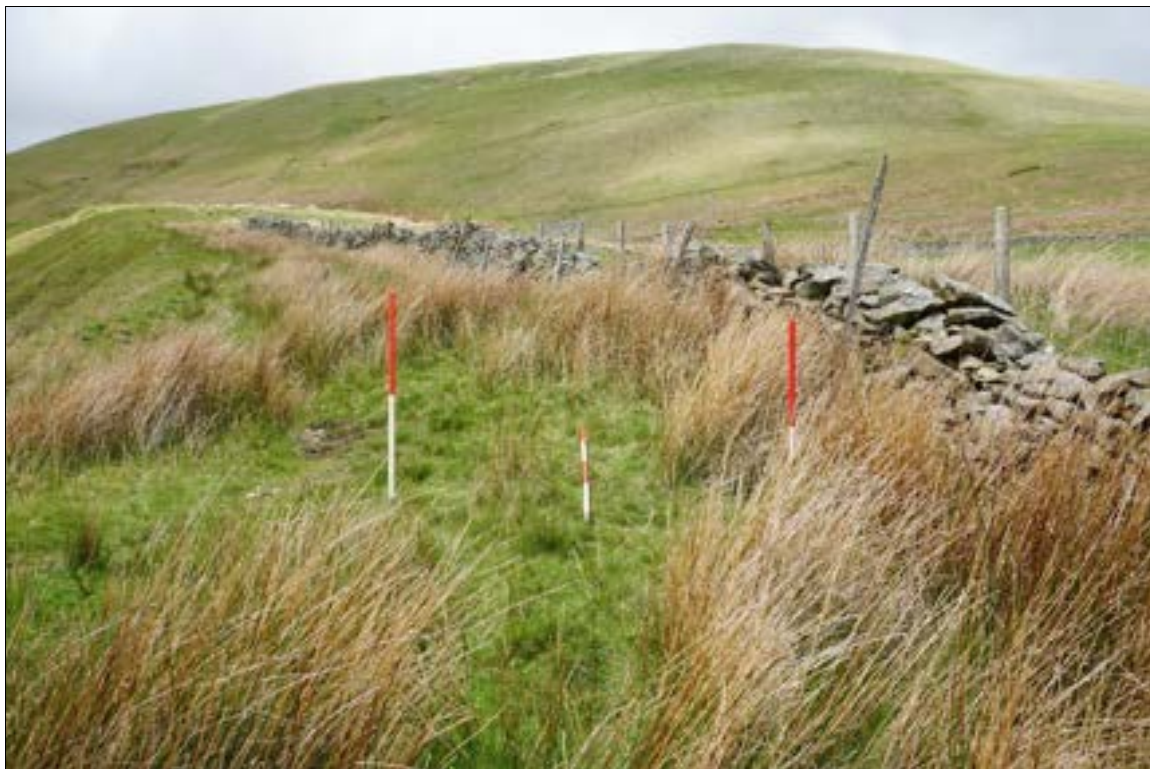
Figure 19: Bank (centre) and ditch (right) (part of FID23) emerging from where it crosses under the boundary wall.

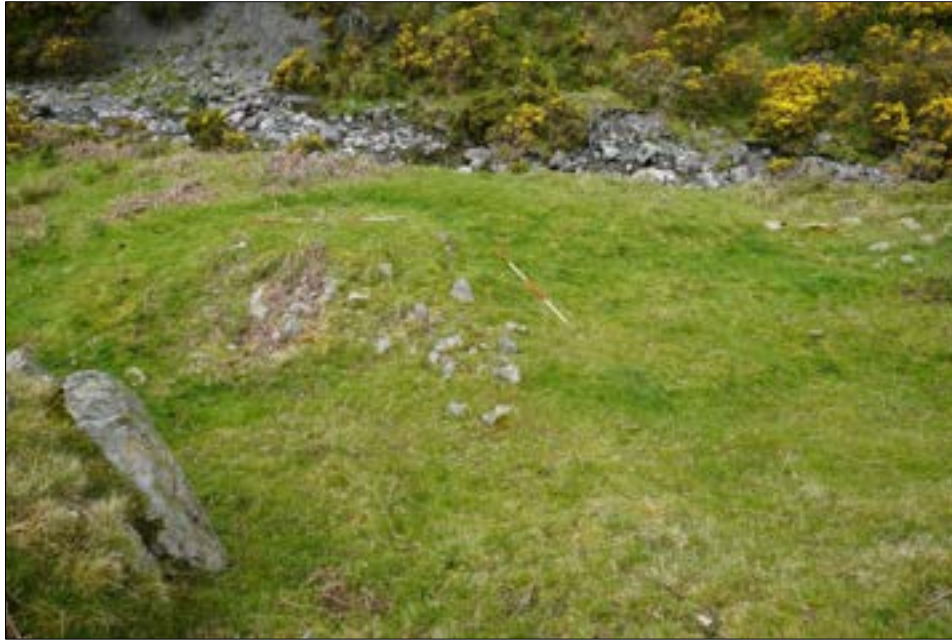
Figure 37: FID35 – Remnants of a rectangular structure.

Finally, the remains of a rectangular structure comprising a series of low, stony earthworks were recorded at SD66038 93020 on the east side of Settlebeck Gill (FID35) (Figure 37). The earthworks measured 4.20m by 4.55m and are circa 0.4-0.5m high. A single entrance is located on the western side, adjacent to the southern wall. The walls are circa 1m wide. A stony mound inside the structure likely reflects rubble from the collapsed structure. It is built adjacent to a shallow scar/rockface which may have been quarried out. The earthworks are interpreted as a stone built shelter or footings for a hut base. It is located close to the line of the water pipe and next to a trackway. It may be associated with the construction of the 19th and 20th century water supply system for Sedbergh Town (MYD1044) or be a shelter associated with the older Post Medieval quarries located along the eastern side of Settlebeck Gill.

35		Building Platform, Shelter	The remains of a rectangular structure comprising a series of low, stony earthworks located at SD66038 93020 on the east side of Settlebeck Gill. The earthworks measure 4.20m by 4.55m and are circa 0.4-0.5m high. A single entrance is located on the western side, adjacent to the southern wall. The walls are circa 1m wide. A stony mound inside the structure likely reflects rubble from the collapsed structure. The structure is built adjacent to a shallow scar/rock face which may have been quarried out. It is interpreted as a stone built shelter or footings for a hut base. It is located close to the line of the water pipe and next to a trackway. It may be associated with the construction of the water supply system for Sedbergh Town (MYD1044) in Settlebeck Gill which was built in the 1880's, or be a shelter associated with the Post Medieval quarries located along the eastern side of Settlebeck Gill.	Post Medieval - 19th/20th century?	SD66038 93020	Bracken	Fair	6728-6731, figure 37

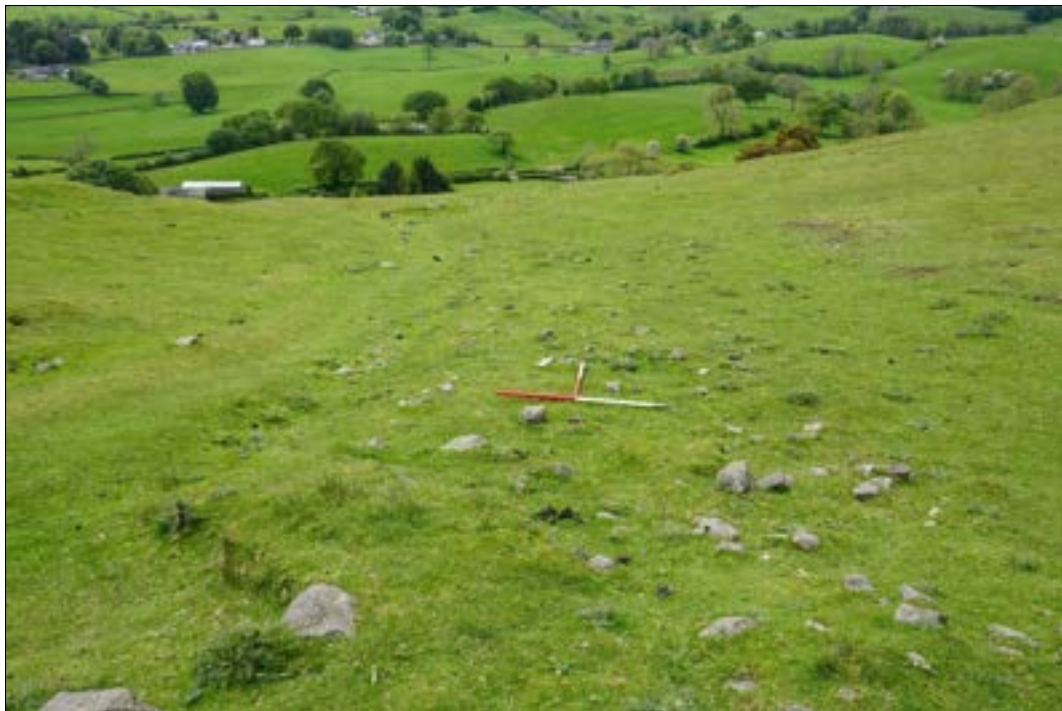
Figure 40: FID41 - An stony spread , interpreted as either a removed and spread wall or a metallated trackway.

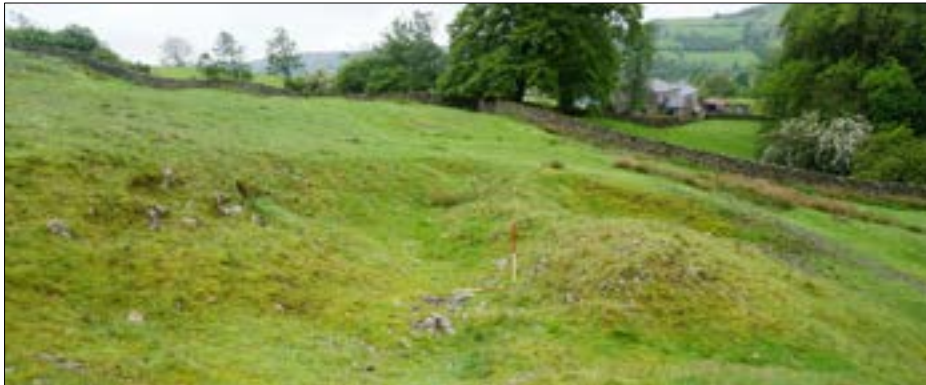
Further features included Post Medieval quarries (FID52) and an irregular stony mound near to the boundary of the common (FID68, figure 110) which was difficult to interpret but might reflect a spoil heap, perhaps connected to various areas of

Figure 46: FID52 - Post Medieval quarries.

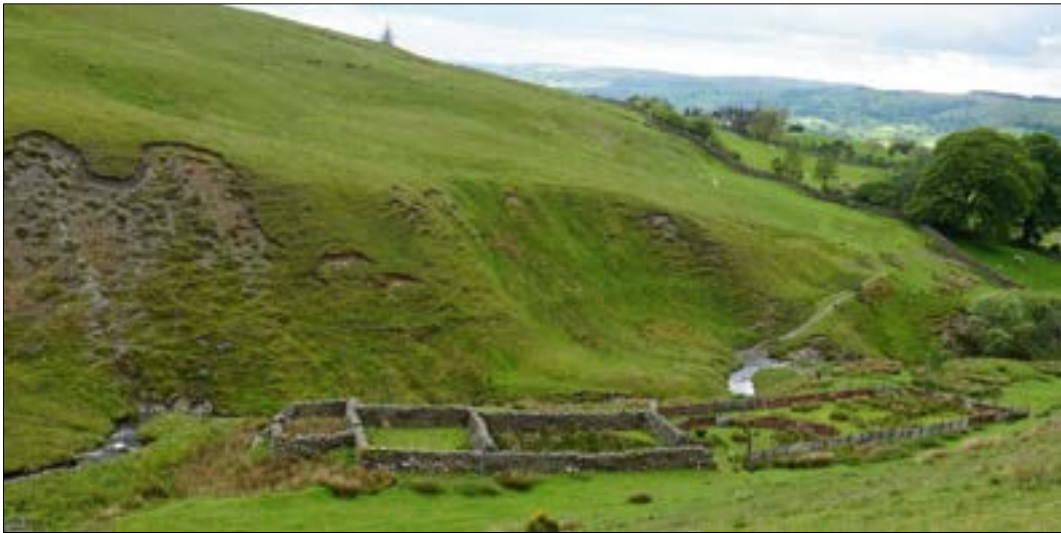
The sheepfold MYD55509 (Crosdale gathering pen) was recorded in detail, which consists of a rectangular drystone wall structure with a sub-rectangular annex that is likely of Post-Medieval date, with a later large extension at its western end built of corrugated metal sheeting and post and wire fencing (FID42) (figure 47, figure 48). An adjacent sheepwash was also identified (FID98) suggesting that the structure has previously functioned as a washfold (figure 146). Further east and upstream of the washfold, a short section of wall was identified but was too insubstantial to interpret, whilst a possible leat and a weir were also recorded (FID97). The leat continues for more than 100m on the south side of the Beck from and has a stone bank in places, which may have originally continued to the sheepwash adjacent to the sheepfold MYD55509.

Figure 48: FID42 (MYD55509) - Washfold at Crosdale Beck. FID98 a sheepwash, is located next to the left hand end of the fold.

42	MYD55509	Washfold, Sheep Wash, Sheepfold	A sheep fold of largely rectangular form and drystone wall construction at SD64389 93733. The stone built fold is 9m wide and the adjacent later extension is 11.34m wide. The overall length is circa 53m and the walls are circa 1.2m in high. The stone built fold has an entrance on its eastern end which is accessed via a ramp which leads out of the adjacent sheep wash FID98. Another entrance is located at its NW corner. A later rectangular extension is constructed from wooden posts and corrugated iron sheeting and is situated on the western side which also has a semi-circular pen within of similar construction. The original function of the stone built fold was as a sheepwash with a substantially constructed and dug out hollow at its eastern end fed via the beck which is immediately east and south of the site. The present stone built fold is largely in fair condition and is largely rectangular in form may indicate a later date or that it has been substantially rebuilt in the 18th of 19th centuries. The extension is likely to be of 20th century date. The complex is also located immediately north east of a ford across Crosdale Beck.	Post Medieval	SD64389 93733	Sheep, structural collapse	Fair	6779-6791, 6824, figure 48

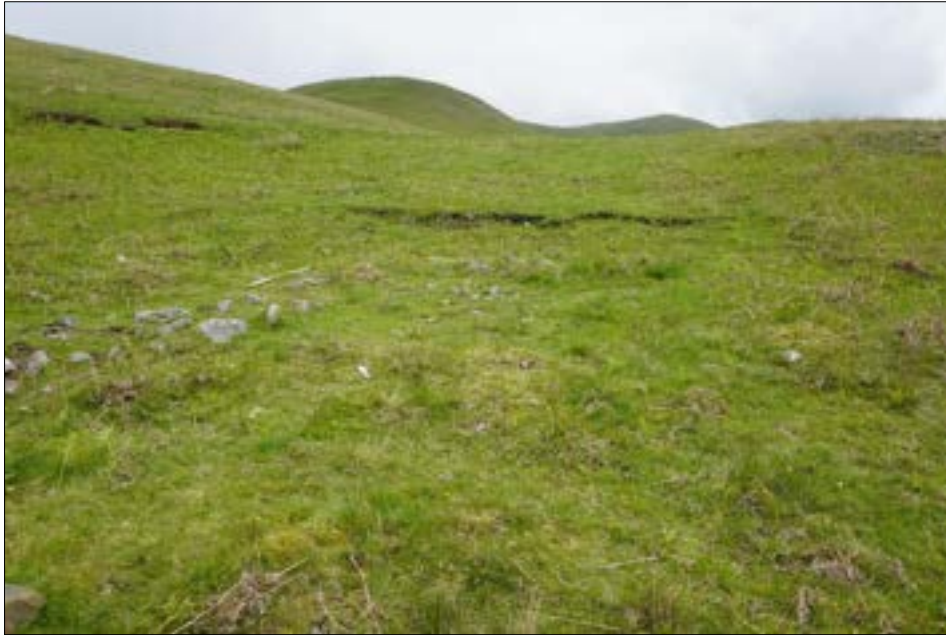
On the north side of Crosdale Beck, the earthwork remains of a rectangular building were located on the north side of Crosdale Beck at SD64533 93827, measuring 7.70m by 9.10m and circa 0.02-0.3m in height (FID43) (figure 49, figure 50) The feature is cut into the hillside to create a level platform and has a single entrance at its western end. This was strangely not marked on the HER as a monument, but appears to be the rectangular Medieval building excavated by SDHS (Howard-Davies *et al.* 1996: 5 & 9, 'structure B'). A curvilinear stony mound at SD64524 93818 may be the remnants of a field and another boundary bank (FID45) located nearby may be associated with this. FID45 is believed to be the bank shown on the SDHS survey (Howard-Davies 1996: 5, 'linear bank C') and was marked on the HER as part of MYD33344.

Figure 50: FID43 – A rectangular Medieval building excavated by SDHS and interpreted as part of a shieling complex.

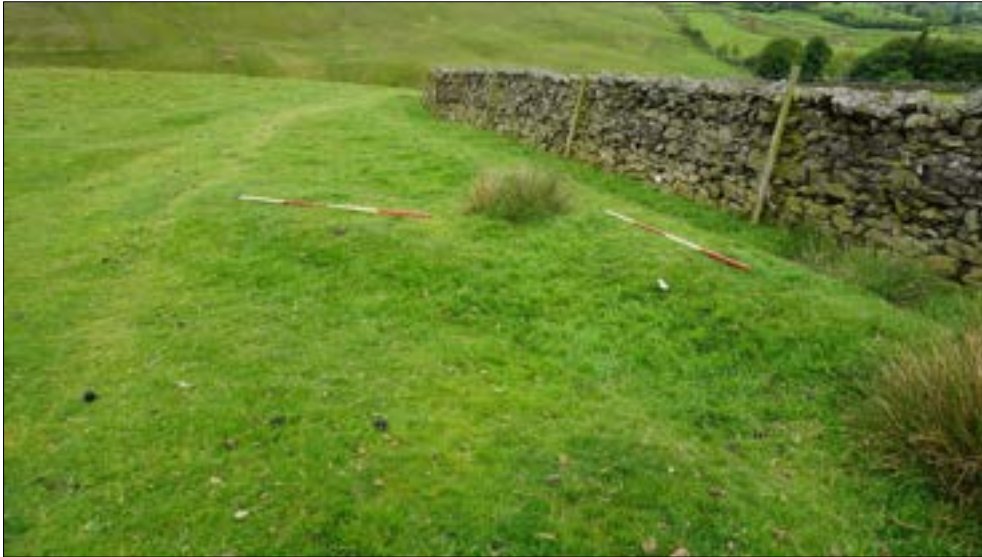
Figure 51: FID50 - Bank and ditch adjacent to the fell wall. A second bank running from centre to left is also visible, appearing to join F50 (right).

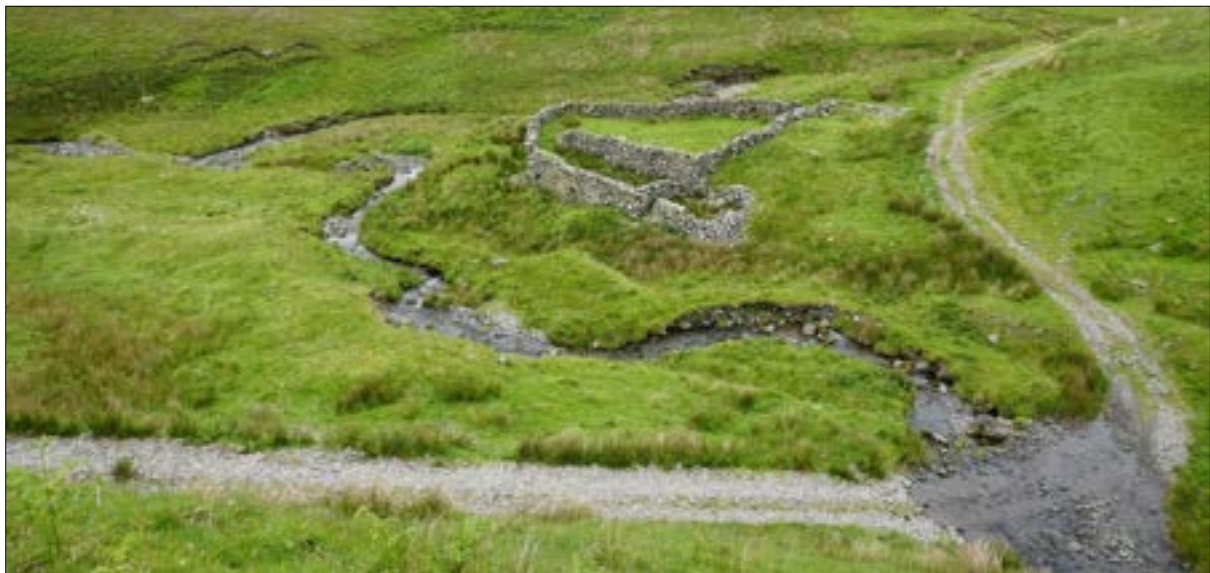
Ben Fold (FID85) comprises a large sheepfold and wash complex known located at SD65041 95751 immediately east of Swarth Greaves Beck (figure 56). The fold overall measures circa 19.3m wide, circa 27m long and varies in height between 1.5-

2m. It comprises a sub-rectangular stone walled structure, the main section of which is subdivided by an internal wall forming a long narrow section in its south western corner. This is presumably a funnel to drive sheep towards the adjacent wash. A rounded corner forming a distinct cell is present at the southern end of the site, adjacent to the funnel which has two entrances, with one measuring 0.5m wide on its south west facing side. This also faces the site of a former sheepwash situated adjacent to the structure on its western side. The wall on the north west side of this entrance measured 0.80m wide at its base and 0.60m wide at its top giving the wall a slight batter. The continuation of this wall was observed to match its profile and thickness. An area of revetment walling was observed at the end of the sheepwash measuring 2.90m long and 1.80m wide. Stone spreads and stony banks that are likely the remnant of additional walls that have now been removed are evident at the south eastern end of the site, which suggests they may have been a rectangular annex measuring 9.60m by 4m wide. The walls of the fold are largely still upstanding and in fair condition, although there are several areas of structural collapse. The style of the walling is varied with some areas of the fold having clear throughstones and quite neat courses and topstones, whilst other sections exhibit a rougher construction with less obvious coursing, throughstones and more irregular topstones. The presence of throughstones and the regular style suggests that some of the walls are no earlier than 18th century in date, whilst other sections may be a little earlier. The fold is associated with a sheepwash which was fed via a leat.

Figure 56: FID85 - Washfold, Ben Fold. The former sheep wash is visible in front of the fold in the centre, with this and the leat (FID100) marked by a concentration of reeds.

The aforementioned leat (FID100) is circa 0.5 to 1m wide and 0.5m deep which runs between SD65058 95716 and SD65013 95757 for a distance of around 73m. The centre of the leat is located at SD65038 95736 (figure 56). The leat on the south east

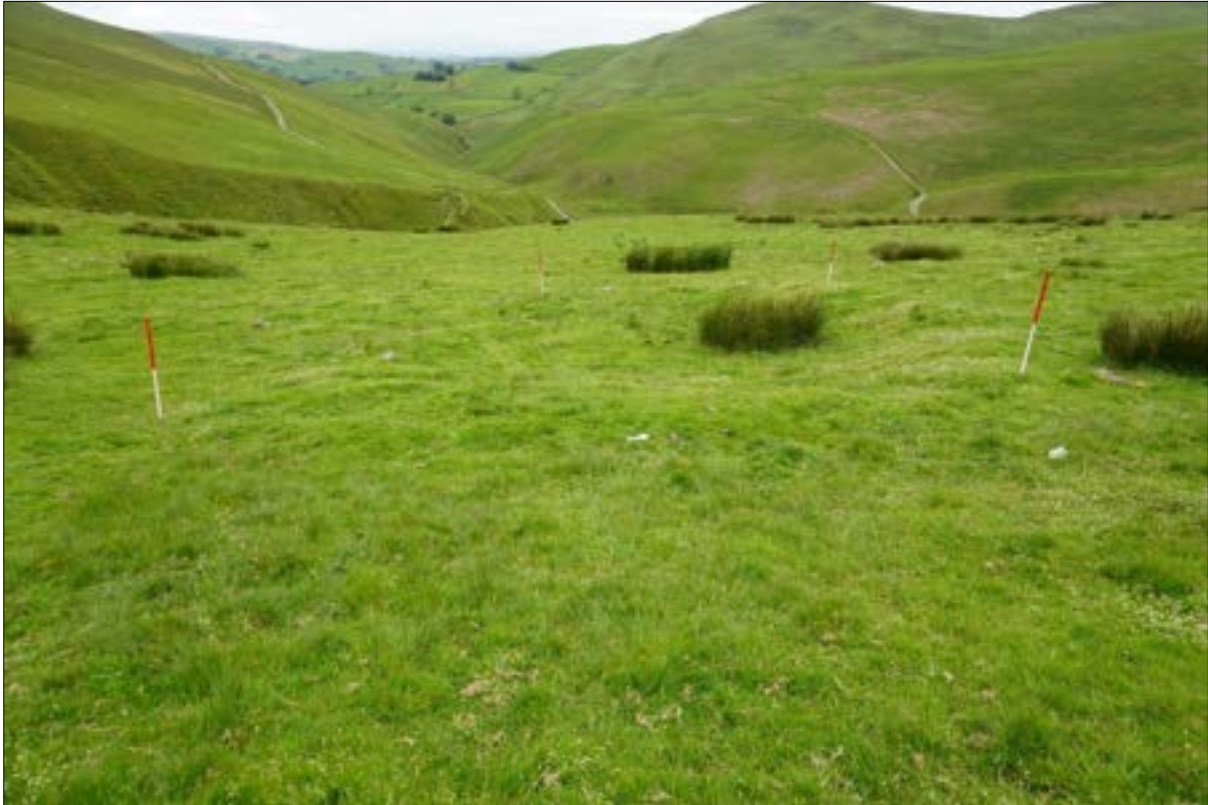
A third sub-rectangular stony earthwork bank forming an enclosure is located at SD65278 95662, measuring 9.3m wide, 14.1m long and circa 0.3m high (FID88) (figure 56). It has a single entrance on its southern side which is 1.10m wide. The ends of the banks forming this entrance showed some surviving evidence of having been faced with stone. The banks varied in width from 1.4m to 2.3m. The feature is constructed on a level platform built up against the hillslope. The feature may be a fold, an enclosure or alternatively a building platform. Although the character of the earthwork was more suggestive of a fold. It is likely related to other nearby features FID86 and FID87, forming part of a shieling complex of Medieval to Post Medieval date. It is unclear if these features are related to the nearby MYD33196 (Possible Prehistoric or Roman Field System, Ben Fold) which are described as a series of

Figure 57: FID88 – An enclosure, with the corners marked by ranging rods, likely forming part of a shieling complex and one of three features forming MYD33195.

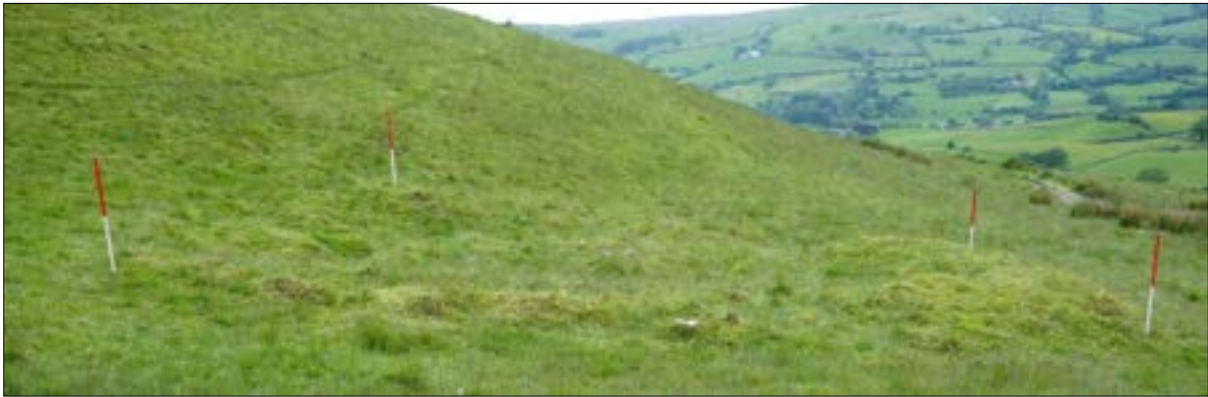
The area of focused line walking in area G identified little, with several possible LiDAR targets turning out to be unconvincing. However, a sub-rectangular enclosure formed by earthwork banks and cut into the hillside was identified at SD64476 95491 on Swarth Greaves, north west of Seat Knott (FID89) (figure 59, figure 58). The enclosure measures circa 8.4m wide and 10.3m long overall. The bank is L-shaped in form on the north east side of the feature where it is most prominent, measures between 2.40m and 1.4m in width and up to 0.4m high. The enclosure has an entrance on its north west side that is 1.8m wide. It is situated about 30m from a major trackway and about 80m east of the edge of MYD3610 Former Field System, Chapel Beck which is interpreted as Prehistoric or Roman, as well having a Medieval element and it could be related to these features. It was recorded to be in fair condition. FID89 It is of uncertain date but given these nearby features it could date from anywhere from the Prehistoric to Medieval periods.

Figure 58: FID89 - enclosure, NW of Seat Knott.

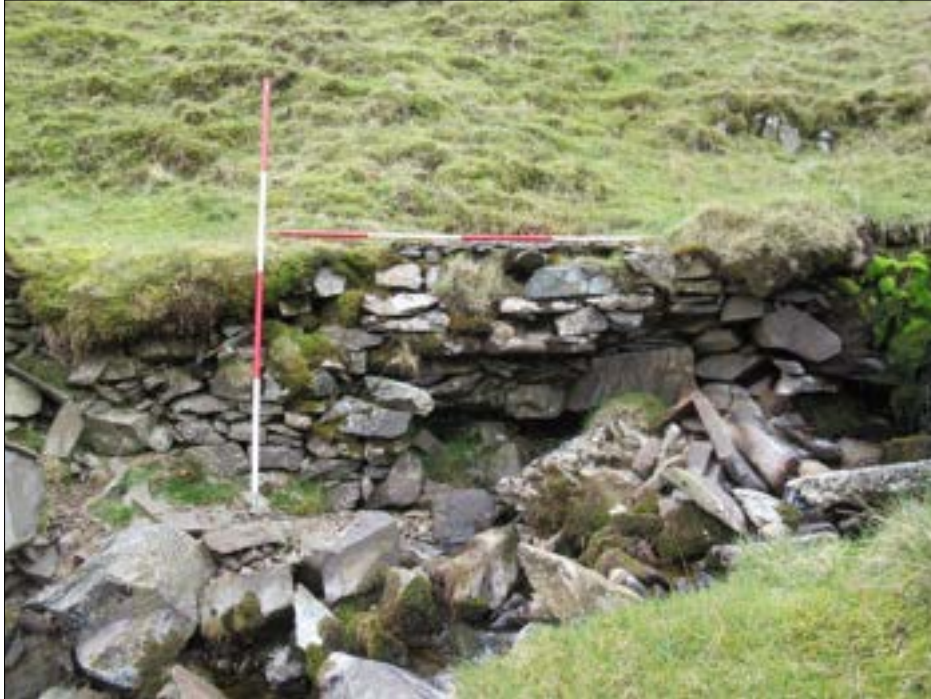
Figure 65: FID2 - Revetment wall with pipe outlet, chamber and trackway behind, Ashbeck Gill.

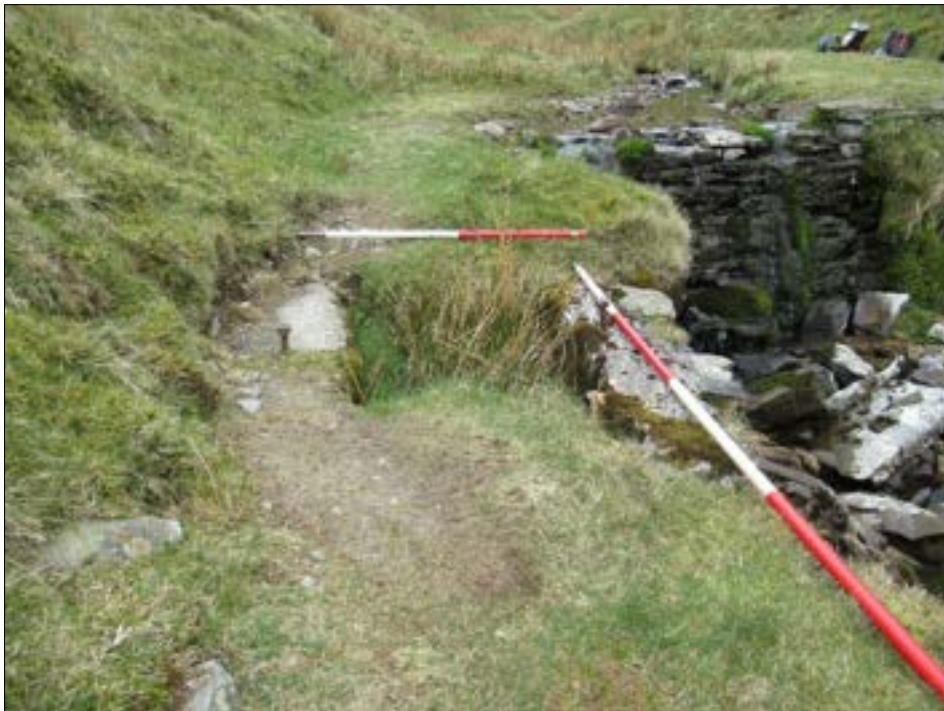
Feature ID	HER No	FISH Monument type	Final description	Period	NGR	Management issue	Condition	Photo No's
2		Water Supply and Drainage	An open topped chamber with a concrete top with some surviving fixing bolts for a cover that is now missing and a coursed drystone revetment wall structure is located at SD66664 94231, immediately south west of a weir recorded as F1 on the western side of Ashbeck Gill. The chamber top measured 1.4m by 1.6m in external size and the revetment wall 5.2m long and 1.25m high. An iron pipe is located just below the top of the chamber, facing out of the side of the structure facing the beck which likely functioned as an overflow outlet. The chamber was partially backfilled with soil and gravel. Its precise function was not known at the time of the survey but it may have acted as a sediment trap, filter or perhaps as means of creating a head of water to maintain pressure. The supporting revetment wall has suffered significant structural collapse due to water erosion and is actively under threat of further deterioration and is in poor condition. The chamber and revetment wall, along with the adjacent weir and pipe track are all part of the former water supply system for Sedbergh town which is of late 19th and early 20th century date. An online reference was found suggesting the section of the system in Ashbeck Gill was built in 1923. An illustration in a 1972 book by Alfred Wainwright shows what appears to be a wooden hut or structure in the area of the chamber but no trace of this is now visible on the ground.	Late 19th/early 20th century	SD66664 94231	Structural collapse, water action, erosion	Poor	0804-05, 0807-08 (wall), 0809-11 (hatch/chamber), figure 65, figure 66

Figure 66: FID2 - Chamber and pipe track with the revetment wall top also visible to the right, with the dam (FID1) in the background, Ashbeck Gill.

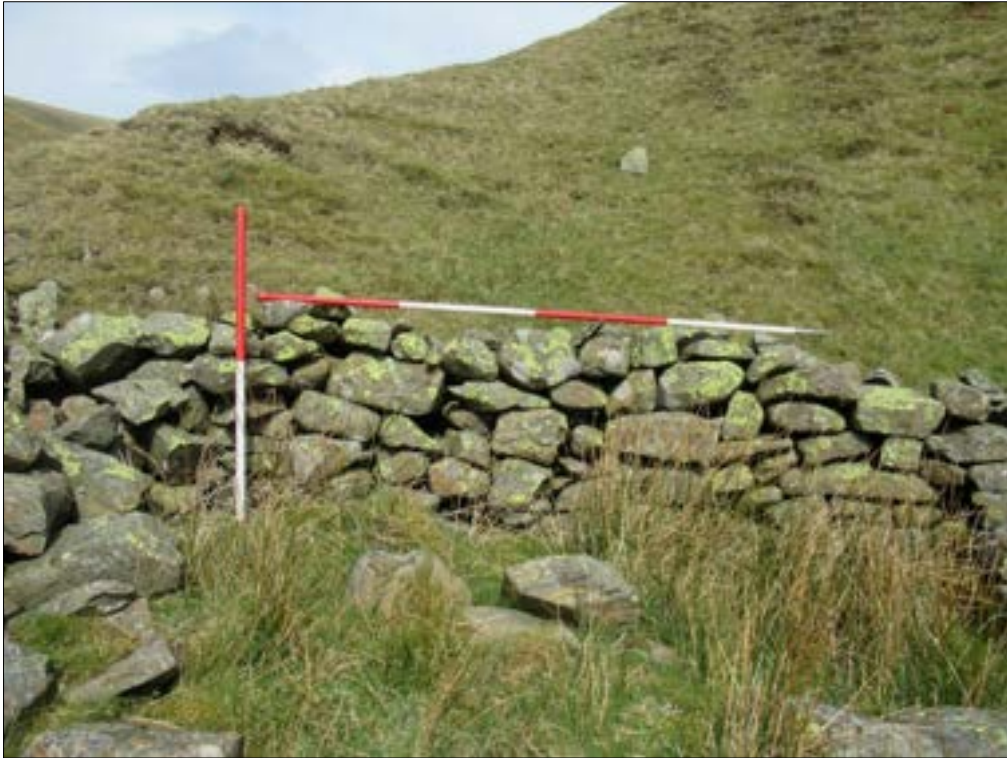
3	MYD60674	Washfold, Sheep Wash, Sheepfold	A large sheepfold located on the west side of Ashgill Beck located at SD66660 94062 of rough drystone wall construction measuring 13.7m wide, 50-60m in length and circa 1.6m in height. The fold is subdivided into three main sections with the internal walls measuring circa 0.8m in thickness. Two possible internal cells were noted with one located at the northern end of the fold comprising a rough arc of stone forming a small sub rectangular space on the inside of the external wall. The second is located in the central area of the fold and formed by corners in the northern external wall, and an internal wall which forms a sub rectangular space with an open end into the fold. The external walls measure circa 1m in thickness at their base and are circa 1.6m in height. Some wall corners were noted as having rounded corners and the use of water worn stone in the structure generally was apparent in places. The walls are generally of rough coursed rubble construction, with some variation apparent with the courses more apparent in some areas than others. Most of the walls are upstanding to some degree although there are a number of significant areas of collapse, with few of the walls surviving to their original height. There is some surviving evidence of topstones at the south end of the fold on the external walls, comprising more sub rounded boulders laid transversely across the wall in a rough fashion. At least two possible entrances or exits were identified with one located on the eastern external wall next to the beck and immediately downstream of the adjacent dam on the other side of the beck recorded as F4. The second entrance or exit was possibly located in the western external wall. It should be noted however that the ruinous nature of the walling made identifying original entrances and exits with certainty difficult. The adjacent dam is clearly related to the function of the fold and its siting next to the beck strongly suggest the feature was a washfold complex used for the washing of sheep with a temporary damming of the beck undertaken to create a deeper pool of water for the purpose. The fold was judged to be in fair condition although the site is becoming ruinous and is vulnerable to further deterioration and collapse. Finally, the ruinous nature of the site and the state of the walling would suggest it has been abandoned for some considerable time. The date of the site is unknown although the character of the walling might suggest an early Post Medieval date for the fold.	Post Medieval	SD6666094062	Structural collapse	Fair	0813-0819, 0820-0840, Figure 21, Figure 67

Figure 67: FID3 – A section of the external wall of washfold MYD60674, viewed from the inside of the fold facing north, Ashbeck Gill.

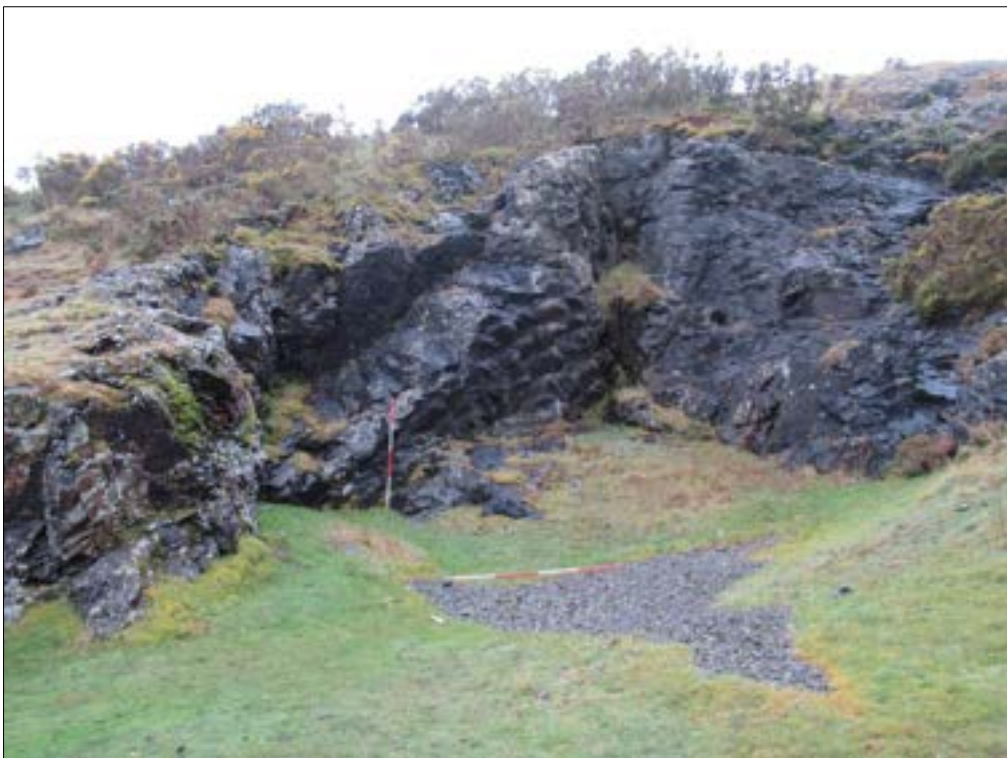
Figure 68: FID5 - Quarry associated with the construction of the Sedbergh Town water supply system, Settlebeck Gill.

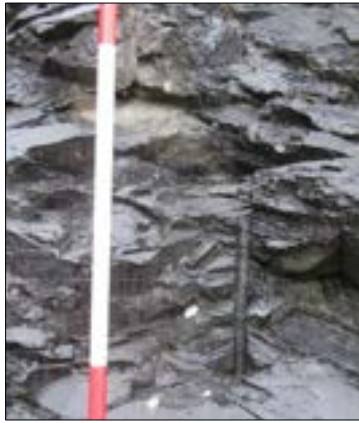
Figure 69: FID5 - Detail of drilled shot hole in quarry face.

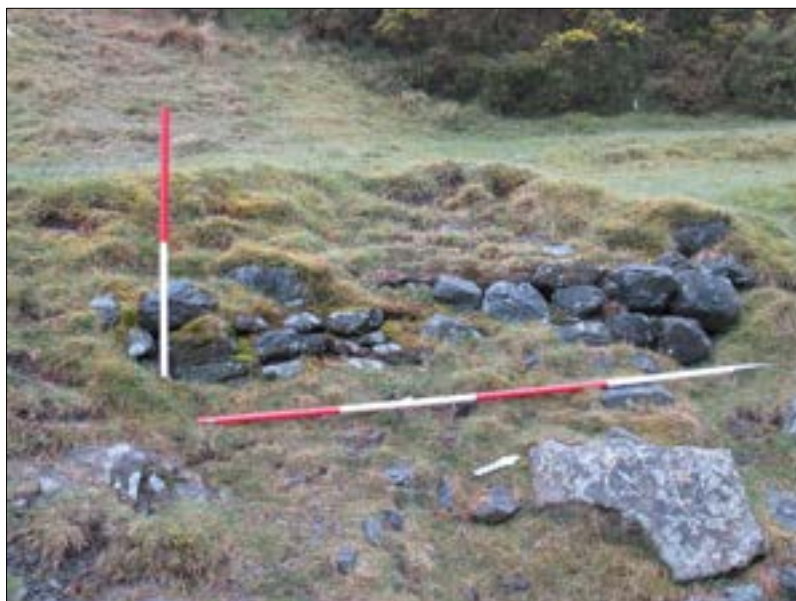
Figure 71: FID7 - Revetment wall supporting a trackway containing a pipe outlet, Settlebeck Gill.

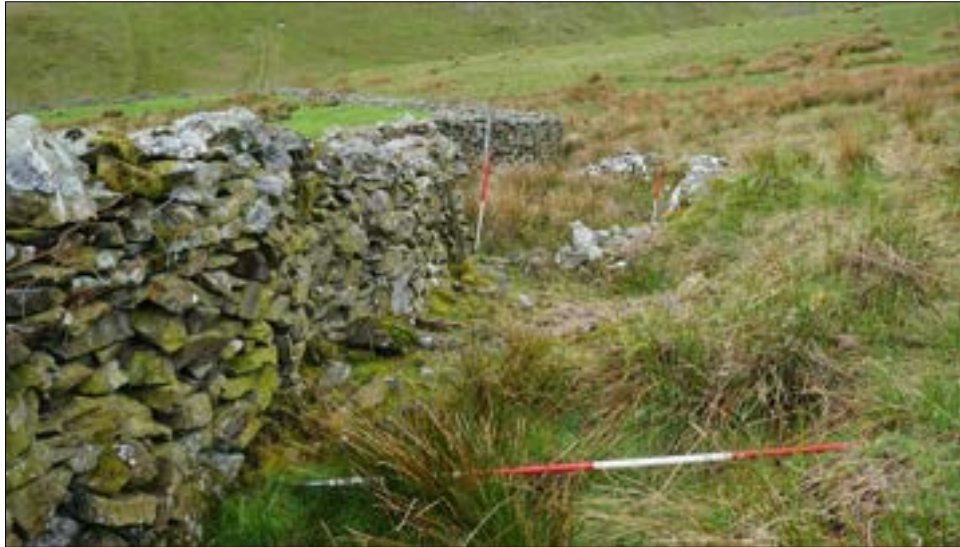
Feature ID	HER No	FISH Monument type	Final description	Period	NGR	Management issue	Condition	Photo No's
20	MYD50570	Sheep Fold	The remains of a two cell sheepfold measuring 18.9m in length and 5.8m wide of drystone wall construction are located at SD67039 93683. The main enclosure is of oval shape measuring 13.6m long and 4.8m wide, with its northern wall measuring circa 1m high and 0.45m wide and which is cut into the slope of Knott which rises behind. It was noted as in fair condition. The southern side of the fold is formed by the common boundary wall which curves out to the south at this point forming the oval shape of the fold. An entrance to the main cell is located on its western side and a smaller annex is located on the east side of the main oval which is largely collapsed and ruinous and in poor condition. The annex measures circa 5.3m by 2.3m with its curving wall dug into the slope. This wall runs to the common boundary wall joining it beyond the curving out section where it follows a straight course. An entrance now partly blocked by collapsed stone may have given access between the larger cell and its eastern annex. The form of the fold, both in utilising the common boundary wall and with its northern wall dug into the slope were observed as being unusual. No similar examples were recorded in the areas covered by the OCC surveys.	Post Medieval	SD67039 93683	Structural failure, bracken	Poor	6650-6655, 6660, figure 77, figure 78

Figure 77: FID20 (MYD50570) – Oval sheepfold with annex at its eastern end (foreground), built into a bulge in the boundary wall.

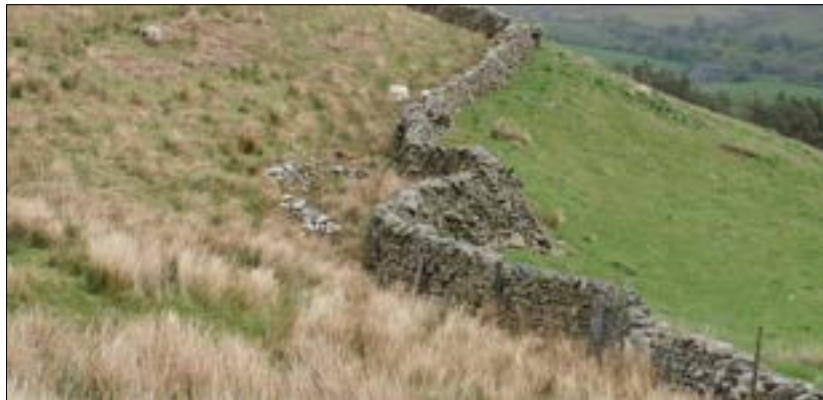
Figure 78: FID20 (MYD50570) – Oval sheepfold, facing south east.

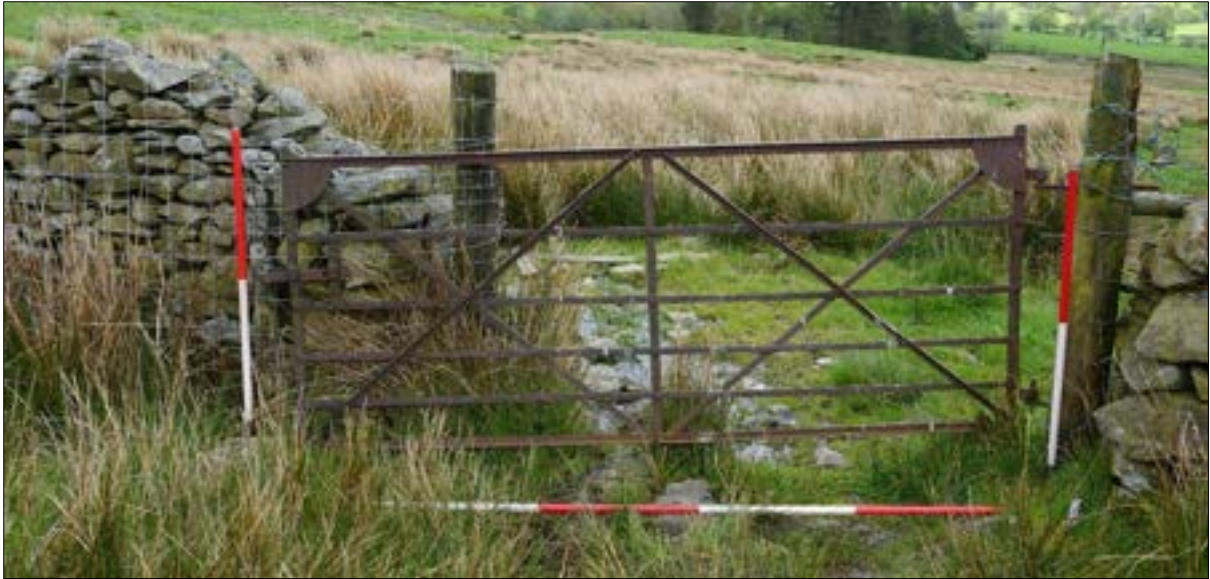
22		Gate	A cast Iron gate of riveted construction at the foot of Sickers Fell is located at SD66990 93670. The gate has a top and bottom rail made of T section cast iron and cross diagonals made of cast angle iron. The cross members are made from cast iron strip. It has cast iron corner re-enforcement pieces in a half moon shape and cast iron hinges. The riveted construction demonstrates that the gate was likely handmade and might be of 19th or early 20th century date. It was suggested this gate may have been from a cast iron post and fence system once located higher up on Brant Fell.	18th to 19th century	SD66990 93670	Decay (of metal)	Fair	6661 to 6663, figure 80

Figure 80: FID22 - Cast iron gate, facing south east.

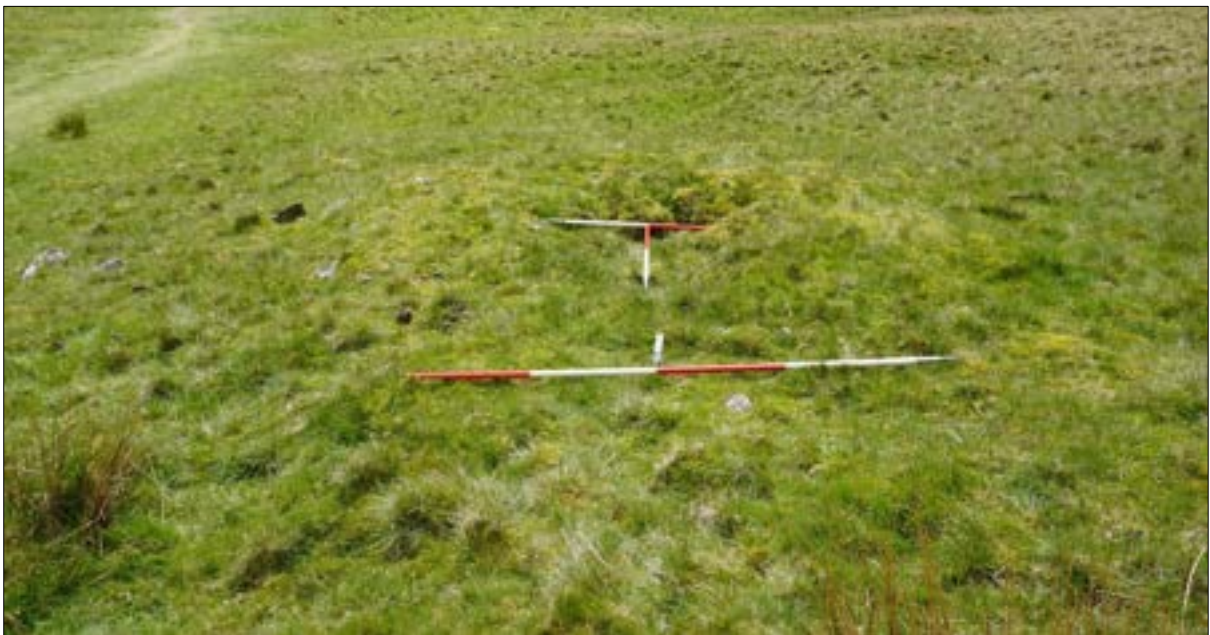
26		Potash Kiln	Two small circular earthworks located at SD65942 95384 and SD65938 93578 on the upper western side of Settlebeck Gill. The northern feature comprises a small circular mound circa 3m by 3.60m and circa 0.4m high, with a hollow centre measuring 1.20m by 2.10m. The former is poorly preserved and difficult to interpret, as it may have been partly destroyed or covered by two larger circular features (FID27) immediately north of it. The second circular earthwork is situated to the south of the first and comprises a larger circular mound measuring 7.3m by 10.7m and circa 0.4m high, with a hollow centre measuring 1.6m by 1.5m. A greater concentration of stone was noted in the fabric of the second larger mound which is in better condition than the smaller one immediately north of it. They are interpreted as possible kilns or drying clamps, perhaps for bracken to produce pot ash or for drying peat, although their exact function and date are unknown. Due to their location in the Howgills and not being situated on limestone geology it is thought unlikely they are limekilns. Similarly, no evidence of mining or other features associated with mining activities were located nearby or in any of the areas of the Howgills surveyed for the OCC project.	Post Medieval	SD65942 93584	Overgrown by reeds	Poor	6689-6694, figure 82

Figure 82: FID26 – A C-shaped earthwork interpreted as a kiln, Settlebeck Gill.

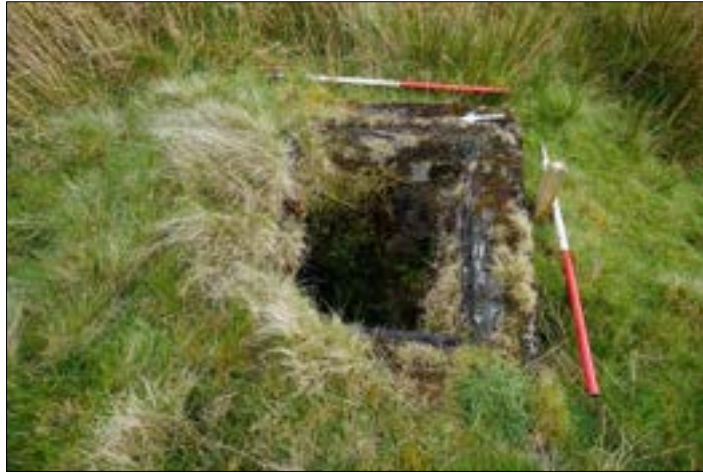
28	MYD1044	Water Supply and Drainage	A small concrete chamber measuring 1.55m by 1m and 0.28m in height, with an opening on its top surface measuring 0.68m by 0.77m located at SD66033 93615 on the west site of a minor tributary stream at the head of Settlebeck Gill. The cover is now missing and the badly rotted remnants of a wooden frame around the opening were noted. The concrete structure was noted as being quite rough and not of very recent origin. A pipe was observed leading from the beck underground into the chamber, and another pipe leading downhill of the chamber along the pipe track which heads towards the concrete chamber recorded as FID25. The lower portion of the chamber was infilled with sediment. The chamber forms part of the former water supply system for Sedbergh Town (MYD1044) and the Settlebeck Gill section was constructed in the 1880's.	Late 19th/early 20th century	SD66033 93615	None	Poor	6703-6705, figure 83

Figure 83: FID28 - Concrete chamber forming part of the former water supply for Sedbergh Town, head of Settlebeck Gill, facing east.

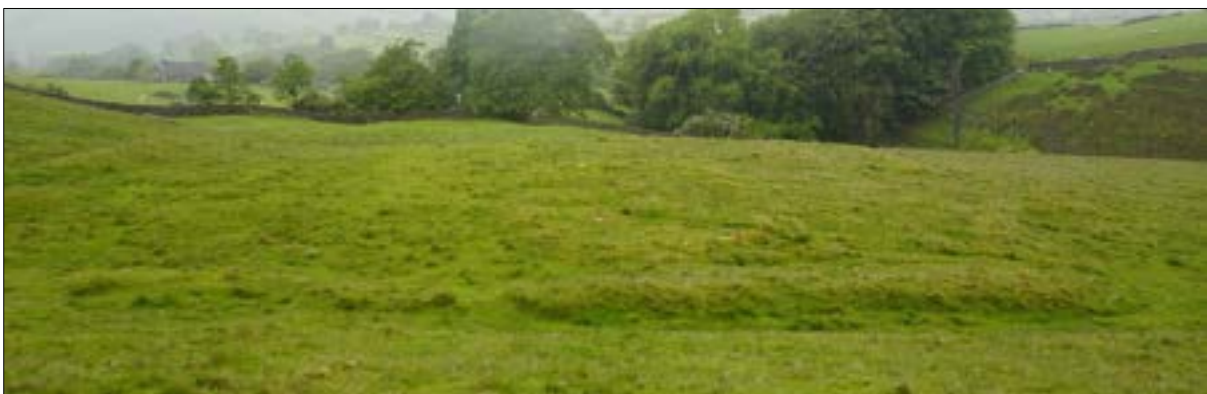
Figure 98: FID51 (MYD33352) - Enclosure with internal rectangular building (marked with ranging rods) at Craggstones. Some truncation and erosion from a track running from bottom right towards the middle left of the image crossing the enclosure and building is visible. View facing west.

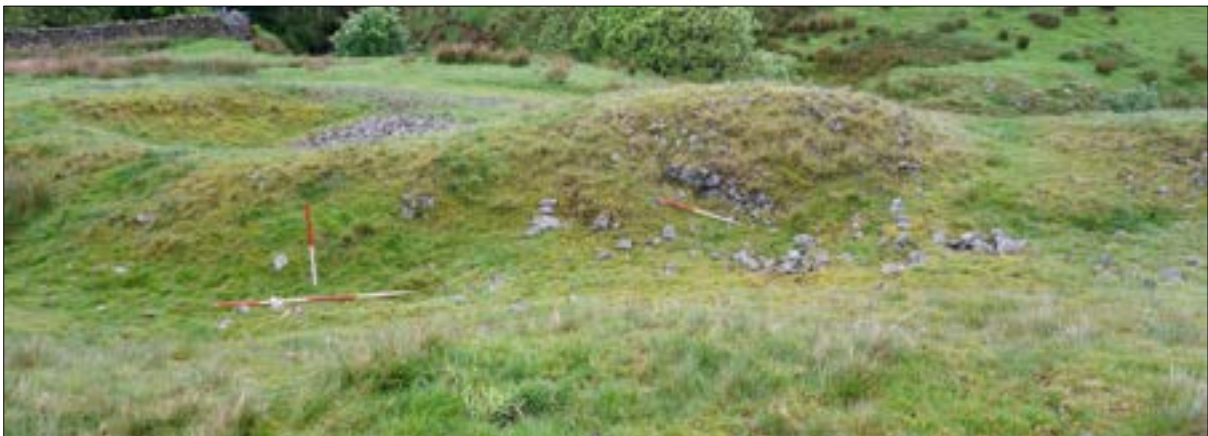
Figure 100: FID52 - Overview shot of quarries with a revetted spoil heap in the centre right. The spoil deposit shown in figure 99 is visible in the background. Facing north west.
