A Report on Community Archaeological Walkover Surveys of the Southern Foothills of Brant Fell

Project Archive Report

By Dr Douglas James Mitcham
Community Heritage Officer
Yorkshire Dales National Park Authority

May 2023

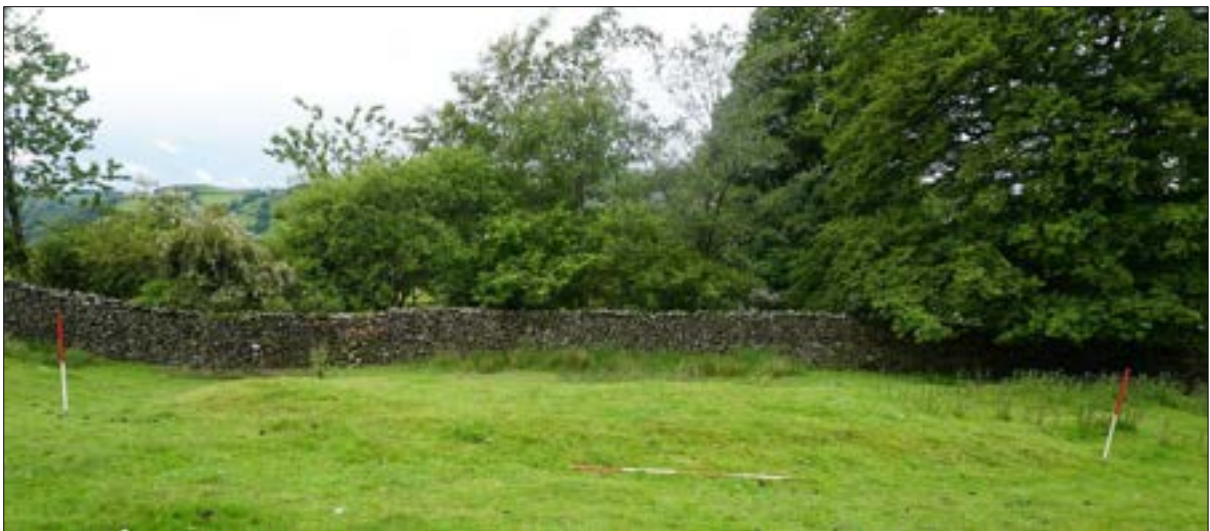
Further features included Post Medieval quarries (FID52) and an irregular stony mound near to the boundary of the common (FID68, figure 110) which was difficult to interpret but might reflect a spoil heap, perhaps connected to various areas of

Figure 110: FID68 - An irregular stony mound located at SD64287 93628 next to a trackway and immediately east of the common boundary wall, south of Crosdale Beck.

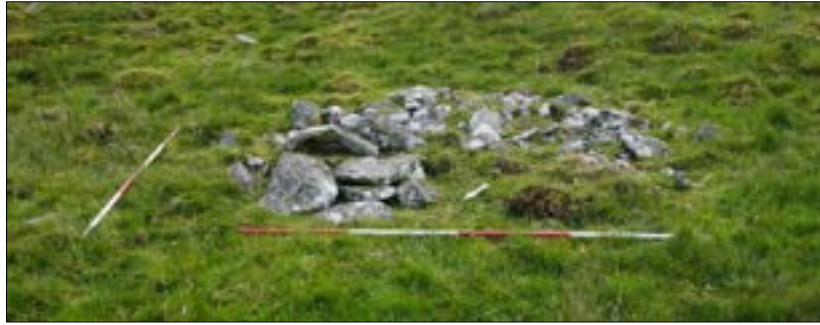
Figure 114: FID73 - A spread of stone on the hillside on the north side of Winder, facing south. It was regarded as looking artificially constructed and was observed to be sitting on a platform. A severely denuded cairn is the favoured interpretation.

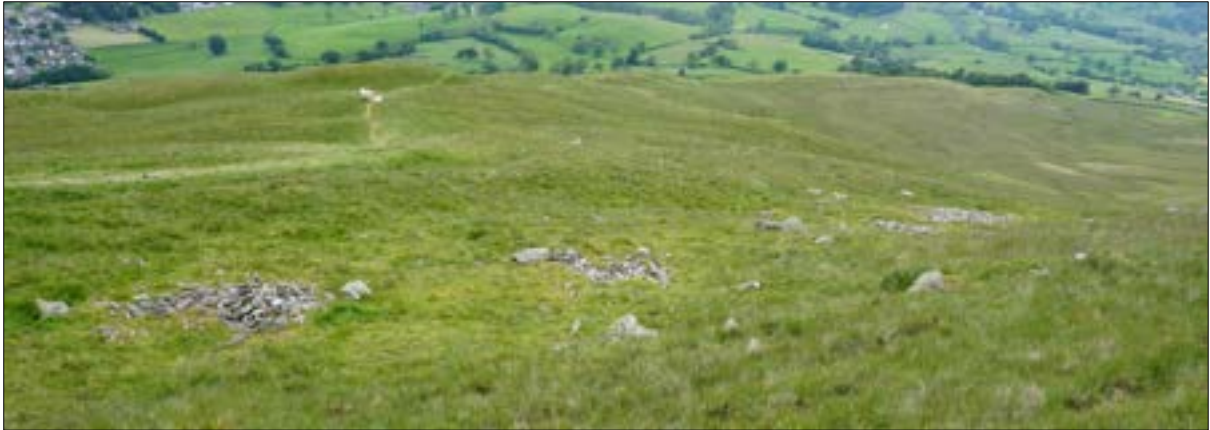
Figure 117: FID76 - A number of stone spreads situated on the south side of Winder spread over an area circa 100m by 30m. Whilst the spreads may be the result of natural scree accumulation some evidence was observed of working or shaping and drill marks on an embedded stone. The spread in the foreground also appears to be infilling an area cut into the slope – suggesting this resulted from human activity rather than natural processes.

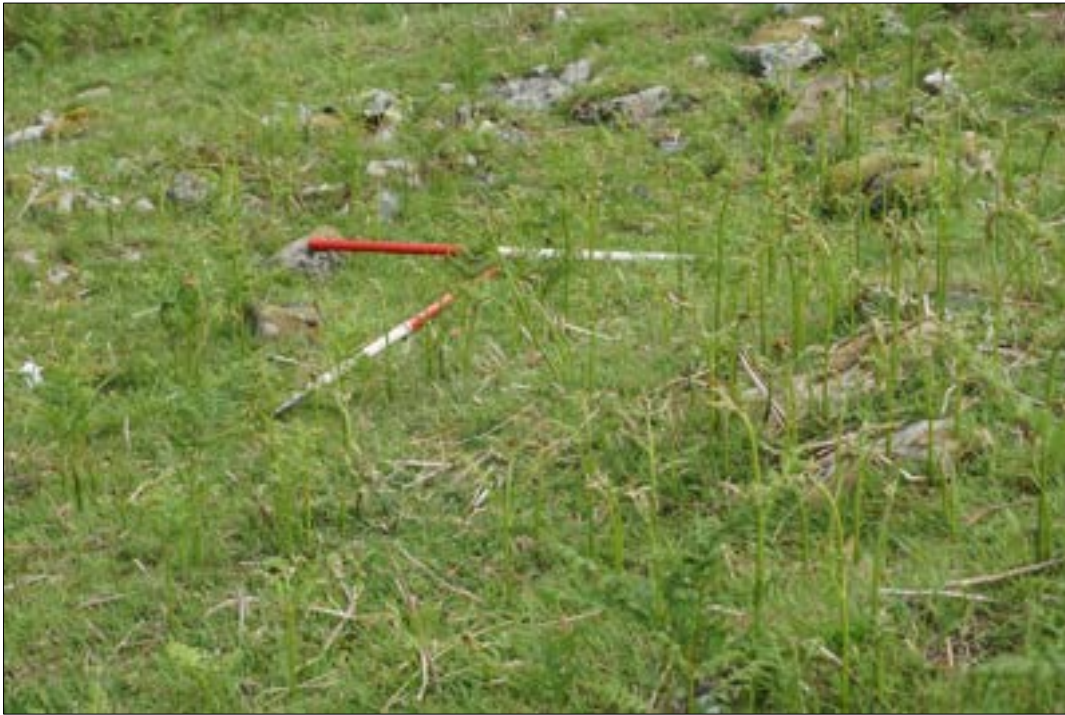
Figure 121: FID78B - A circular stony bank measuring 6.7m by 6m and circa 2m wide, which may have an entrance facing north, although largely obscured by bracken. View facing south.

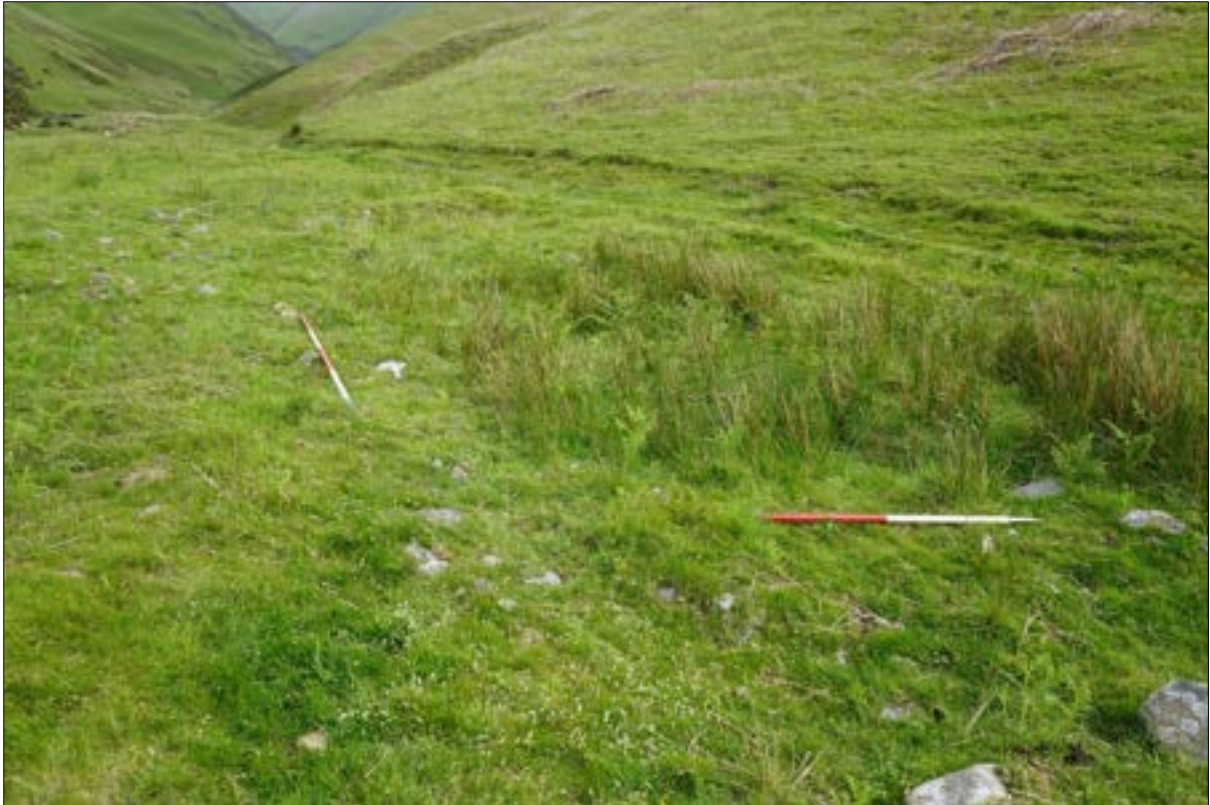
Figure 122: FID78C (MYD33256) – Another sub-circular feature within the group, again obscured by vegetation growth. Possibly another hut comprising a U-shaped stony bank. View facing north east.

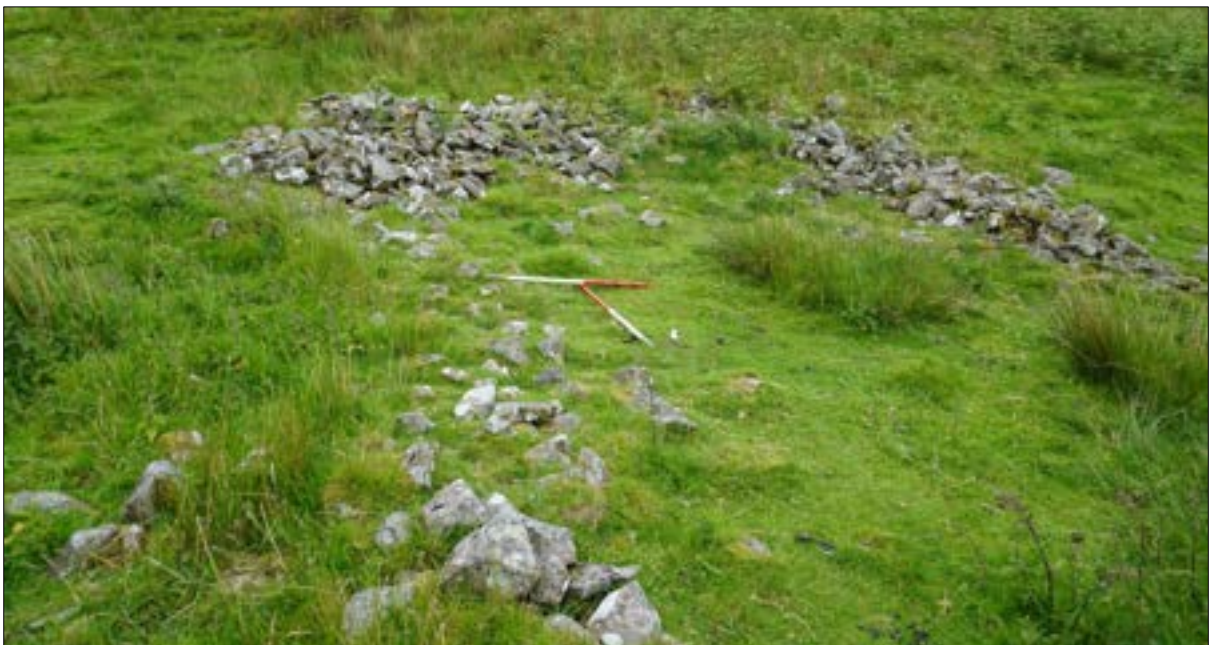
79	MYD33257	Sheep Fold	A ruinous sheepfold of sub rectangular shape, with a linear arm extending west from its northern end located at SD64884 96375 on the south side of Calf Beck. The feature is recorded on the HER as MYD33257. The walls of the structure are now almost entirely collapsed, forming stony spreads circa 1m 10cm wide. The fold measured circa 10.8m wide by circa 13m long overall. The internal dimensions of the main enclosed rectangular area is circa 3.90m wide by 8.20m long. A single entrance is evident on its western side measuring circa 2.40m wide. The structure is circa 24m south of the beck and located on a level area of ground that is considerably higher than the beck, suggesting it is a sheepfold and not a washfold. It is presumed to be of Post Medieval date. Bracken encroachment was also noted as an issue.	Post Medieval	SD64884 96375	Bracken	Poor	6897-6899, figure 125

Figure 125: FID79 (MYD33257) - A ruinous sheepfold of sub rectangular shape, with a linear arm extending west from its northern end on the south side of Calf Beck.

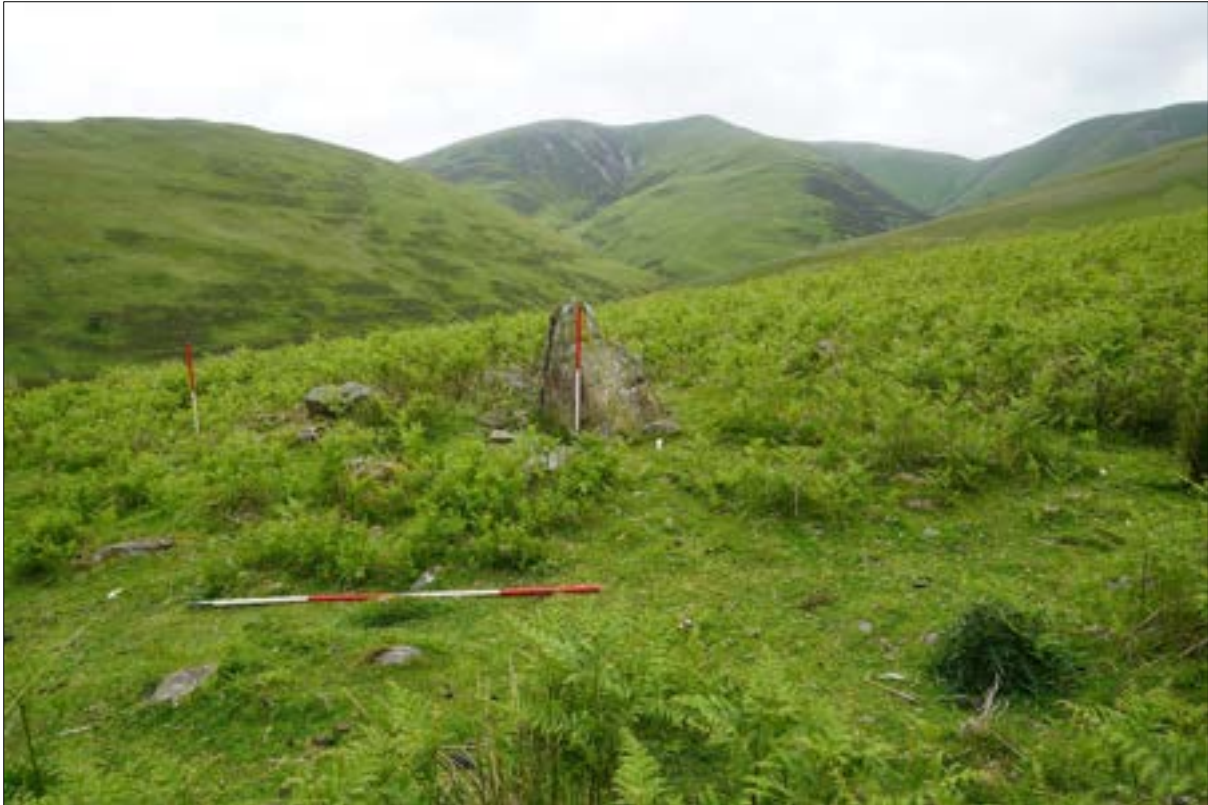
81		Stone, Natural Feature, Ring Cairn	A large upright stone circa 1m high and 1m wide located at SD64797 96147 at Bram Rigg which is partially surrounded by a spread of stone and a possible ring cairn measuring circa 7.5m by 5.30m. The upright stone may be a natural outcrop around which a ring cairn was constructed. Bracken encroachment was noted as an issue.	Unknown, prehistoric?	SD64797 96147	Bracken	Fair	6904-6906, figure 126
82	MYD866	Longhouse	A rectangular building at Bram Rigg located at SD64779 96129 measuring 5.3m wide, 12.8m long and 0.4m in height recorded on the HER as MYD866. The building is formed of stone walls which incorporate natural outcrops and has a cross passage in its centre with entrances on both sides of the building, dividing the structure into two rectangular cells. The eastern half of the building has an internal length of about 2m and the walls are circa 1.2m. The western half of the building is longer and measures circa 4.2m internally and also has an area of tumbled stone within. The building is of long house form with a cross passage and is likely to be of Medieval date. It is situated on a level area of the hillside. It is being impacted by a bracken infestation. It sits within the area enclosed by MYD33261 and could be related.	Medieval?	SD64779 96129	Bracken	Fair	6907-6909, figure 54.

Figure 126: FID81 - A large upright stone (probably natural) circa 1m high and 1m wide located at Bram Rigg which is partially surrounded by a spread of stone and a possible ring cairn measuring circa 7.5m by 5.30m.

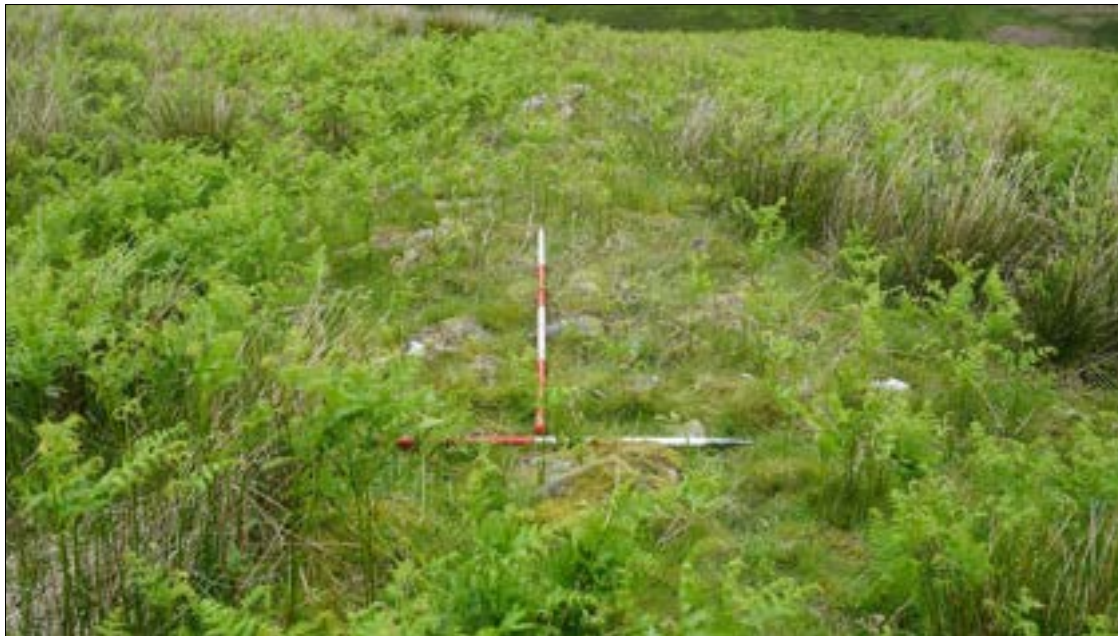
83		Bank (Earthwork)	A large stone and earth bank running east-west up the hillside on Bram Rigg at SD64754 96092 which measures 2.40m wide, circa 164m long and up to 0.3m high. It may be an internal division of the larger enclosure MYD33261. It is visible on EA Lidar as a curvilinear bank with a right angled extension, with a possible gap visible in the bank. It is situated circa 45m south of the rectangular building MYD866 and could be related to it. Encroachment by bracken was noted as an issue.	Medieval?	SD64754 96092	Bracken	Fair	6910-6912, figure 127
84		Sheep Fold, Circular Enclosure	A stony earthwork bank defining a circular feature with a central depression located at SD64751 95978. It measures 11.9m wide, 8.4m long and up to 0.3m high. The feature was difficult to identify on the ground due to bracken growth but is visible on EA LiDAR data. It is interpreted as a possible small fold and is located within the area enclosed by MYD33261.	Medieval/Post Medieval?	SD64751 95978	Bracken	Poor	6913-6914, figure 128

Figure 127: FID83 - A large stone and earth bank running east-west up the hillside on Bram Rigg. It may be an internal division of the larger enclosure MYD33261.

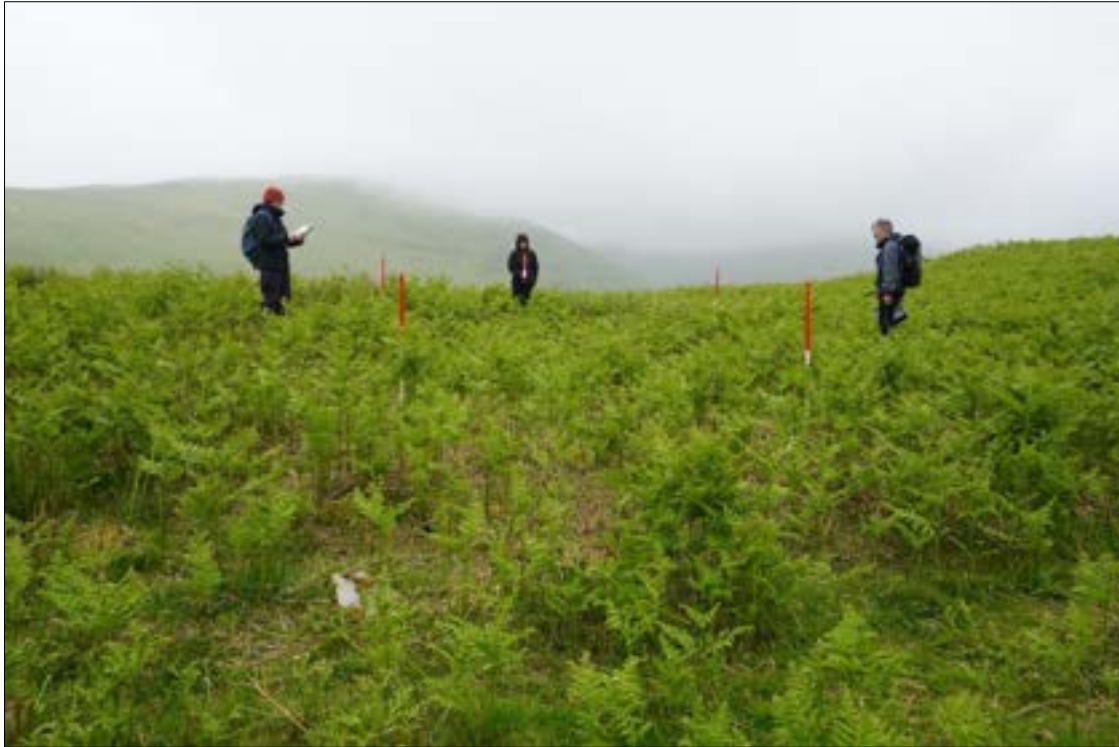
Figure 128: FID84 - A stony earthwork bank defining a circular feature with a central depression located at SD64751 95978. The feature was difficult to identify on the ground due to bracken growth, volunteers and ranging rods mark its outline. View facing north.

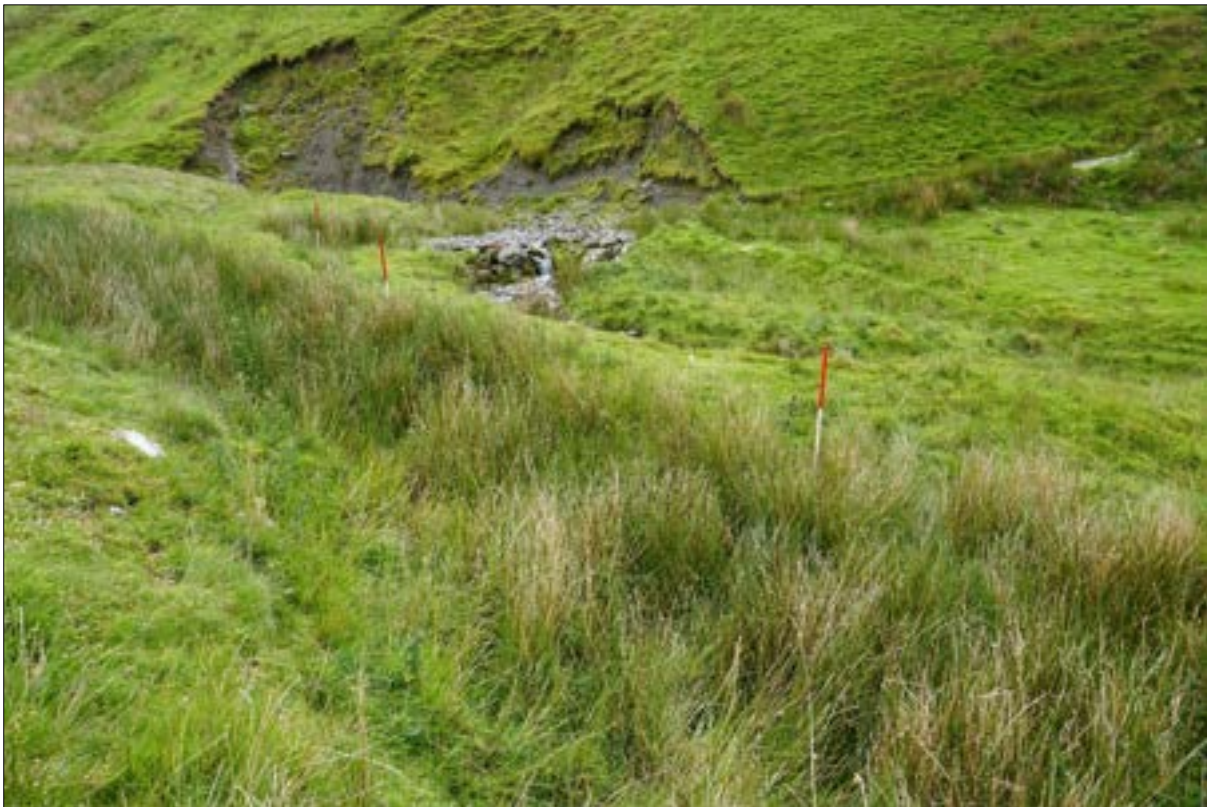
Figure 129: FID85 – View along the leat associated with the sheepwash and fold, facing south.

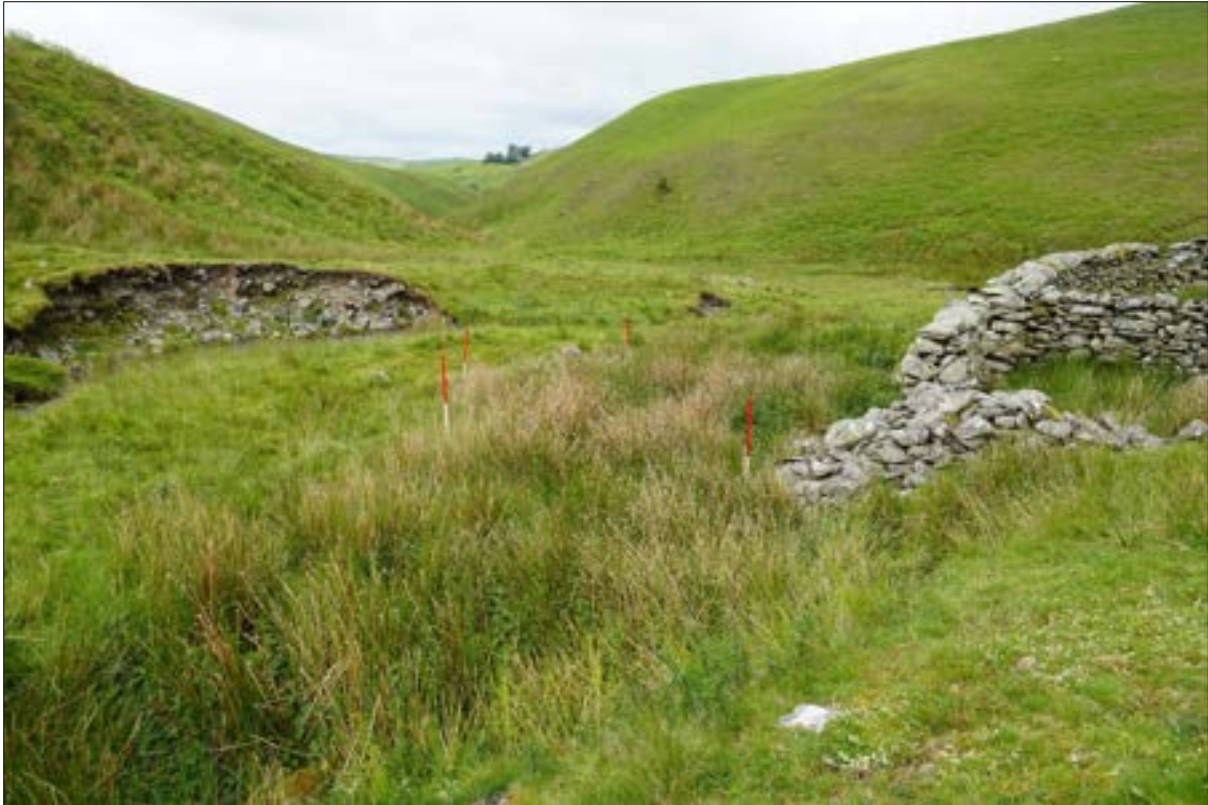
Figure 130: FID85 - Sheepwash and leat associated with fold at Ben Folds. Ranging rods mark the outline of the sheepwash.

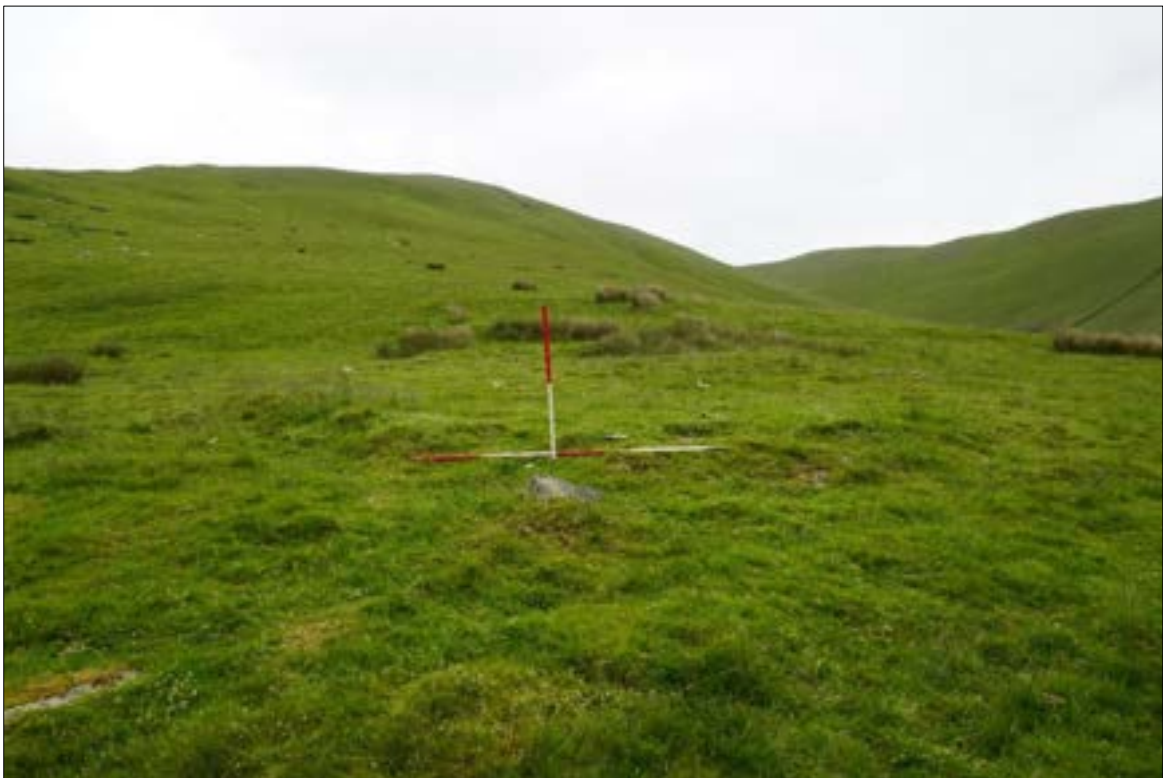
86	MYD33195	Curvilinear Enclosure, Bank (Earthwork), Building Platform	A series of stony earthworks located at SD65238 95627 north of Swarth Greaves Beck comprising a partial U-shaped enclosure bank within which sits within a second U-shaped earthwork. The partial enclosure bank is circa 1.4-2.5m wide and covers an area 9.9m by 5.9m with its open end facing west. Another U-shaped stony earthwork bank that is circa 1.10m wide is sat within the former, with an internal length of circa 4.5m and is open at its western end, which may be a stance for a building. Another sub rectangular earthwork bank is situated next to this on its eastern side. The immediately adjacent sub rectangular stony earthwork bank measures between 1.3m and 1.9m in width, and its external dimensions are circa 9m by circa 3m. It was recorded as in good condition and interpreted a shieling of Medieval to Post Medieval date. Two other nearby features FID87 and FID88 may be related and form part of the same complex. Three nearby existing HER monument points for shielings or sheep folds (MYD33195) are located circa 30-40m north west and probably reflect erroneous grid references for the same features.	Medieval?	SD65238 95627	None	Fair	6939-6946, figure 131

Figure 131: FID86 - A partial U-shaped enclosure bank within which sits within a second U-shaped earthwork located north of Swarth Greaves Beck. View facing east.

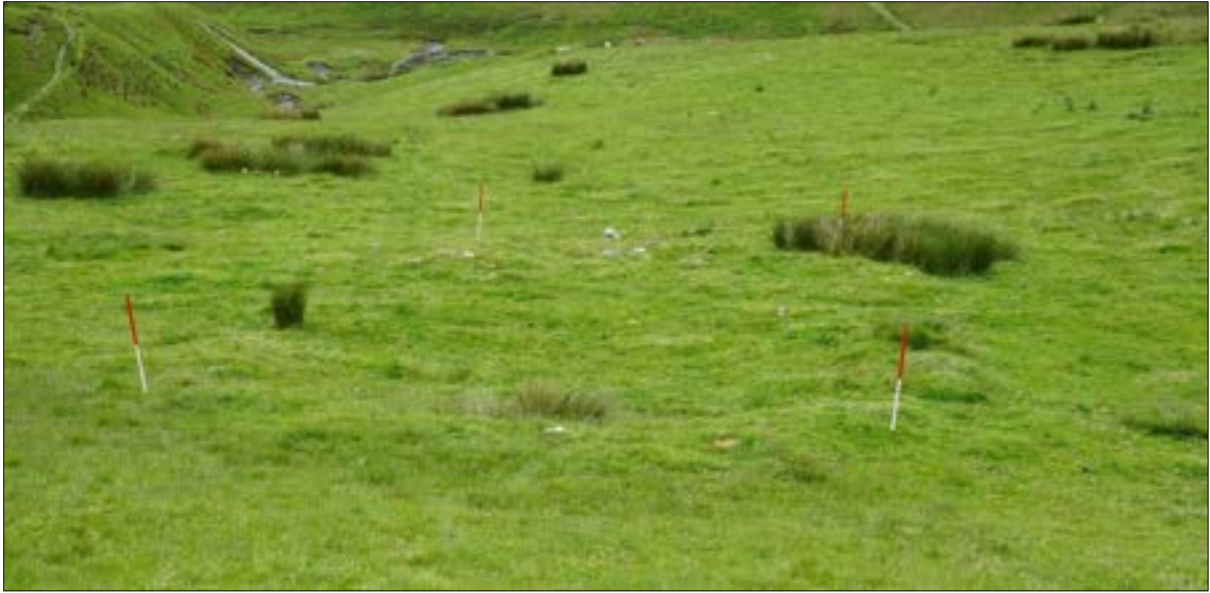
87	MYD33195	Revetment, Curvilinear Enclosure, Bank (Earthwork)	A sub rectangular earthwork bank located at SD65261 95639 to the north of Swarth Greaves Beck forming an enclosure, measuring 13.3m long, circa 4m wide and around 0.3-0.5m high. The banks vary in width from 1.3-2.5m. The western half of the enclosure has a stone spread within and evident stone within its banks, as well as a section of revetment wall on the outside of the bank at its western end, suggesting there may have been a single cell structure at this end. A possible entrance was noted on the southern side of the enclosure in the centre that is 1.2m wide. The feature is situated at the base of a slope on a level area, circa 26m north east of FID86. It is in fair condition and may be related to the former, as part of a shieling complex of Medieval to Post Medieval date. It is likely one of the features indicated by the central point of HER record MYD33195 which is currently circa 46m north west of its location.	Medieval?	SD65261 95639	None	Fair	6947-6953, figure 132

Figure 132: FID87 - A sub rectangular earthwork bank located to the north of Swarth Greaves Beck forming an enclosure with a stone spread within.

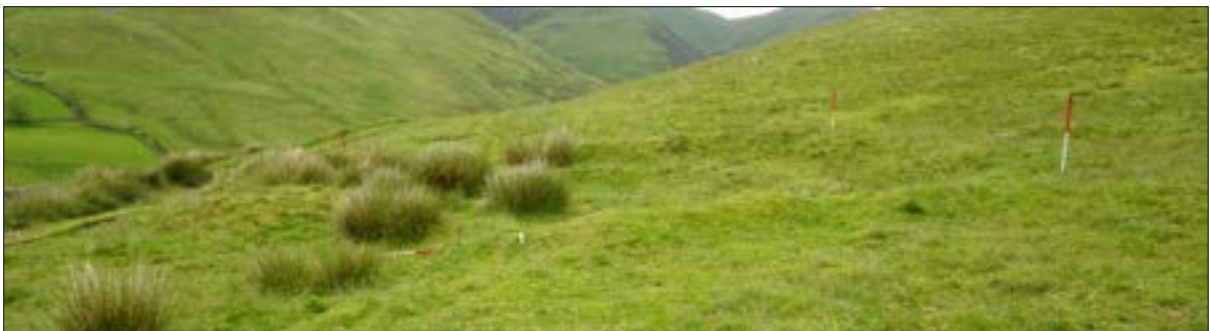
90	MYD33262	Sub Rectangular Enclosure, Curvilinear Bank, Bank (Earthwork), Building Platform	A sub rectangular earthwork enclosure containing a second U-shaped earthwork bank located at SD64355 95379 at Swarth Greaves recorded on the HER as MYD33262. The larger sub rectangular enclosure measures 11.2m wide by 12.8m long overall and 0.3m high. The bank varies in width from 1.2m to 2.3m and has a 2.5m wide entrances on its southern side. A section of missing bank on the north side appears to be a result of erosion from vehicle traffic. The internal earthwork bank within is U-shaped with the open end facing west and is circa 5m wide by 4.1m, with a 1.2m wide bank and may reflect a former building. The feature is set against the hillside and a track is located next to the feature at its western end. The feature is in fair condition and of uncertain date, and could be Early to Late Medieval.	Medieval?	SD64355 95379	Erosion - vehicle traffic	Fair	6967-6972, figure 133

Figure 133: FID90 - A sub rectangular earthwork enclosure containing a second U-shaped earthwork bank located at Swarth Greaves recorded on the HER as MYD33262.

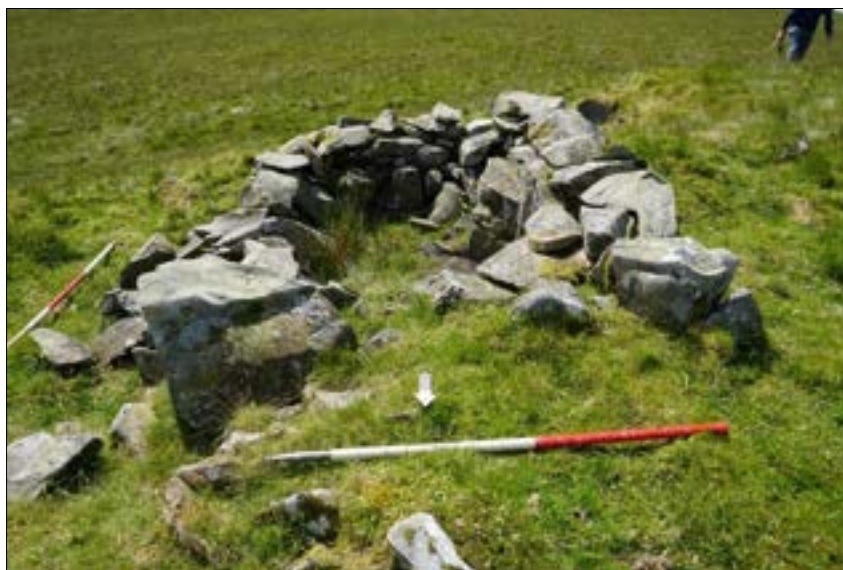
Figure 134: FID91 - A sub rectangular stone structure presumed to be a shelter located on the north east side of Crook.

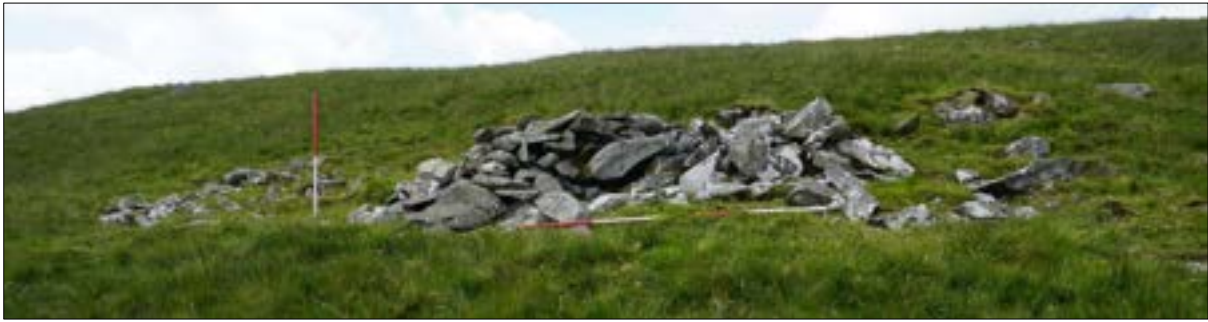
Figure 135: FID92 - A small sub rectangular stone built shelter to the east of the summit of Crook.

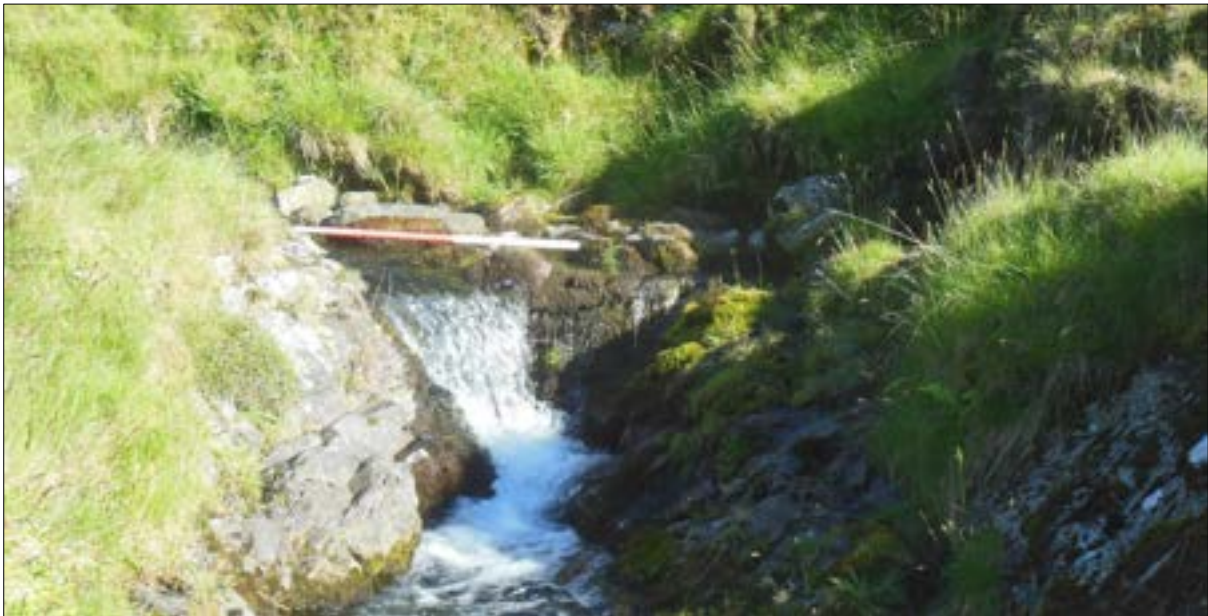
97		Weir, Leat	A small structure on the bank of Crosdale Beck marked on OS mapping as a weir at SD64569 93764. It measures circa 1.6m wide with a 0.6m high fall and comprised a low stony bank constructed on south side of Crosdale Beck with a metal pole (now covered in growth/moss) extending across to the north bank. There was no evidence of a man-made structure on the north side. A shallow leat was also observed on the south side of the beck, running along the hillside parallel to the beck which is up to 0.2m deep but is frequently silted up. The leat continues for more than 100m and has a stone bank in places, terminating near to the sheepfold MYD55509 at a large pile of stones where the channel runs to the beck but it may have originally gone further to SD64425 93714 very close to the washfold.	Modern?	SD64569 93764	Water action - erosion	Fair	6996-7006, figure 140 (weir), figure 141 (structure, south bank), figure 142, figure 143, figure 145 (leat), figure 140, figure 141, figure 142, figure 143, figure 144, figure 145

Figure 140: FID97 – Weir in Crosdale Beck marked on OS mapping and located at SD64569 93764.

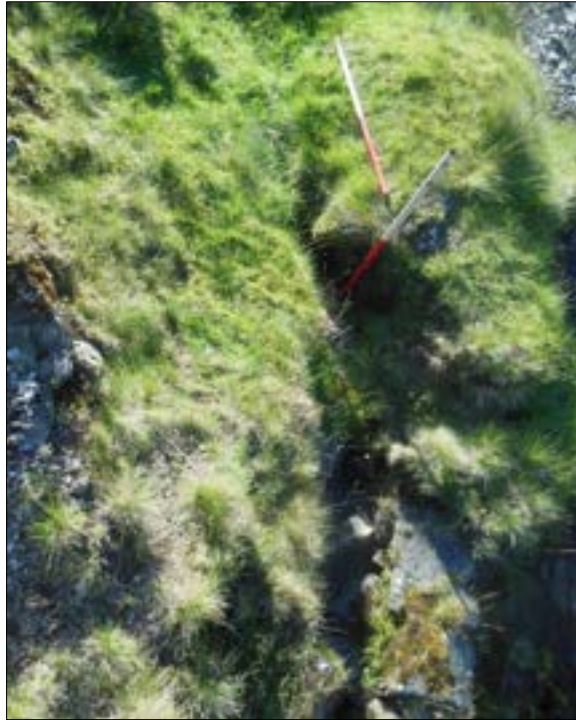
Figure 141: FID97 – View of the end of the leat and the structure (right hand side) on the south side of Crosdale Beck, located next to the weir shown in figure 140.

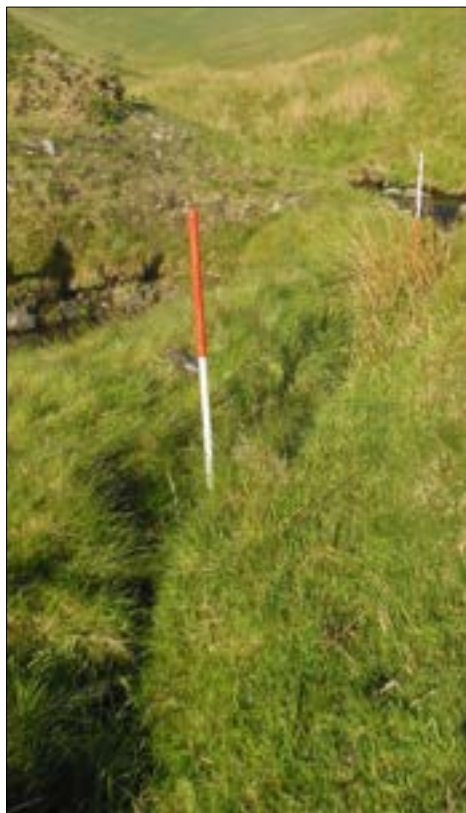
Figure 142: FID97 – Leat on the south side of Crosdale Beck looking east.

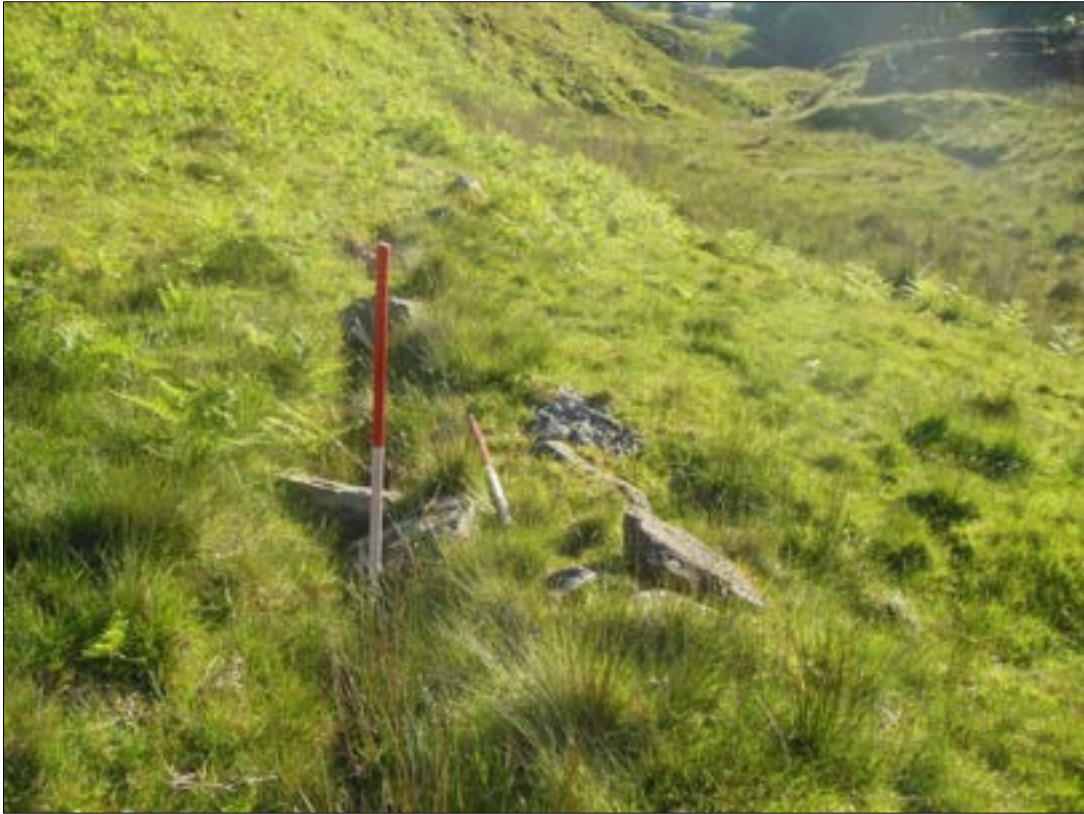
Figure 143: FID97 – View showing the line of the leat close to its end approaching the sheepfold and sheepwash (facing west).

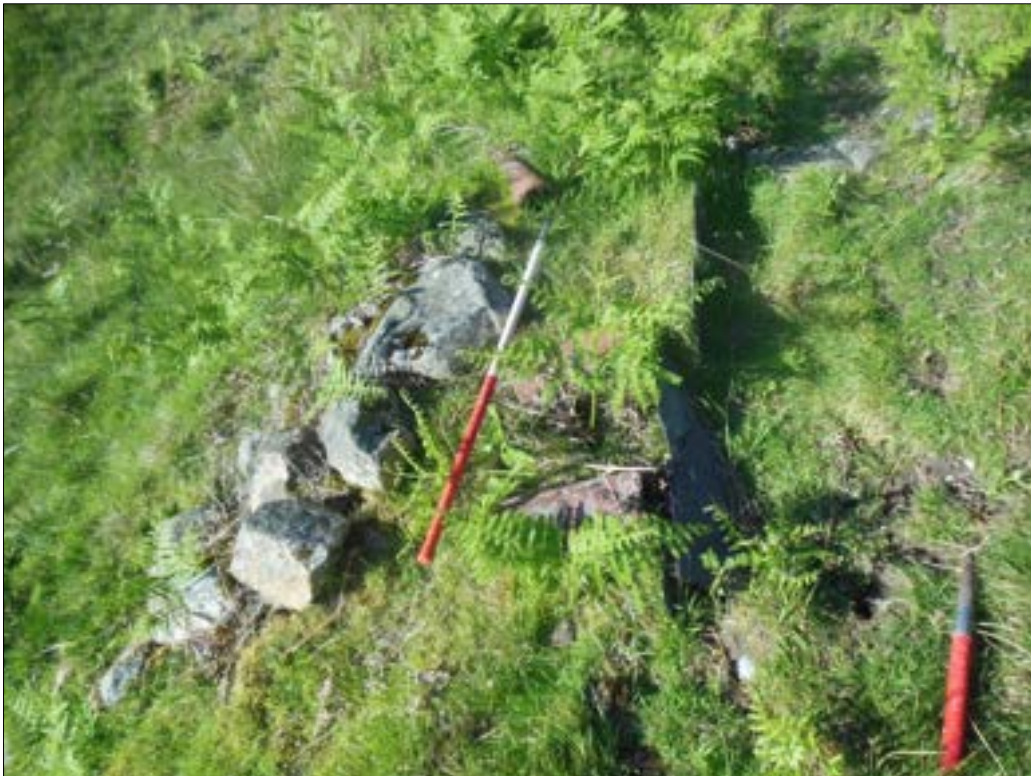
Figure 144: FID97 – View of the end of the leat from above with North to the left. The upper edge is marked by slates stuck edge on into the ground. A section of ceramic drain pipe is also visible.

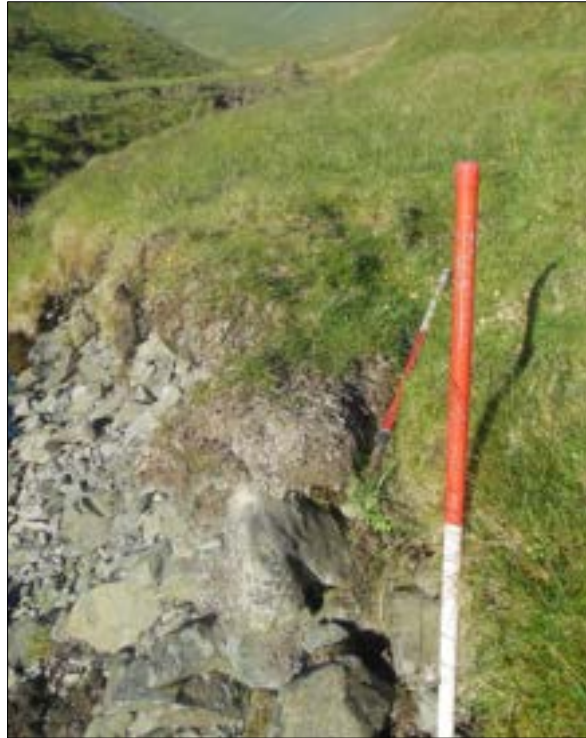
Figure 145: FID97 – View of the leat where it enters Crosdale Beck, facing east.

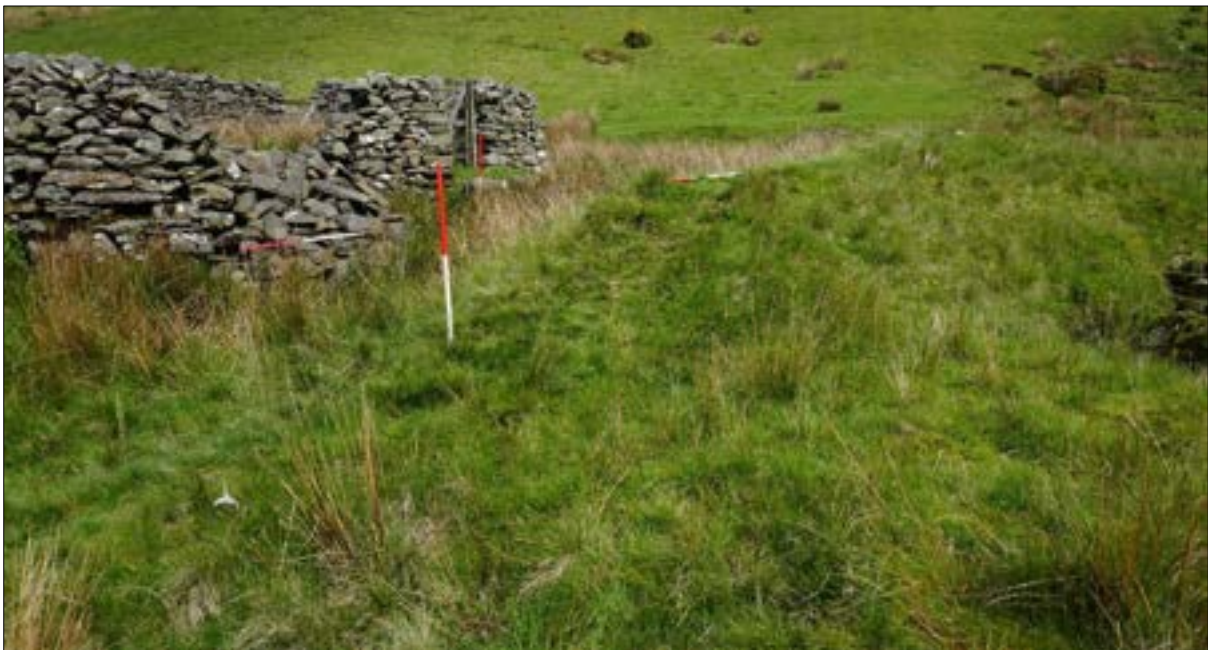
98		Sheep Wash	A sheep wash adjacent to the sheepfold MYD55509 recorded as FID42 and located at SD64404 93735. The narrowest section of the sheep wash measures 2.60m wide, 13.3m long and up to 1m high. It has been created in a low lying area next to the beck which is now silted up and full of reeds, comprising a stone and earth bank to the south measuring 13.30m long and 1m high and a leat which runs north towards the beck and continues to re-join the beck to the south. The section of the leat on the south side of the wash was noted as partly stone lined. A stone built plinth was noted on the western side of the wash on the outside of the sheep fold. The sheepwash was noted as of in poor condition because it is very overgrown with reeds and silted up, although its major components all still survive to a good extent. It is of post Medieval date and associated with a sheepfold that is likely to be of 18th century or later date. It is believed to have been used into the mid-20th century.	Post Medieval	SD64404 93735	Silted up, overgrown with reeds	Poor	6790-6791, figure 146

Figure 146: FID98 - A sheep wash adjacent to the sheepfold MYD55509 (FID42), north of Crosdale Beck. It has been created in a low lying area next to the beck marked by the reeds in the photo. It comprises a stone and earth bank and an area that has been excavated out to create a pool (towards the rear of the image). It is associated with a leat which runs towards the beck and continues to re-join the beck to the south (FID97).

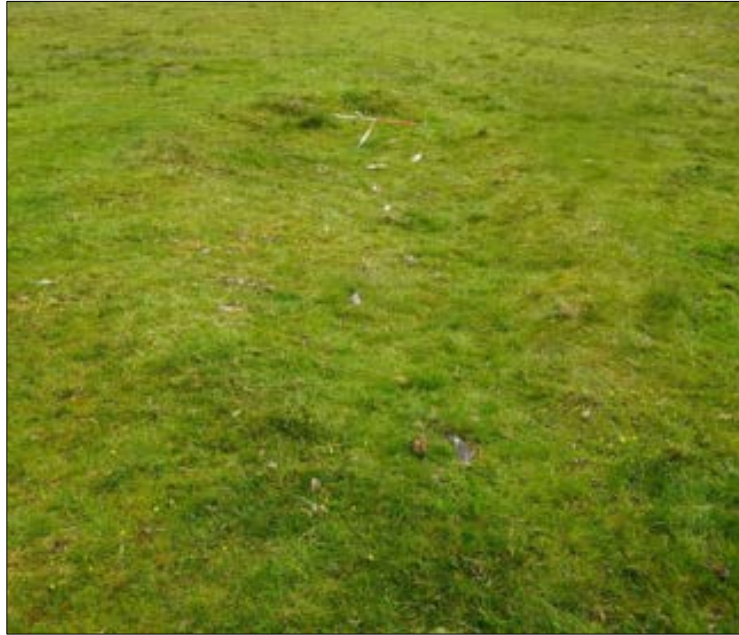
Figure 147: FID99 - A shallow quarry scoop on the south side of Crosdale Beck which likely reflects a surface quarry.
